# James A. FitzPatrick Nuclear Power Plant

**ACRS License Renewal Subcommittee Presentation  
September 5, 2007**

# ***Torus Repair***

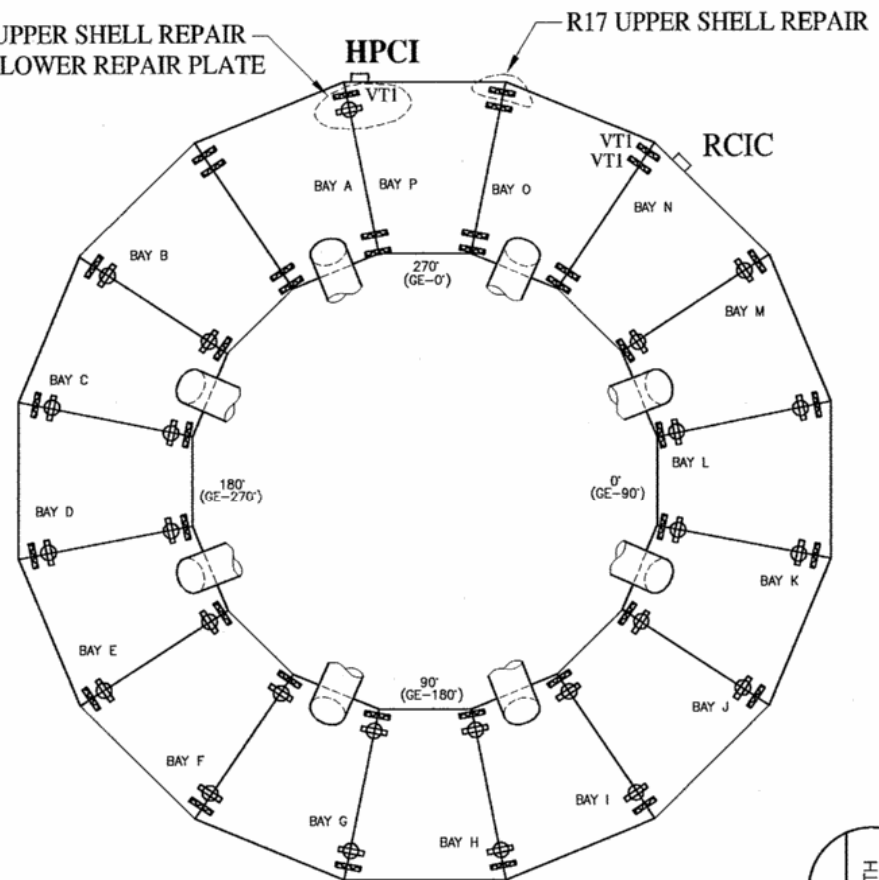
R17 UPPER SHELL REPAIR  
2005 LOWER REPAIR PLATE

- Extent of condition actions from Root Cause required additional shell exams during refueling outage October 2006
- ASME visual exams of similar ring girder gusset welds performed at HPCI and RCIC steam discharge locations
- General visual exams of similar ring girder gusset welds performed at several locations throughout the Torus
- Exam results reported shell base metal flaws at two additional locations in the HPCI discharge bay

- ASME Section XI code repairs were performed by grinding to remove the flaws and welding to restore configuration
- Review was performed to confirm the HPCI steam discharge loading also caused these flaws
