Oyster Creek Generating Station  
Facility Operating License No. DPR-16  
NRC Docket No. 50-219

Subject: Submittal of Information to ACRS Plant License Renewal Subcommittee Related to AmerGen's Application for Renewed Operating License for Oyster Creek Generating Station (TAC No. MC7624)

**Oyster Creek  
License Renewal Project  
Drywell Monitoring Program**

**Information for ACRS Subcommittee**

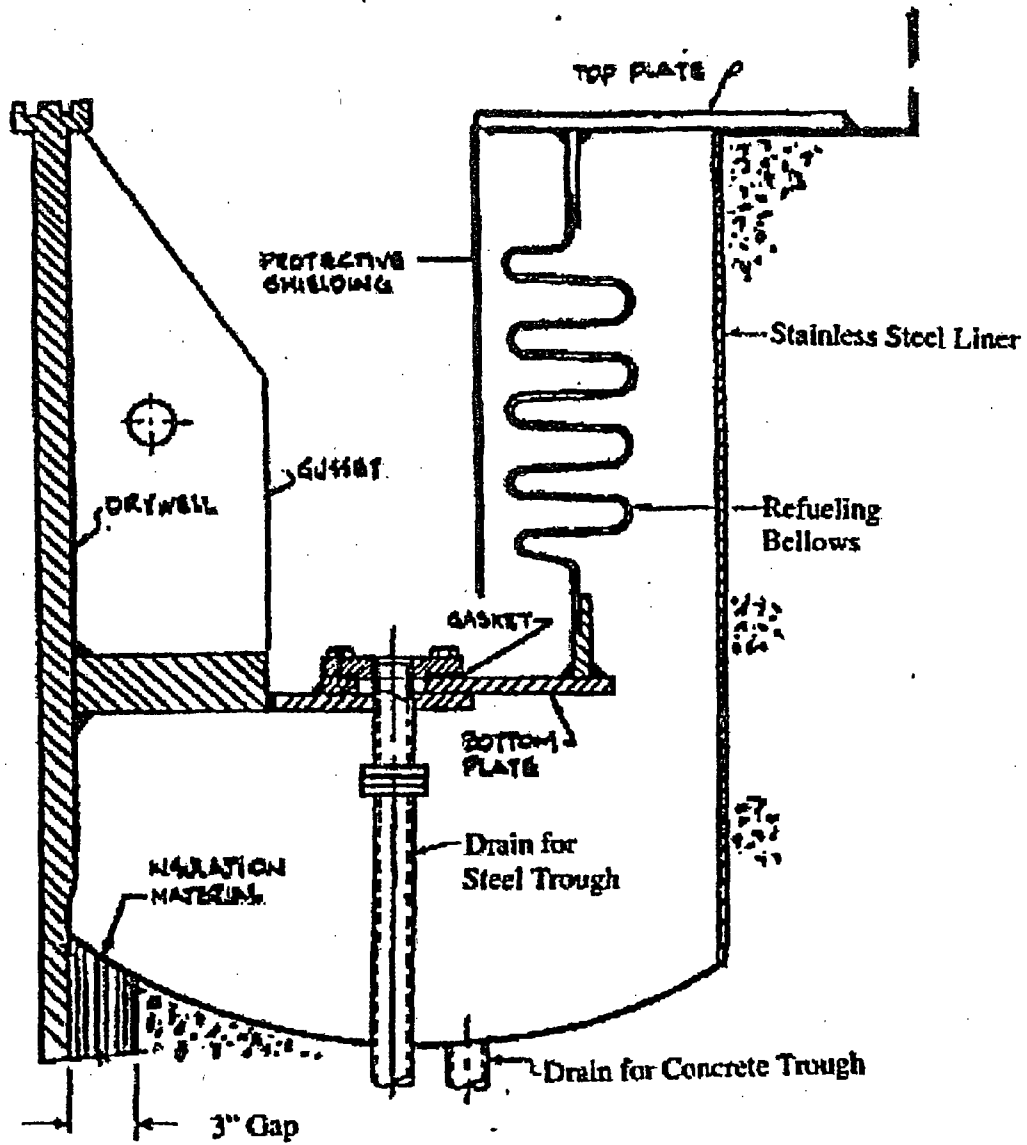
FIGURE 6 - REACTOR CAVITY TROUGH DRAIN

- Leakage was not attributed to the reactor cavity metal trough drain line gasket or the refueling bellows seal (See Figure 6 of Section 3 of this Enclosure).

- The leakage path was from the reactor cavity, to the concrete trough (later found to have been degraded – see Section C below) and through the drywell expansion gap down to the sandbed region within the reactor building (See Figure 6 of Section 3 of this Enclosure).

- Replaced reactor cavity metal trough drain gasket, which was found to be leaking (See Figure 6 of Section 3 of this Enclosure).
  - Removed water from the sand bed region.

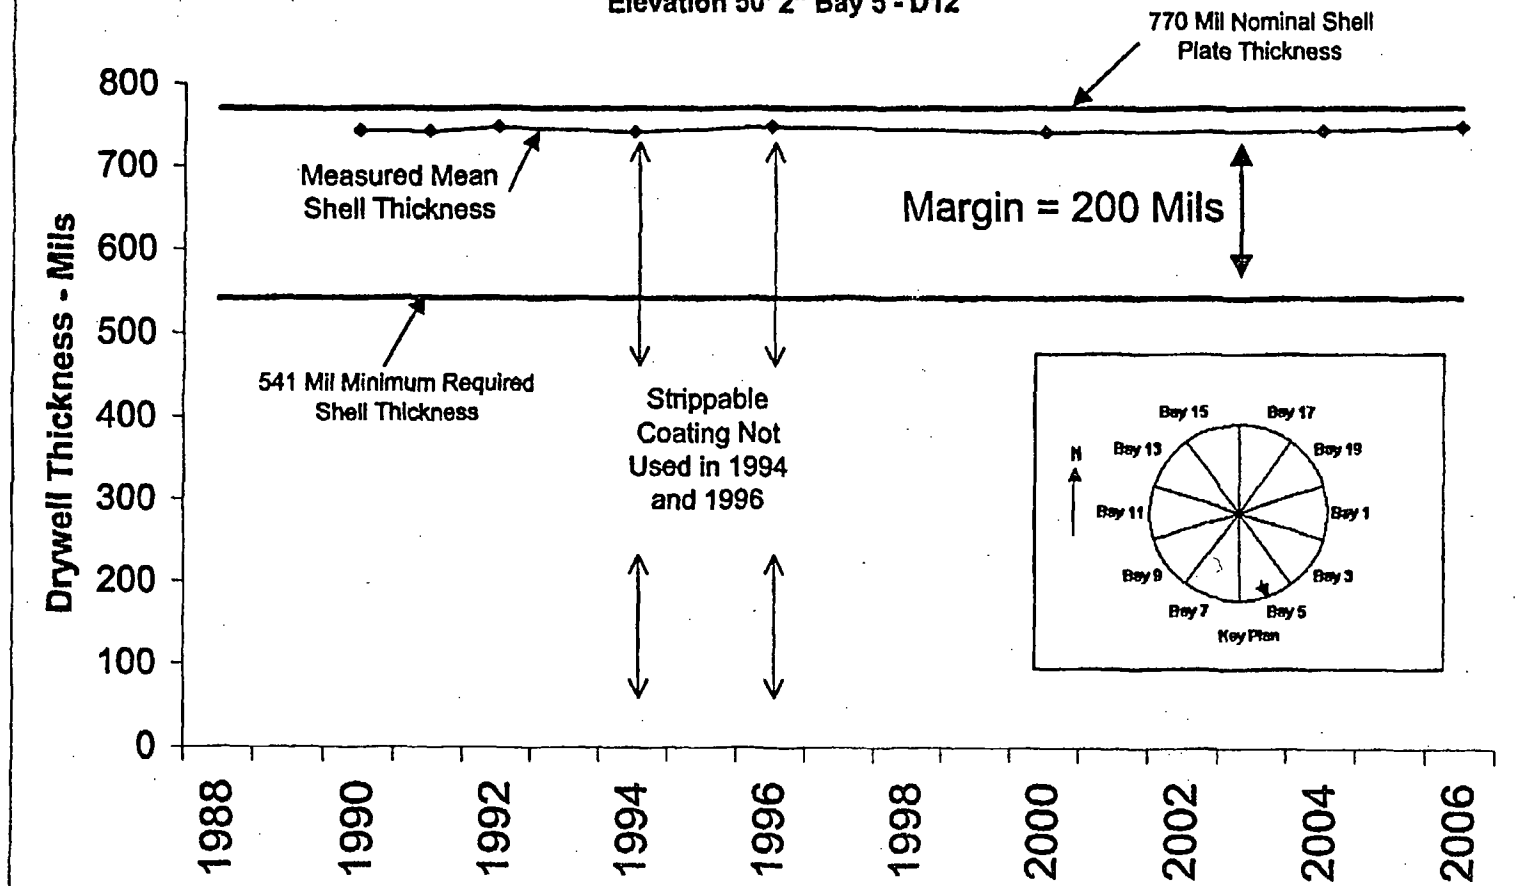
Elevation 50' 2" Bay 5 - D12

# 1. Upper Drywell Corrosion Trend and Margin

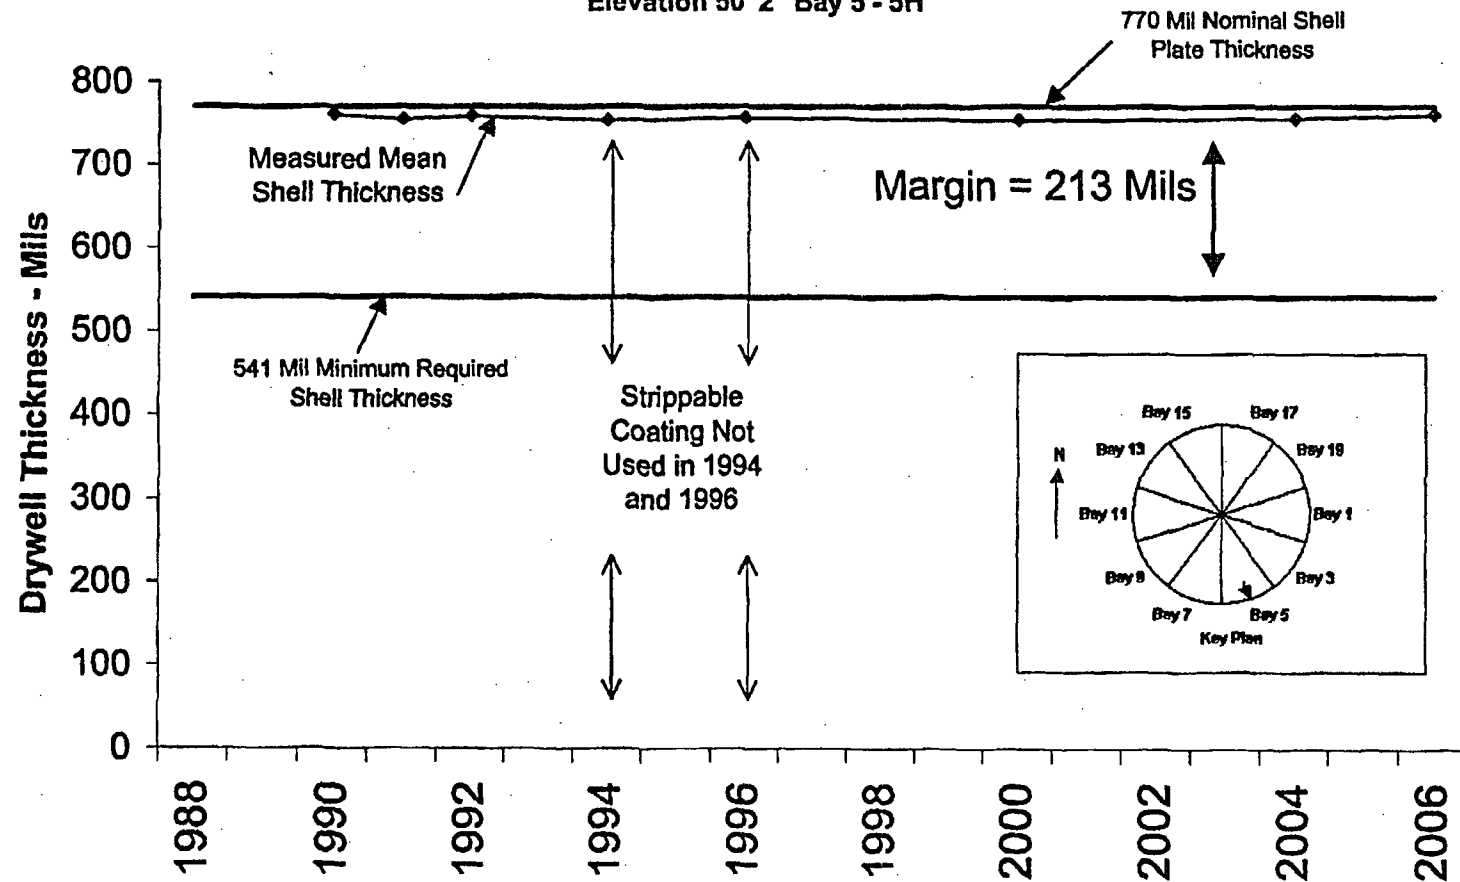
Elevation 50' 2" Bay 5 - 5H

## 2. Upper Drywell Corrosion Trend and Margin

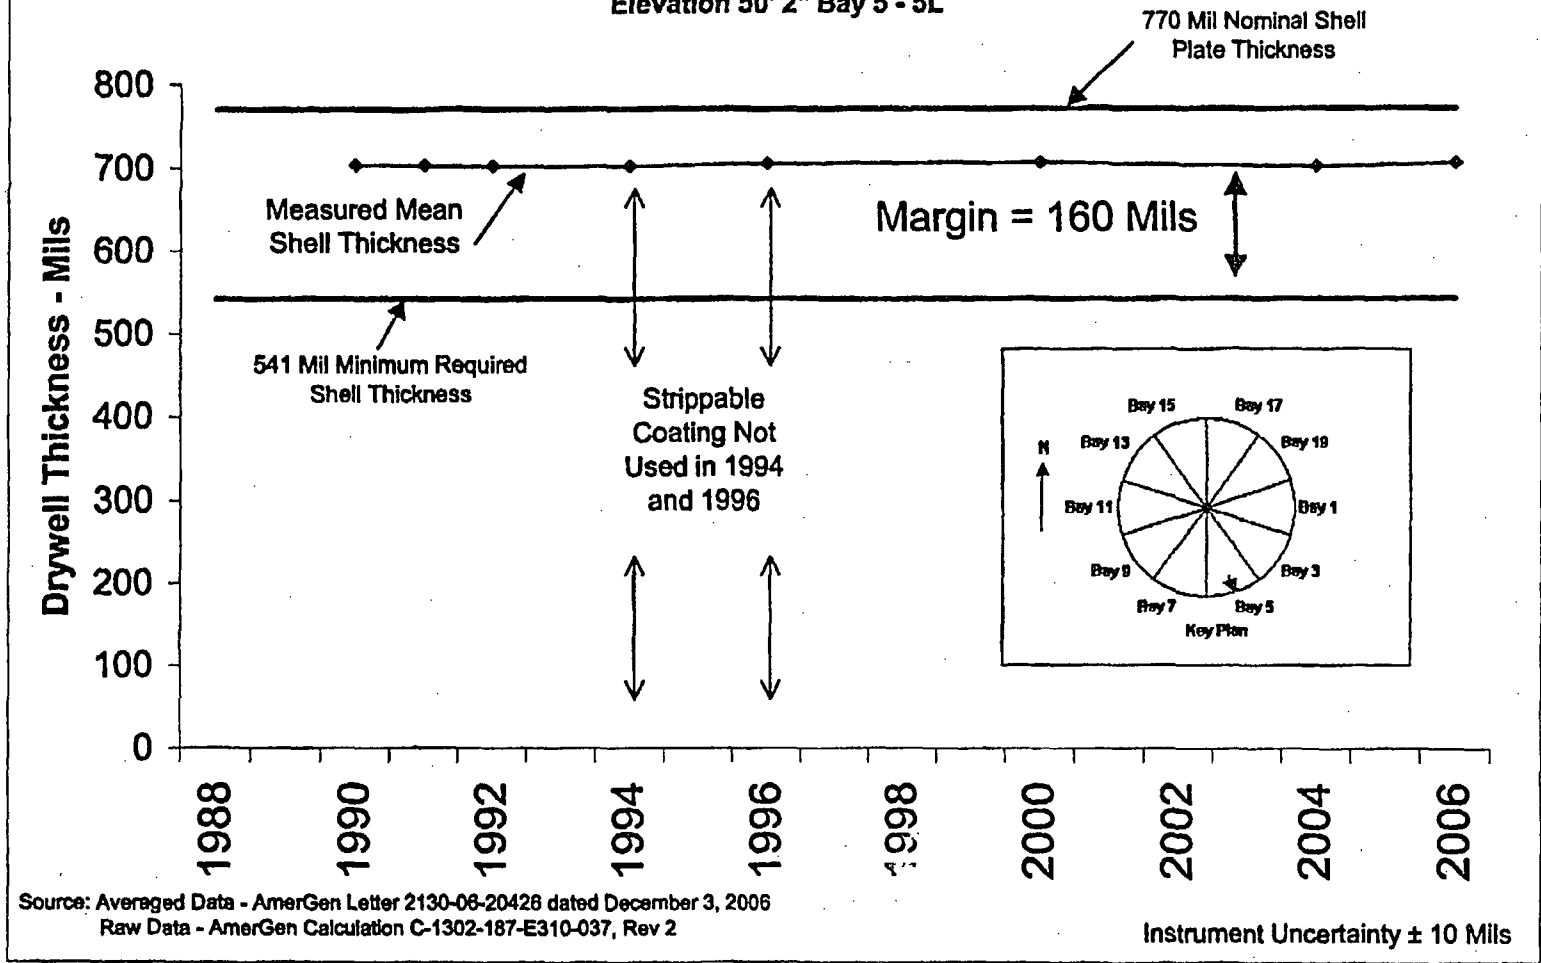
Elevation 50' 2" Bay 5 - 5L

### 3. Upper Drywell Corrosion Trend and Margin

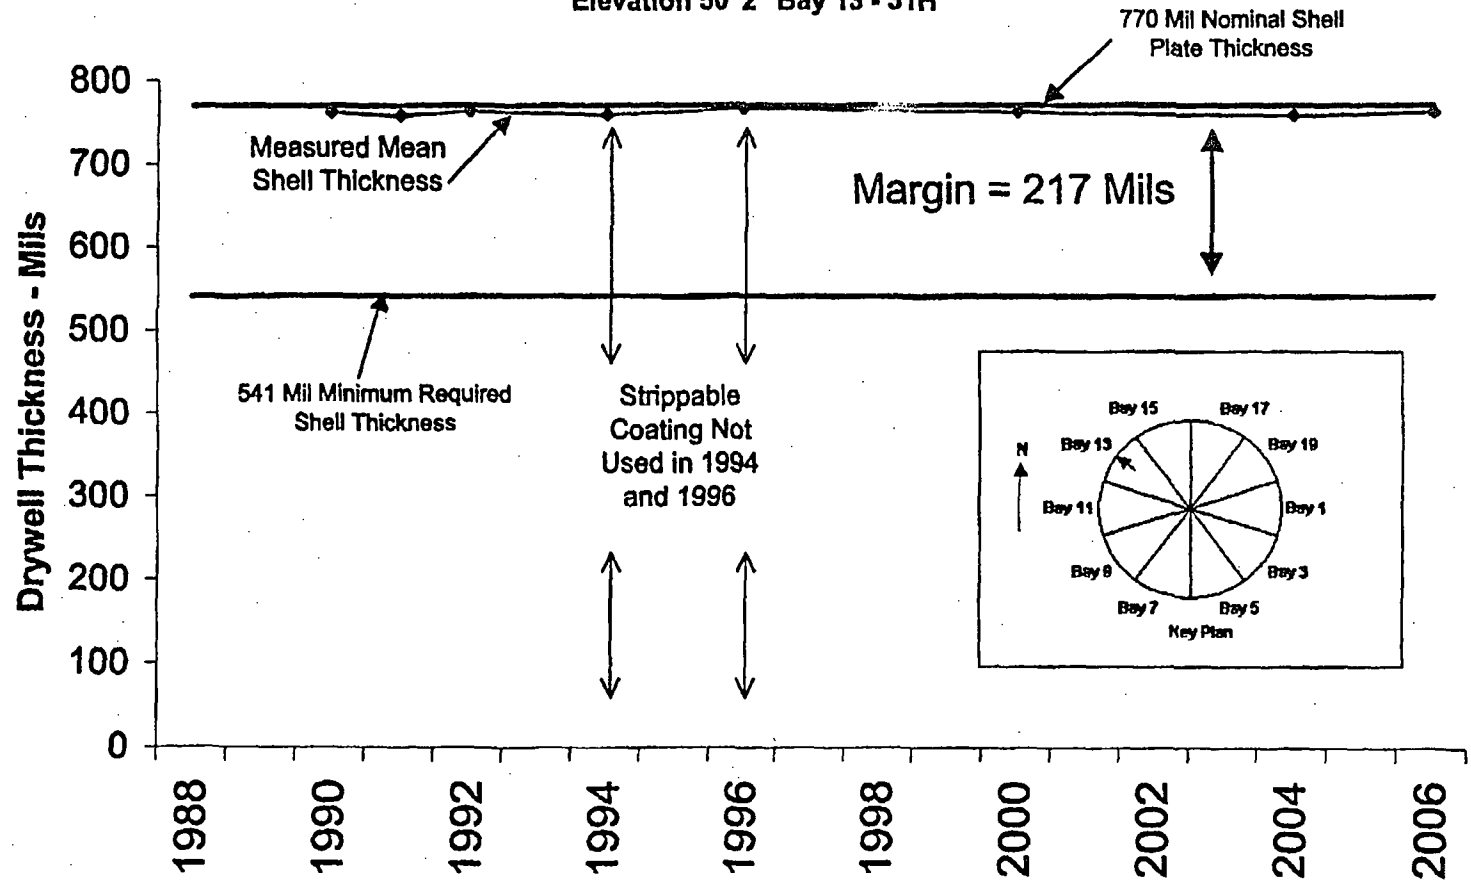
### 4. Upper Drywell Corrosion Trend and Margin Elevation 50' 2" Bay 13 - 31H

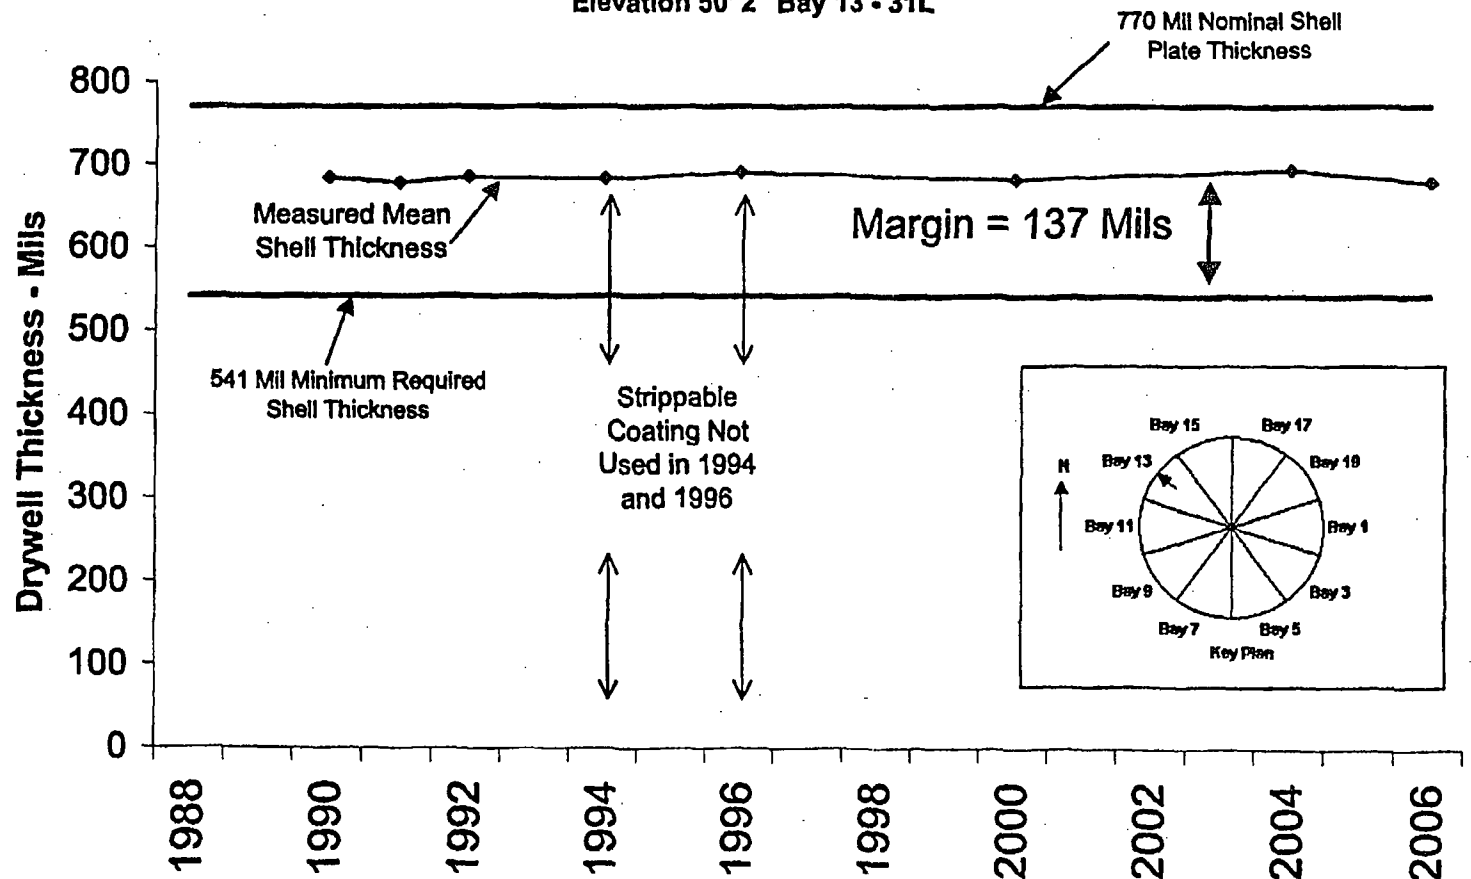
Elevation 50' 2" Bay 13 - 31L

### 5. Upper Drywell Corrosion Trend and Margin

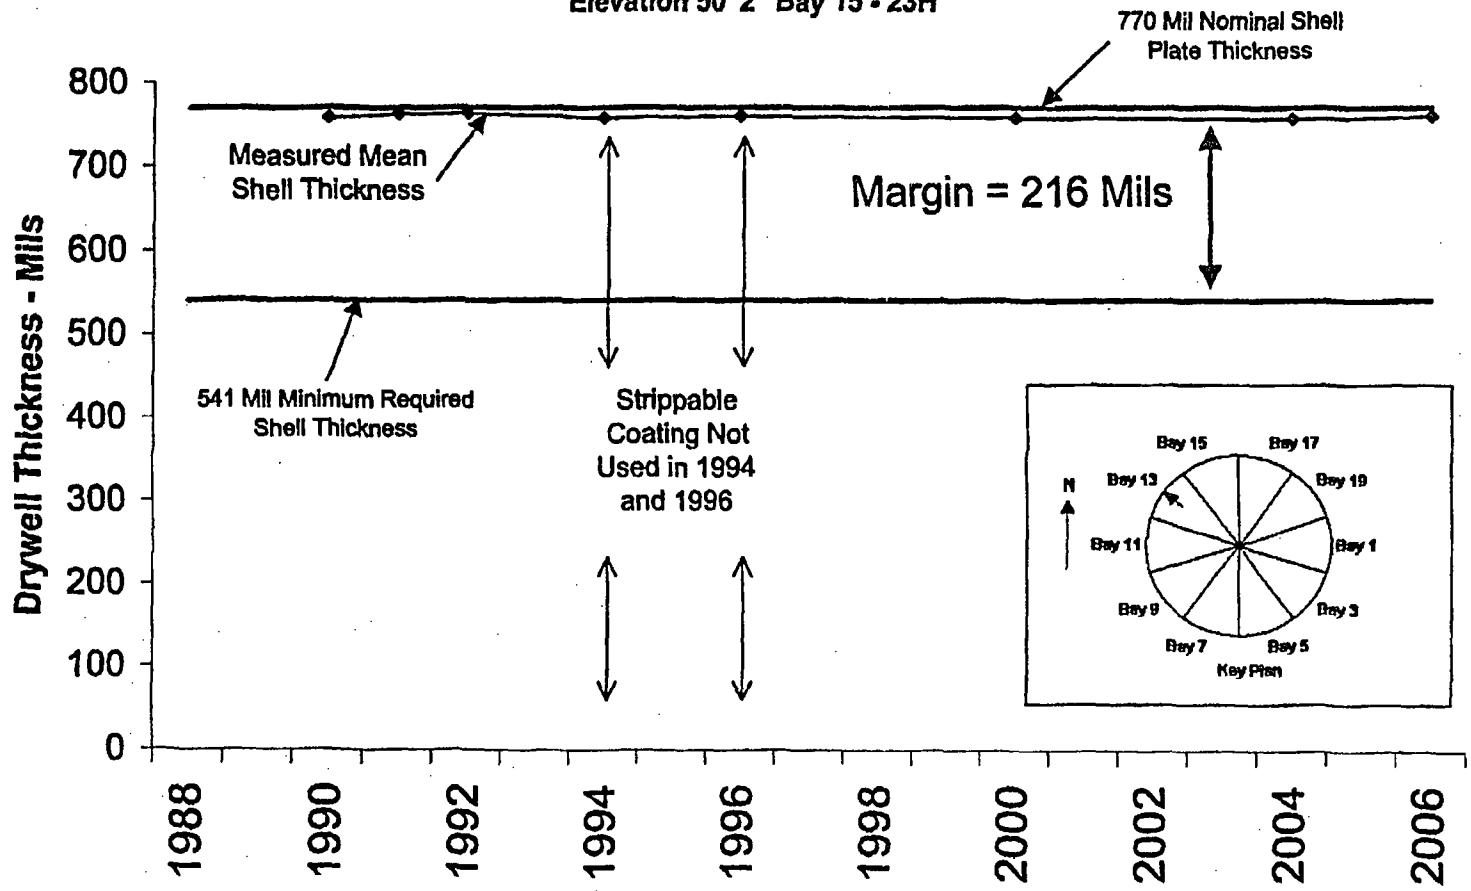
Elevation 50' 2" Bay 15 - 23H

### 6. Upper Drywell Corrosion Trend and Margin

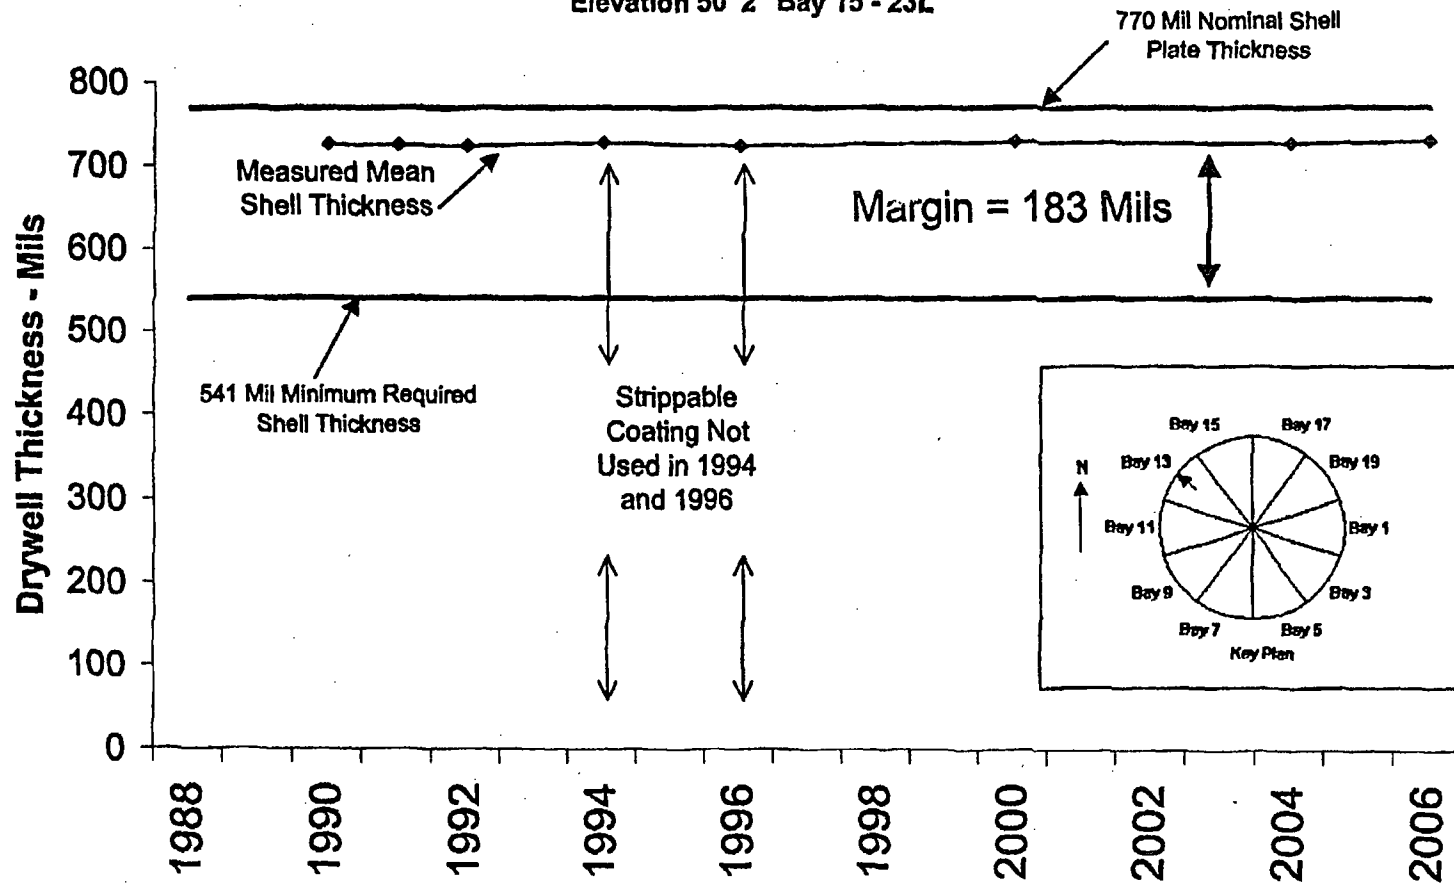
Elevation 50' 2" Bay 15 - 23L

### 7. Upper Drywell Corrosion Trend and Margin

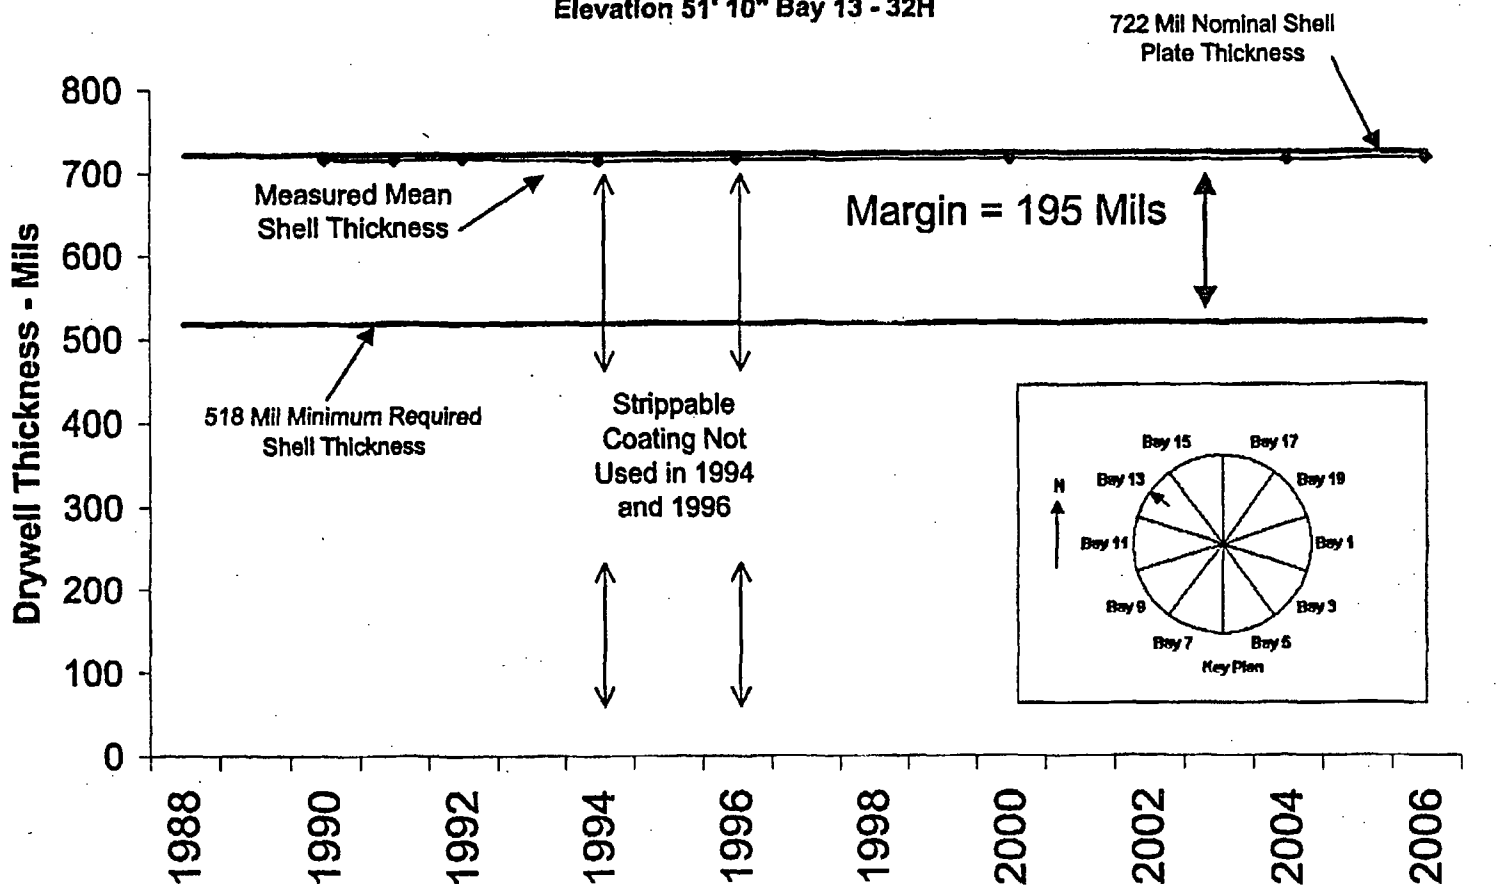
Elevation 51' 10" Bay 13 - 32H

### 8. Upper Drywell Corrosion Trend and Margin

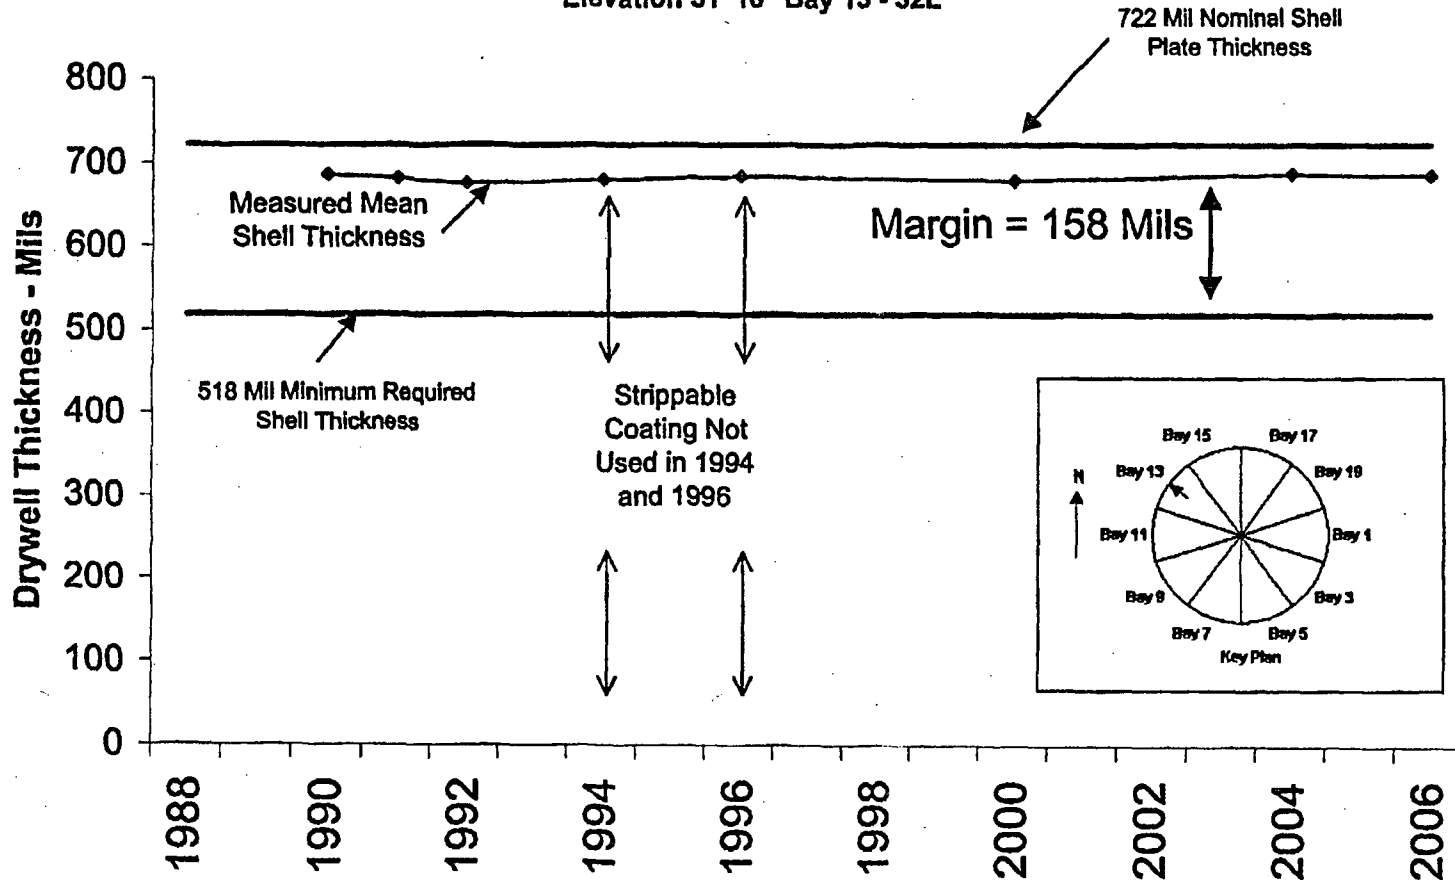
Elevation 51' 10" Bay 13 - 32L

### 9. Upper Drywell Corrosion Trend and Margin

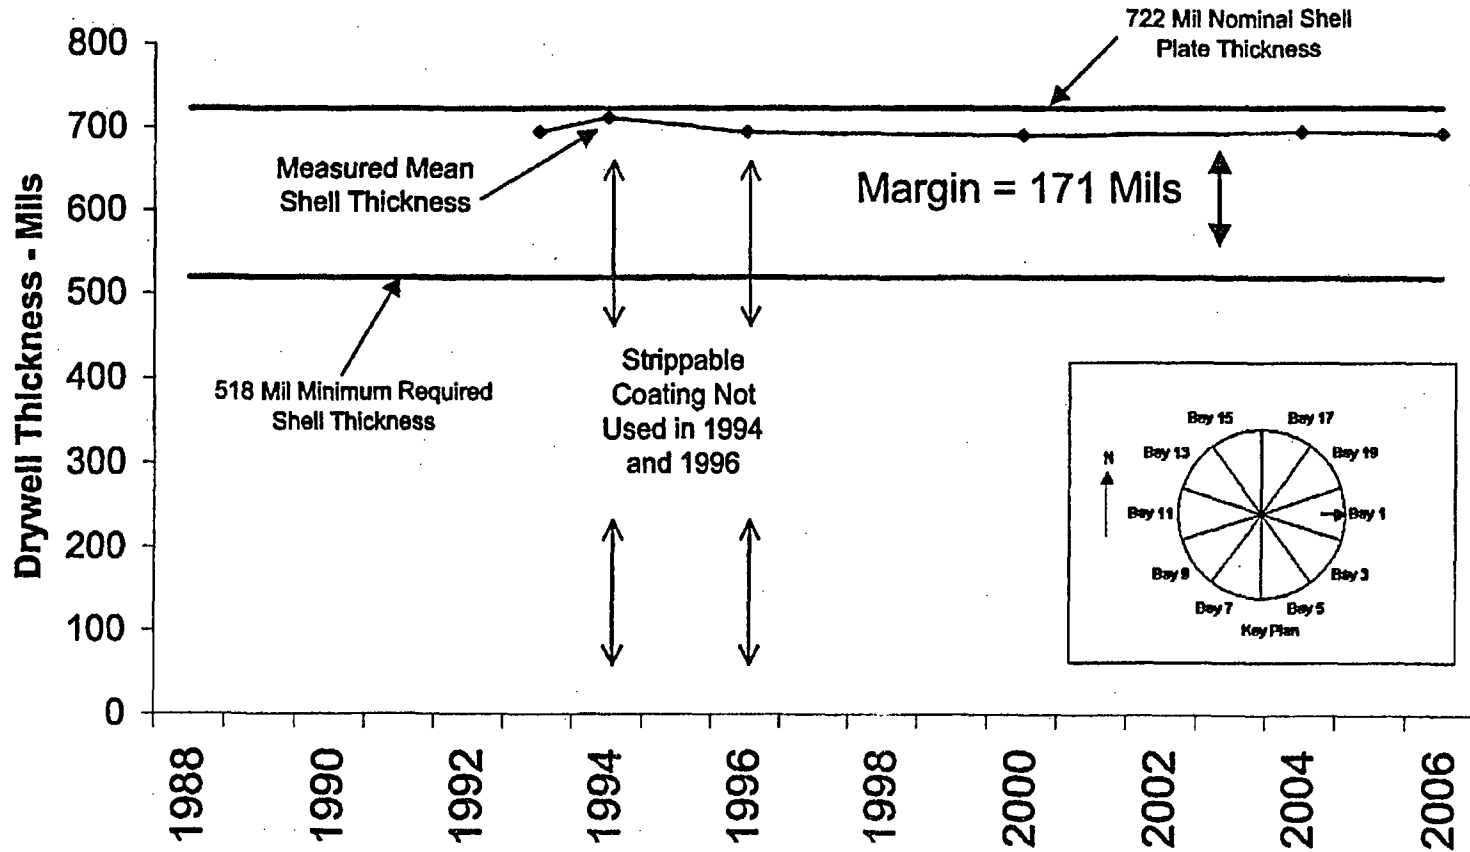
### 10. Upper Drywell Corrosion Trend and Margin Elevation 60' 10" Bay 1 - 50 - 22

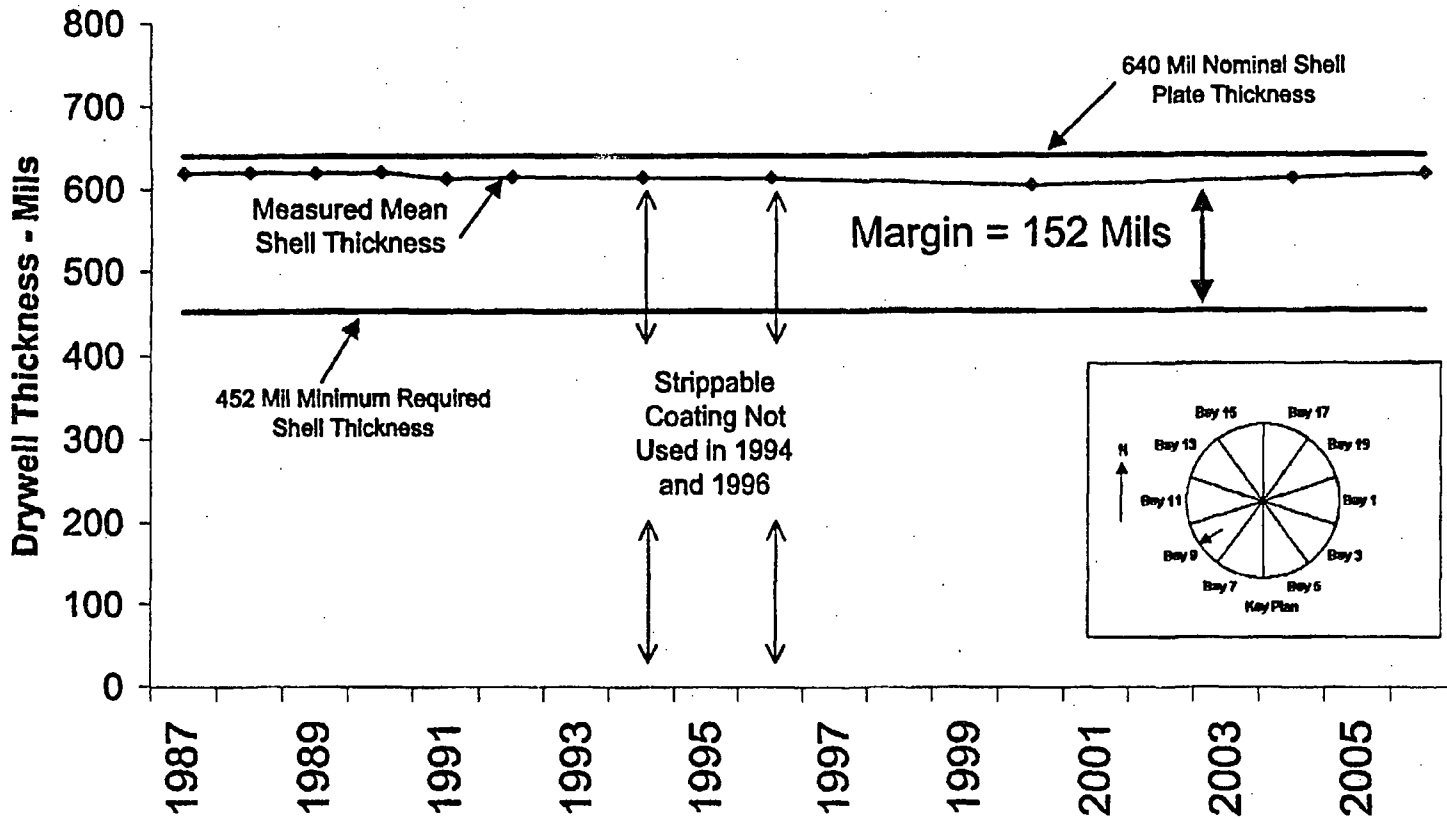
### 11. Upper Drywell Corrosion Trend and Margin Elevation 87' 5" Bay 9 - 20

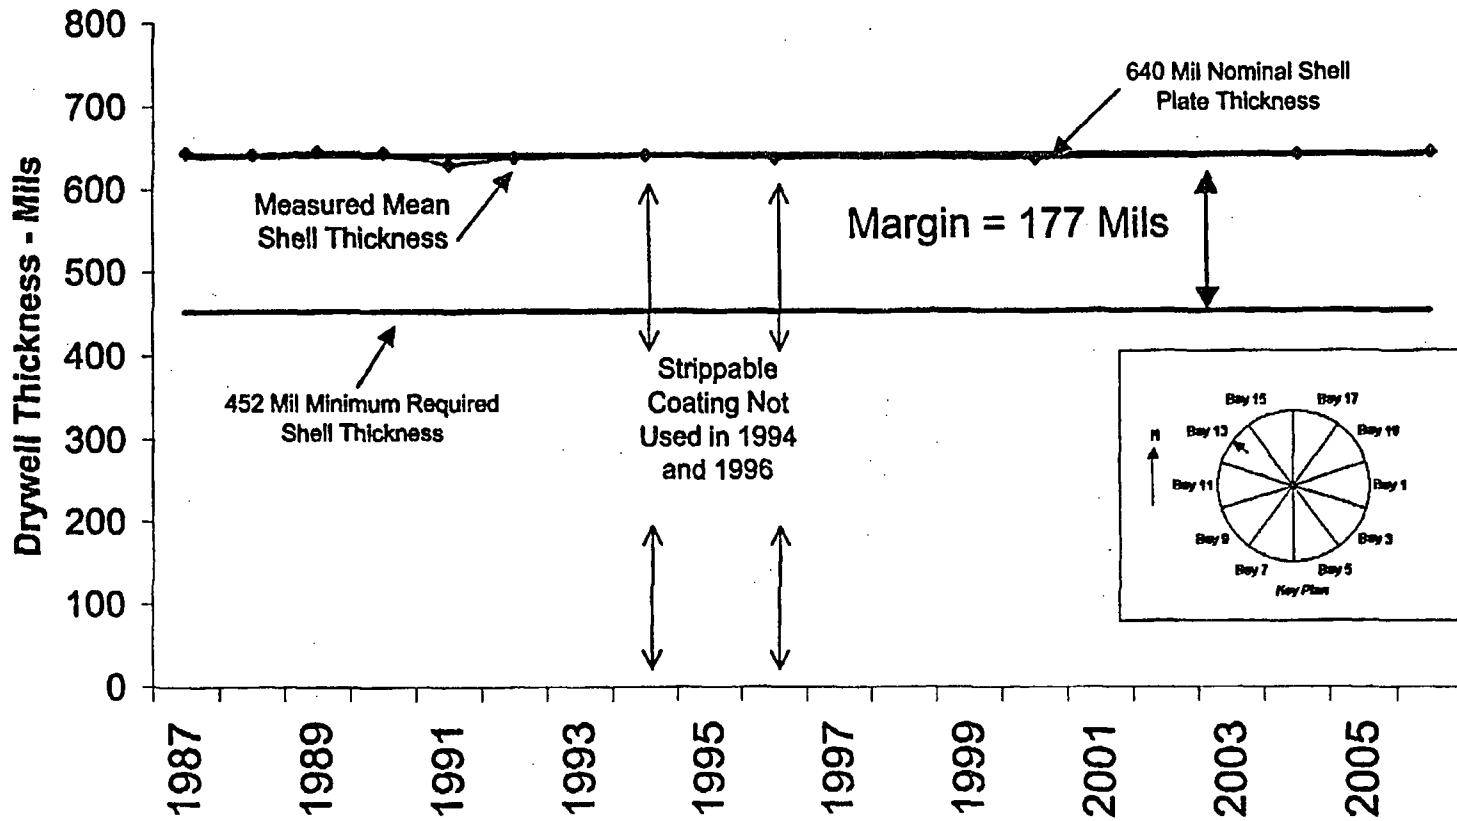
Elevation 87' 5" Bay 13 - 28

## 12. Upper Drywell Corrosion Trend and Margin

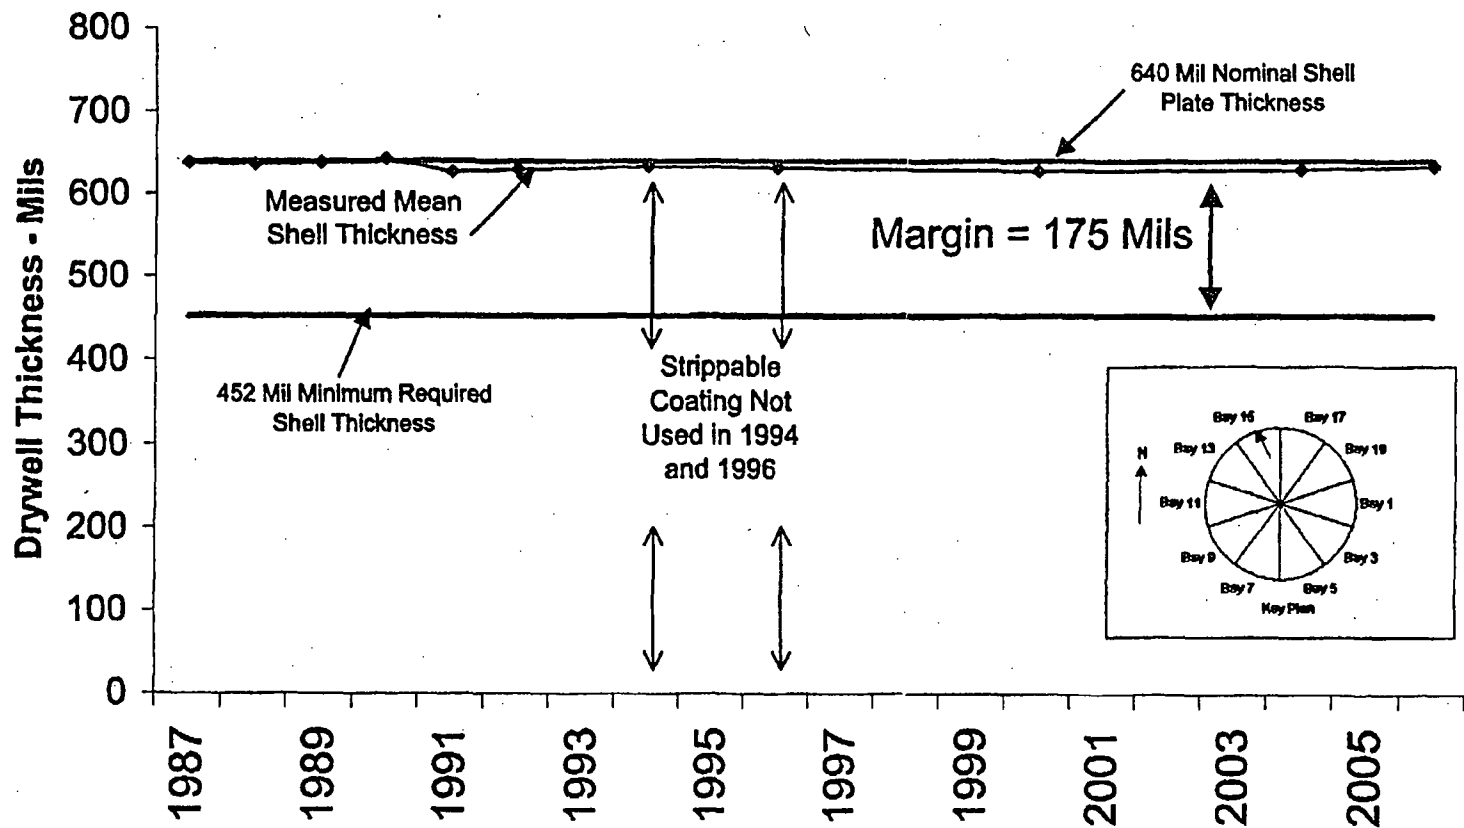
Elevation 87' 5" Bay 15 - 31

### 13. Upper Drywell Corrosion Trend and Margin

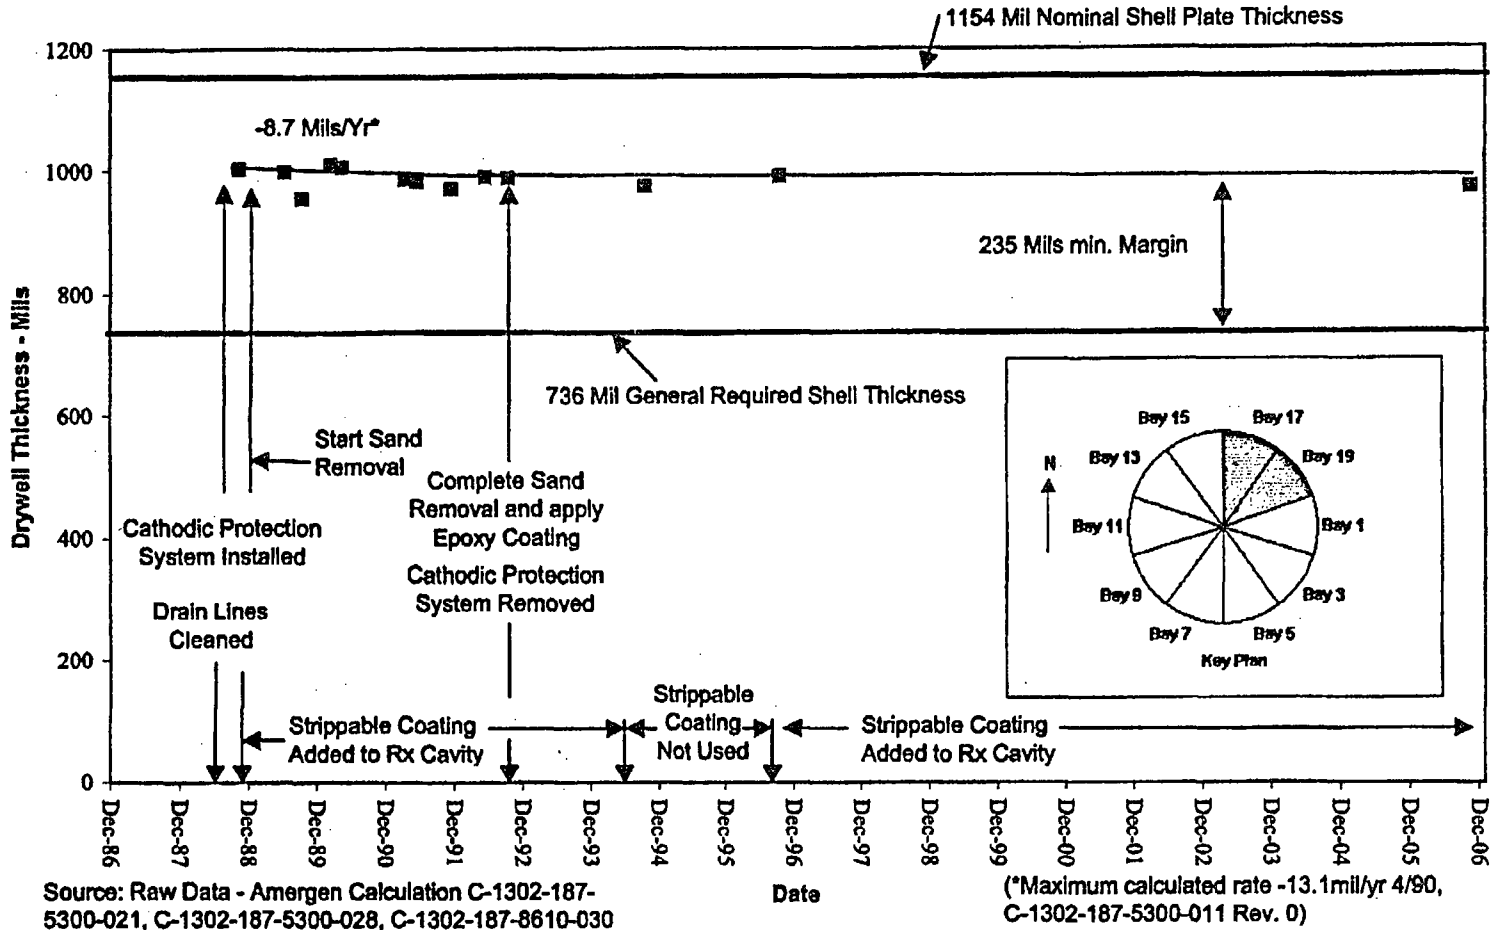
**Figure 20. Sandbed Bays # 17/19  
Frame Bottom**

(\*Maximum calculated rate -13.1mil/yr 4/90, C-1302-187-5300-011 Rev. 0)
