In the Matter of Amergen Energy Co., LLC

Docket No. 50-0219-LR

PRE-FILED DIRECT TESTIMONY OF DR. RUDOLF H. HAUSLER

**AFFIDAVIT OF DR. RUDOLF H. HAUSLER
REGARDING HIS PREFILED TESTIMONY
IN SUPPORT OF
CITIZENS' DRYWELL CONTENTION**

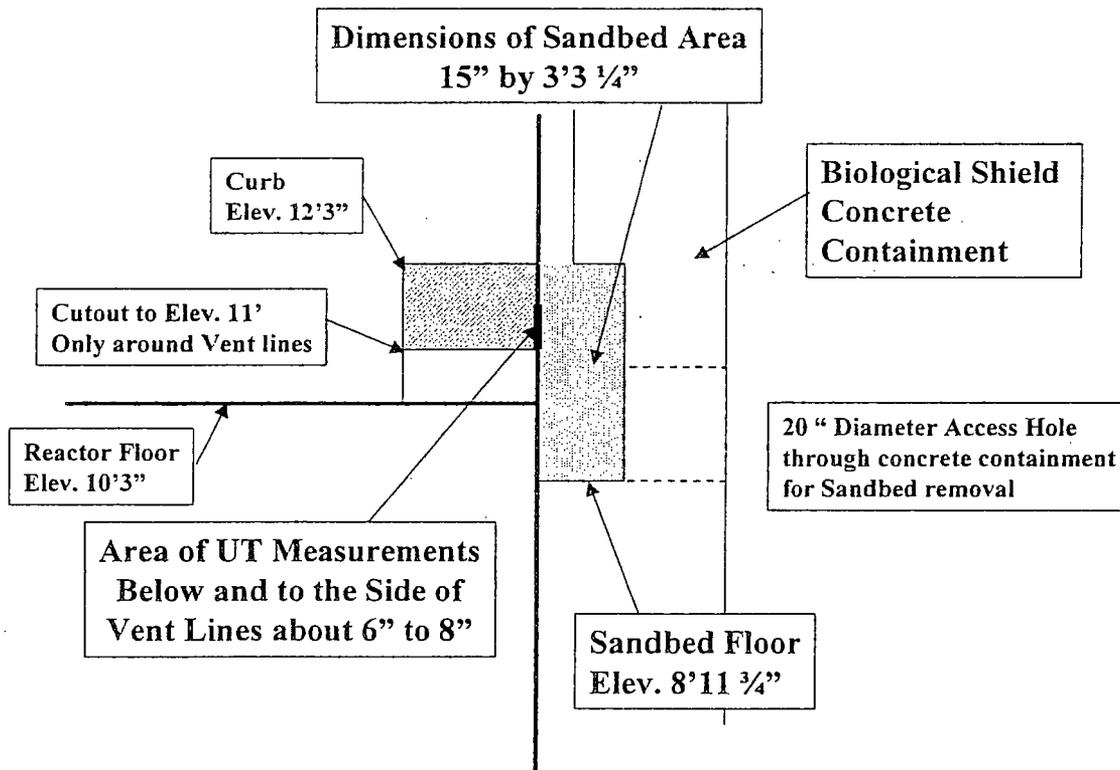
Figure 1

After corrosion had been found in the sandbed area a concerted effort was made to assess the corrosion rate in order to project the life of the structure. The tools in this effort were ultrasonic measurements (UT) at well-defined locations. In order to assure repeatability of the measurements, a template was constructed containing 49 openings for placement of the UT transducer. The 49 openings were spaced 1 inch apart over a 6 by 6 inch square. This 6 by 6 inch grid was placed repetitively at the inside of the drywell liner just below the vent pipe where the inside curb was lowered from about 2

feet to just over 9 inches (see Figure 1). In this manner, every bay was monitored systematically at intervals over the past 20⁺ years.¹⁾ In 1992 the sand was removed from the sandbed, and all steel surfaces as well as the sandbed floor were coated with an epoxy resin. UT measurements using the 6 by 6 inch grid performed in 1992, 1994, 1996 and 2006, always at exactly the same position, indicated that within the accuracy of the test (measuring procedure) the continued corrosion was at most small. That should not be surprising because a) the outside steel surface was now coated, b) water would not accumulate against the vessel at the location where the measurements were made because of the drains in the sandbed floor, and c) if corrosion were to commence it would most likely be at imperfections in the coating near the sandbed floor where indeed, standing water could be present (see discussion below).²⁾

Schematic Cross Section through Sandbed Area
(not to size)

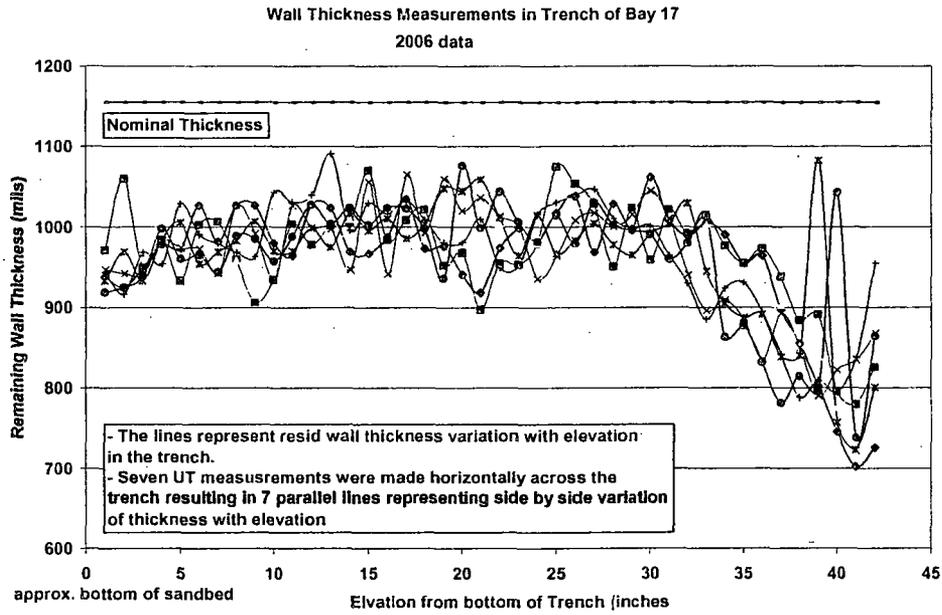
We take issue with this statement. In support of this contention, an effort was made to show graphically the remaining wall thickness observed in all of these various locations. Thus Figure 2 shows, by way of example, the remaining wall thickness from the 2006 UT measurements made with the help of 6 by 6 inch grids as a function of elevation in the **trench of Bay 17**. It is understood, as is described in Ref. 3 that 6 such grids were placed one on top of the other in the trench in order to capture the corrosion from the bottom to the top of the sandbed. Hence, if the bottom of the trench had the elevation about 9 feet, then the top of the 6 grids would have had an elevation of about 12 feet, which according to Figure 1 corresponds to the top of the sandbed and is at least 9 inches higher than the top of the grid used for UT measurements from the inside. (Note, none of these elevations is terribly accurate, however, the top of the trench measurements were definitely lower (deeper pits) by a good margin than the inside grid measurements). Figure 2 plots all individual 2006 measurements from the trench in bay 17. The 6 traces represent the variation of the wall thickness in the horizontal direction while the traces themselves extend from the bottom of the trench (left hand side) to the top of the trench (right hand side). The

undulations of the 6 traces, which are at times (at the same elevation) in synch and at other times out of phase clearly depict the nature of the “golf ball type” surface described in AmerGen literature (Ref. 1 pg. 4). Where the undulations are in synch one can estimate that the extent of the pit at that location extends over an area larger than just one inch in diameter ³⁾. It should also be noted that the average amplitude of the undulations in Fig. 2 are of the order of 0.1 inch, i.e. the roughness of the surface at this point is only of that order of magnitude. AmerGen estimated the “roughness” of the surface to be rather of the order of 0.2 inches (Ref. 5 pg. 5).

The most striking observation is that the corrosion is most severe at the top, almost uniform in severity over most of the depth of the sandbed and again somewhat more severe at the very bottom.

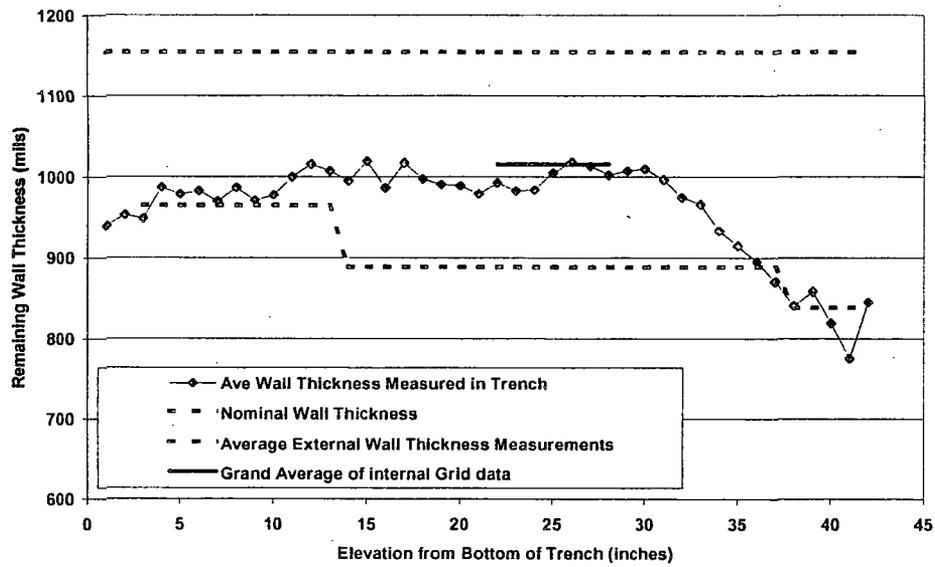
Figure 3

Conclusion: What the superposition of the UT measurements in Bay 17 demonstrates is that wall loss ranges from zero to 33 percent, however, only the trench and outside measurements come close to represent the most severe corrosion at the highest elevations. It should also be remembered that the grid measurements at the inside curb cutout as well as those in the trench are only 6 inches wide. One does not have, therefore any indications as to how far serious corrosion may have spread laterally around the circumference of the bay.

Comparison of Various Thickness Measurements in Bay 17
2006 data

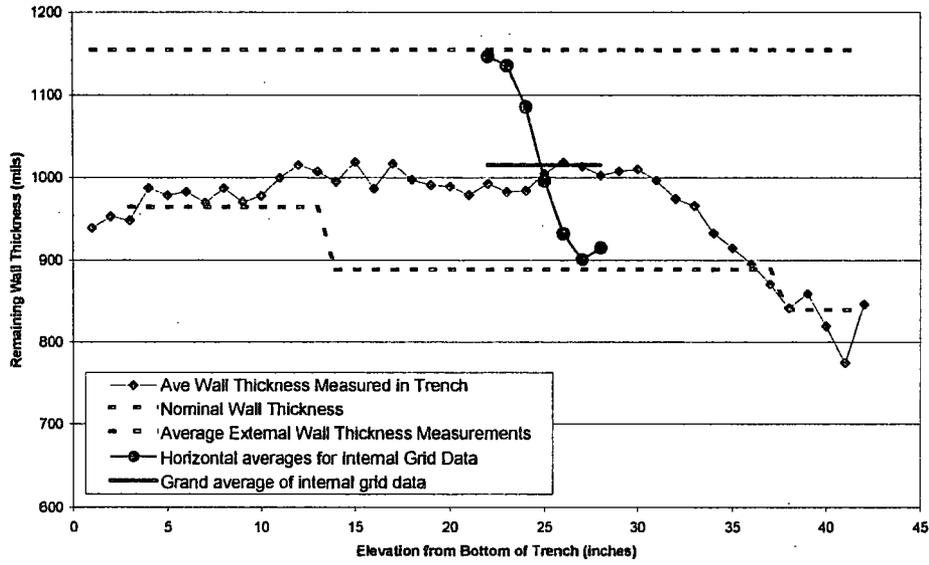
Figure 4

Comparison of Various Thickness Measurements in Bay 17
2006 data

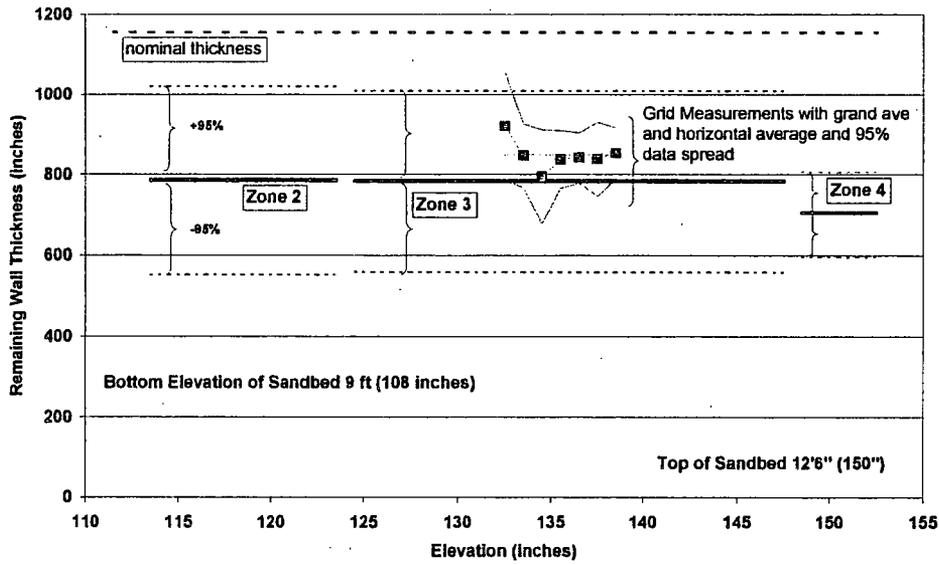
Figure 5 shows an analysis of the available 2006 data for Bay 13. Bay 13 is probably the second worst corroded bay apart from Bay 1. The averages for the external measurements for each zone are fairly similar, as are the 95% limits for the data spread. There is a 95% percent probability for the deepest penetration to be of the order of 48% of the original wall thickness. The superposition of the internal grid data shows a higher average and a narrower distribution of the data spread. Again one recognizes that the internal 6 by 6 inch grid measurements do not represent the worst corrosion degradation.

External 2006 UT Measurements in Bay 13
averages and 95% limits of data spread

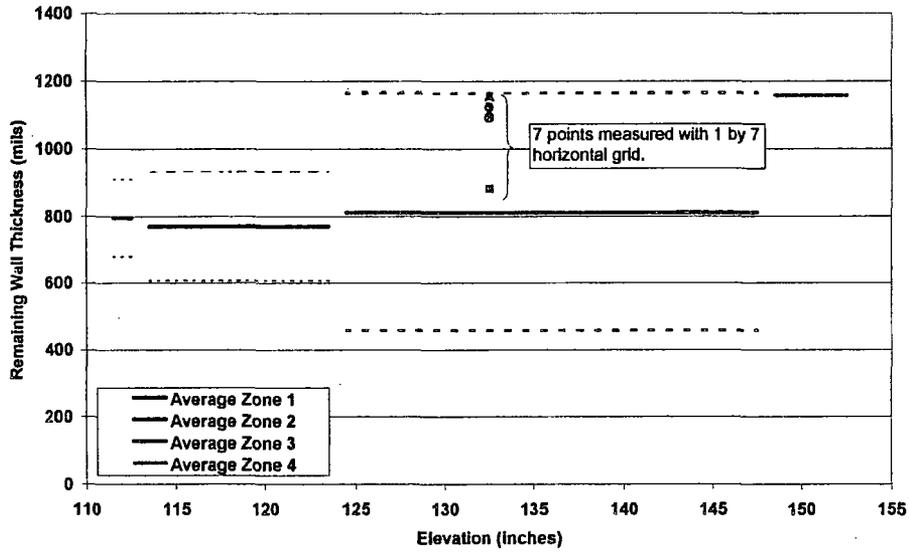
Figure 6

External UT Measurements 2006 in Bay 1
Averages and 95% limits of data spread

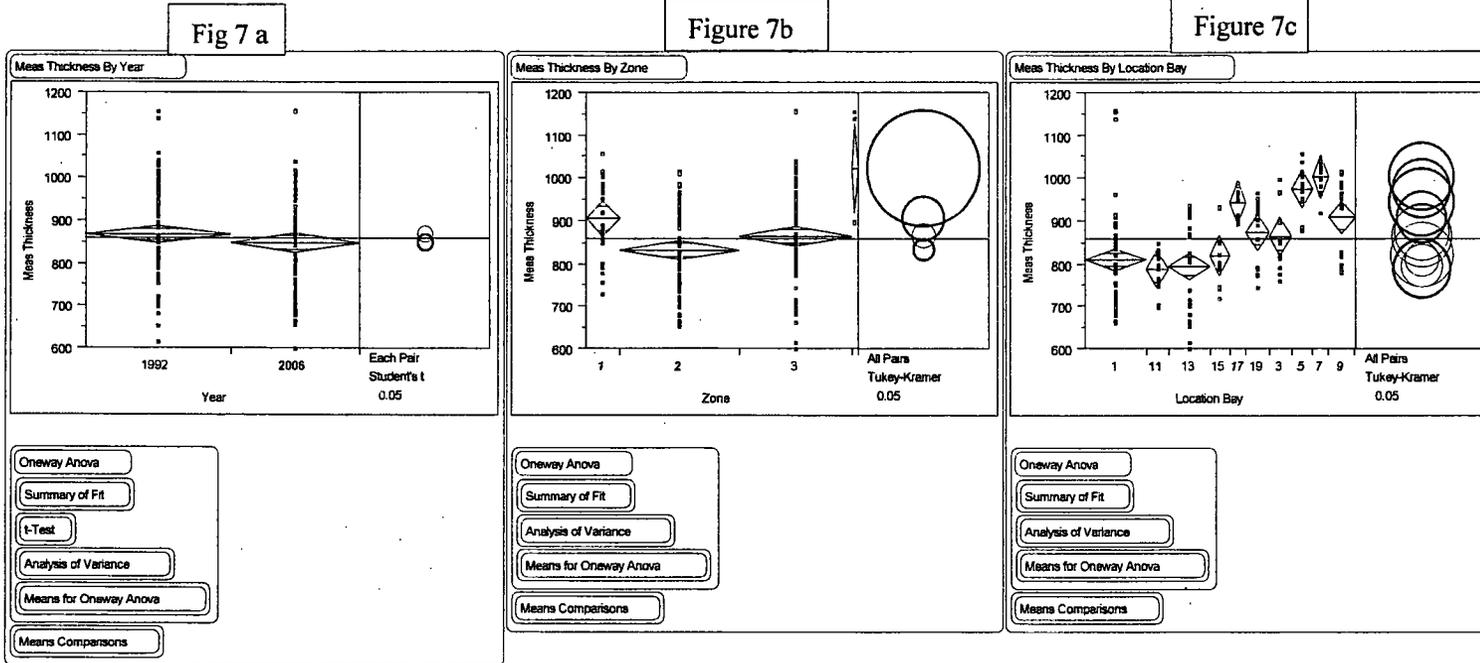
Figure 7

It was found that there is no significant effect of the time (Fig. 7a). While there is a decrease of 19 mils between 1992 and 2006, this difference is not statistically significant within the variability of the data. The differences between the zones, however are significant. Zone 2 is by far the most corrosive zone. When the bays are compared, one finds as expected that some bays have experienced little corrosion in contrast to others. The importance of these observations is obvious: they point again to the fact that the intensity of corrosion is a clear function of elevation and bay. Hence, averaging data and generalization may lead to doubtful conclusions.

Statistical Analysis of all External UT Measurements

Comments: Figure 7a: Comparison between measurements I 1992 and 2006 show no significant difference. The means from 1992 and 2006 show a bias of 0.018 inches, but the bias is statistically not significant despite of the many data points. Fig. 7b: The comparison between the “zones” (elevations) is significant. Zones 1 is significantly different from zones 2 and 3. For zone 4 there are not enough data for statistical significance. Fig. 7c: Some bays, red ones, are significantly different from the black ones.

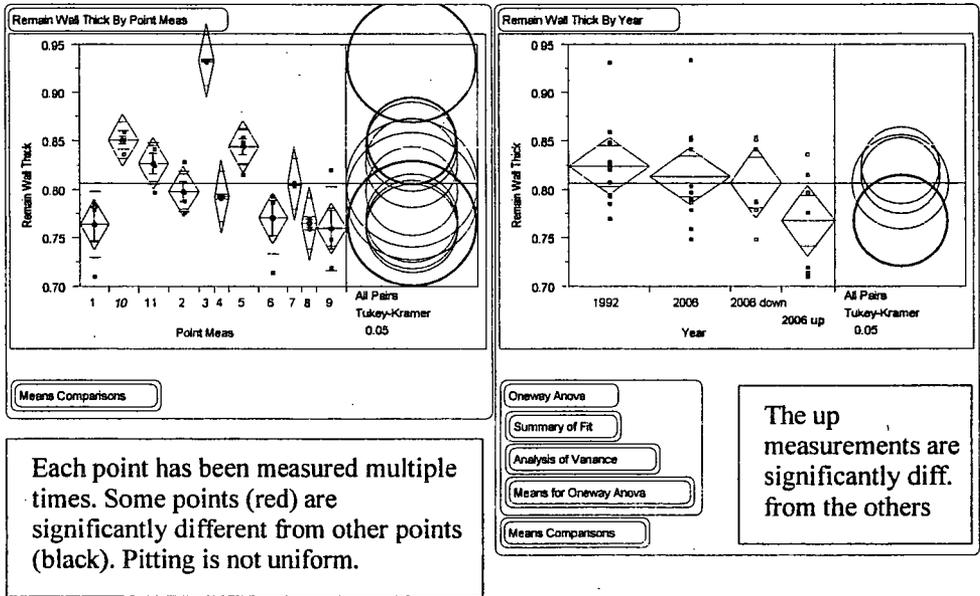
Figure 8: External UT Measurements in Bay 15

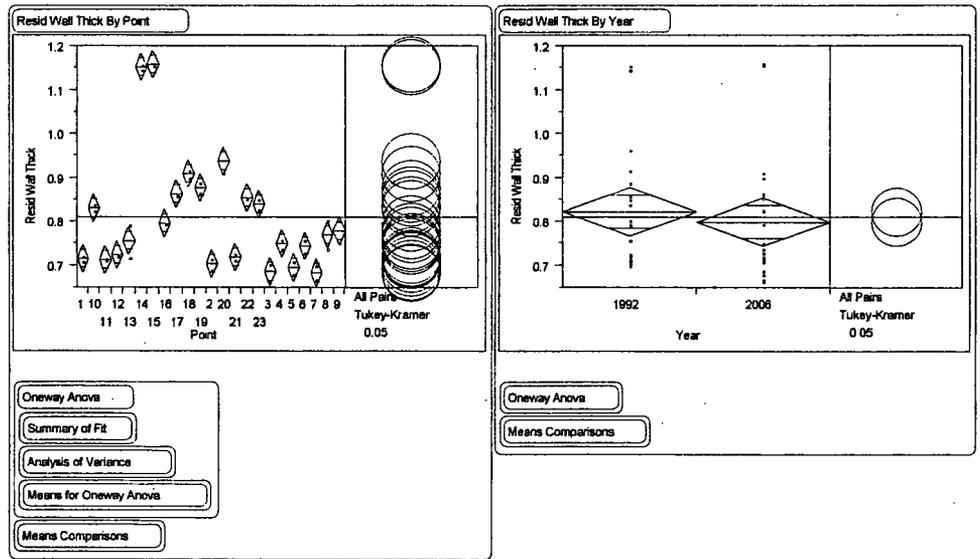
Figure 9: External UT Measurements in Bay 1.

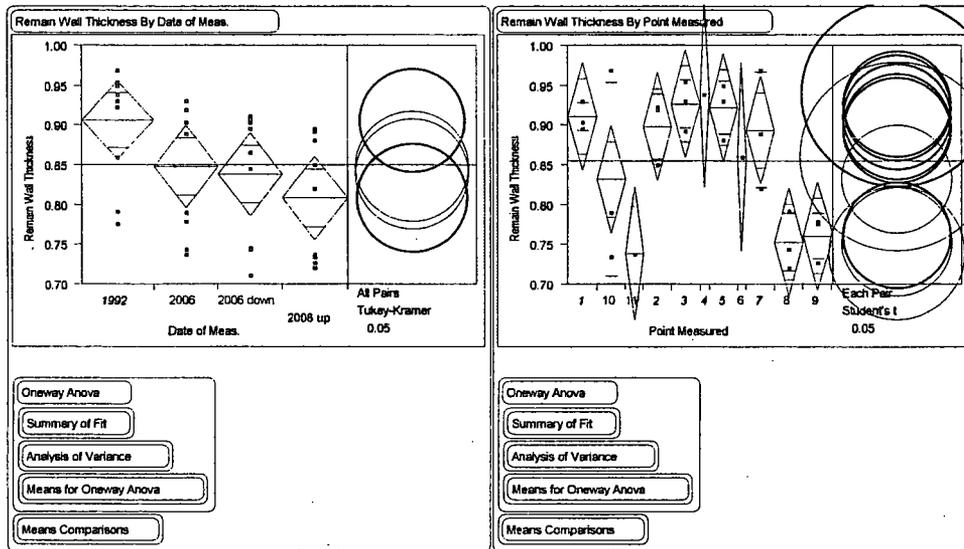
Figure 10: External UT measurements in Bay 19

Again one finds that the “up” measurements are significantly lower from the 1992 measurements.

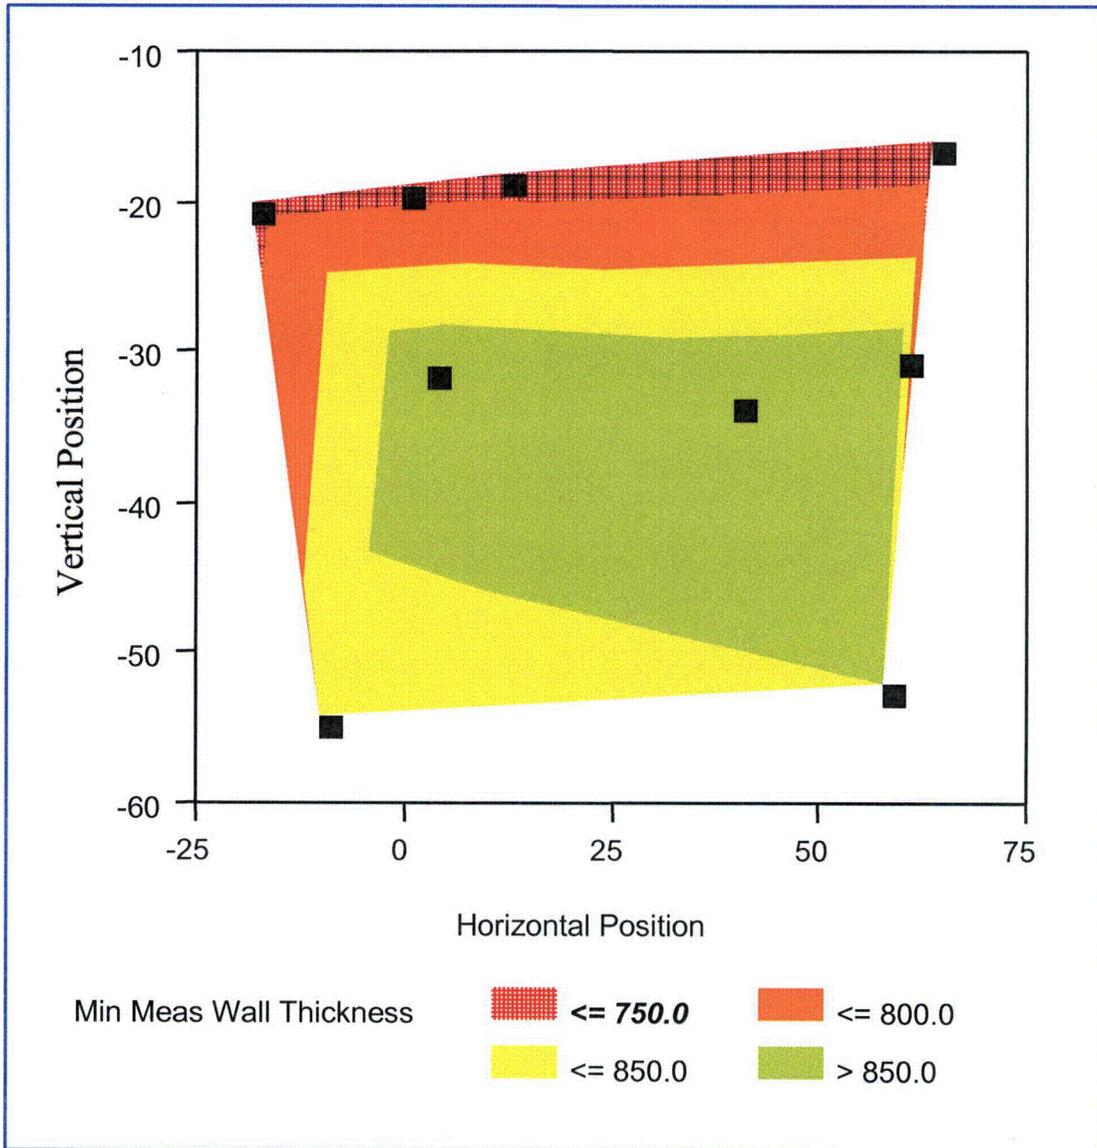
Figure 1

Bay 19 External 2006 UT Measurements, Minimum Values

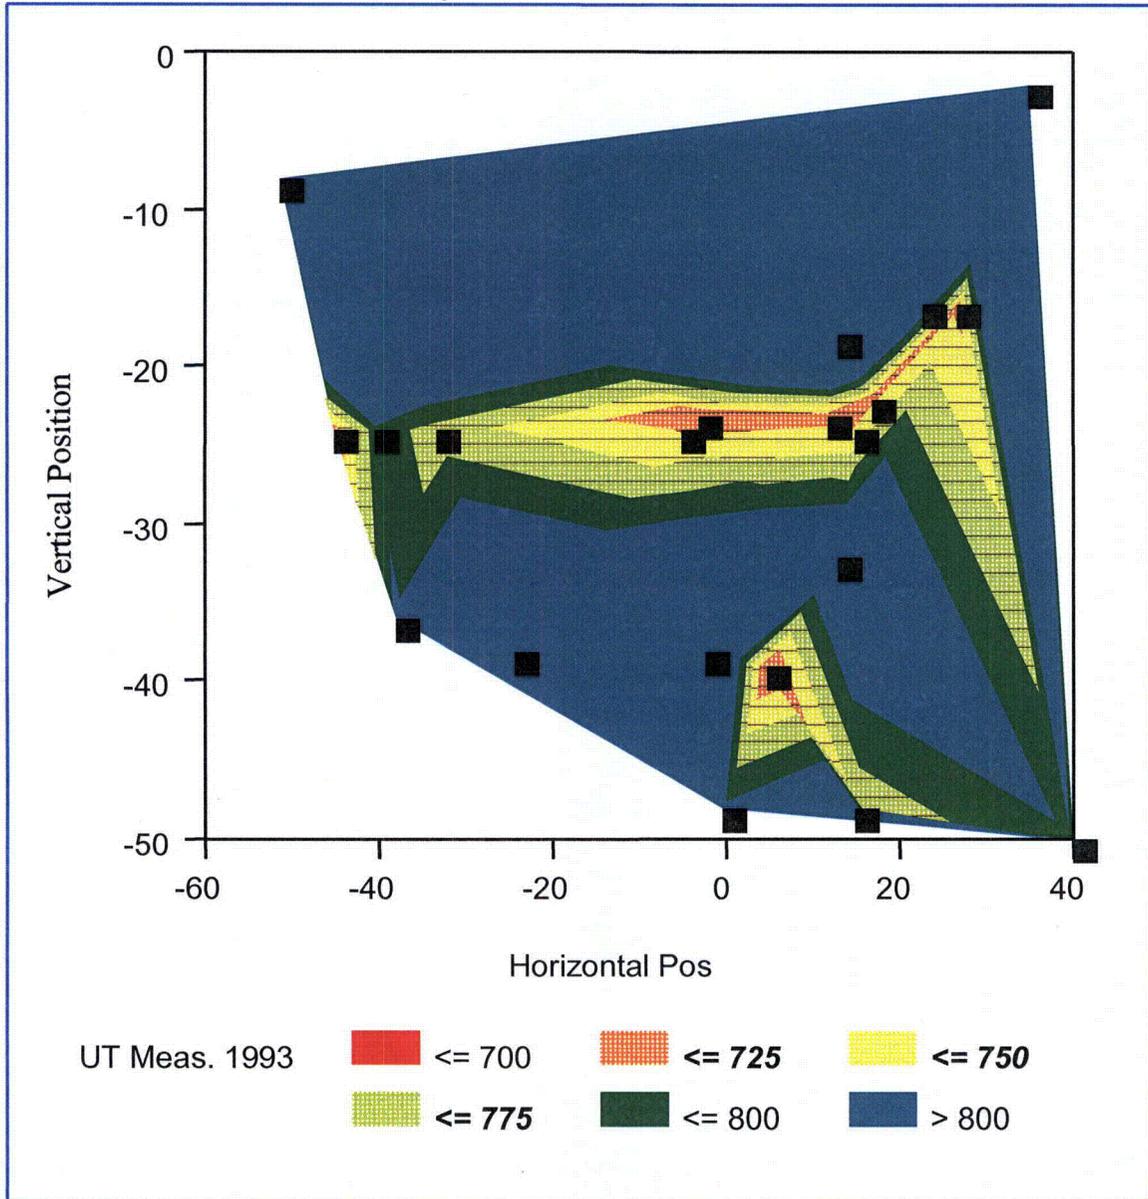
Figure 2
Bay 1 Remaining Wall thickness
External UT Measurements 1992/1993

Contour Plot For Bay 1: 1992/1993 External UT Measurements

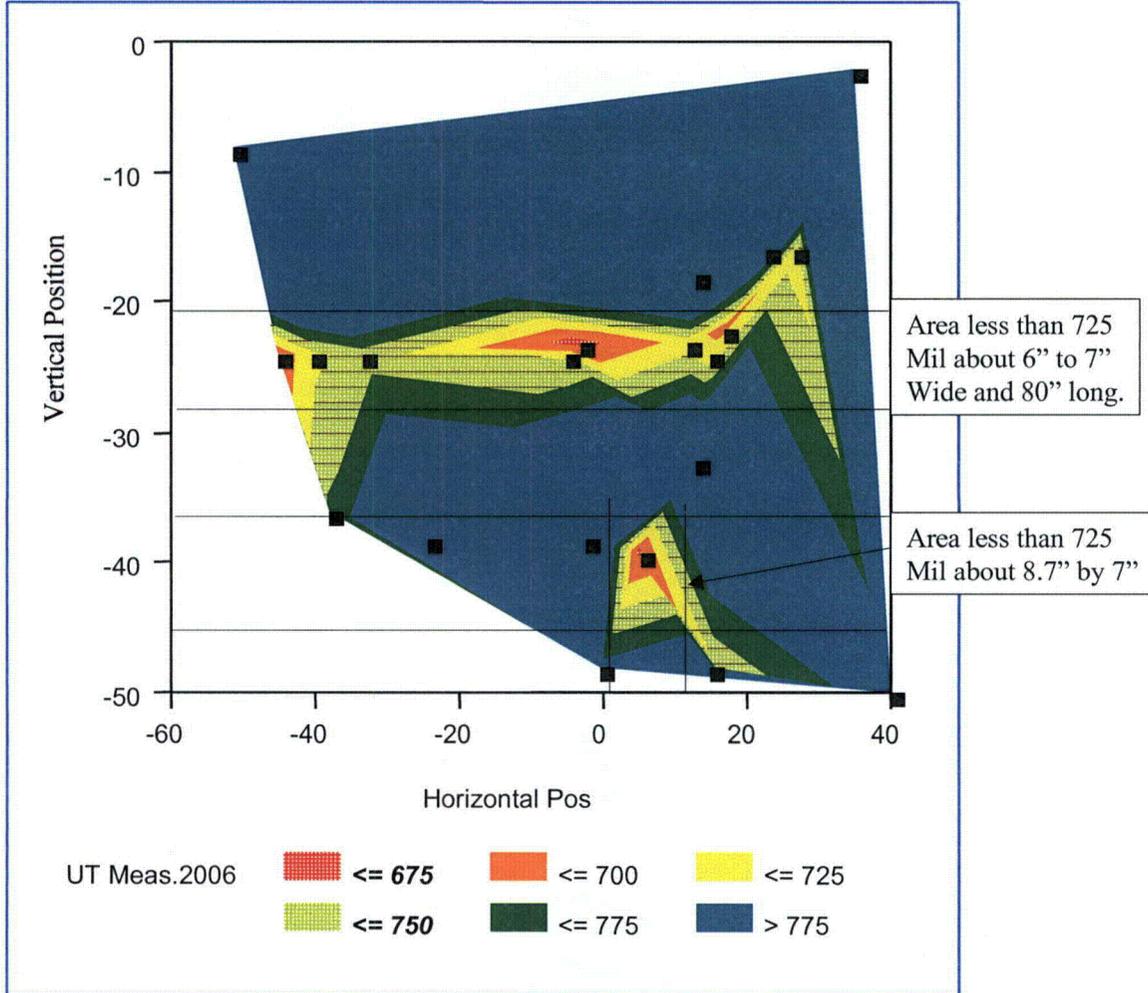
Figure 3

Bay 1 Remaining Wall thickness
External UT Measurements 2006

Contour Plot for Bay 1 2006 External UT Measurements 2006

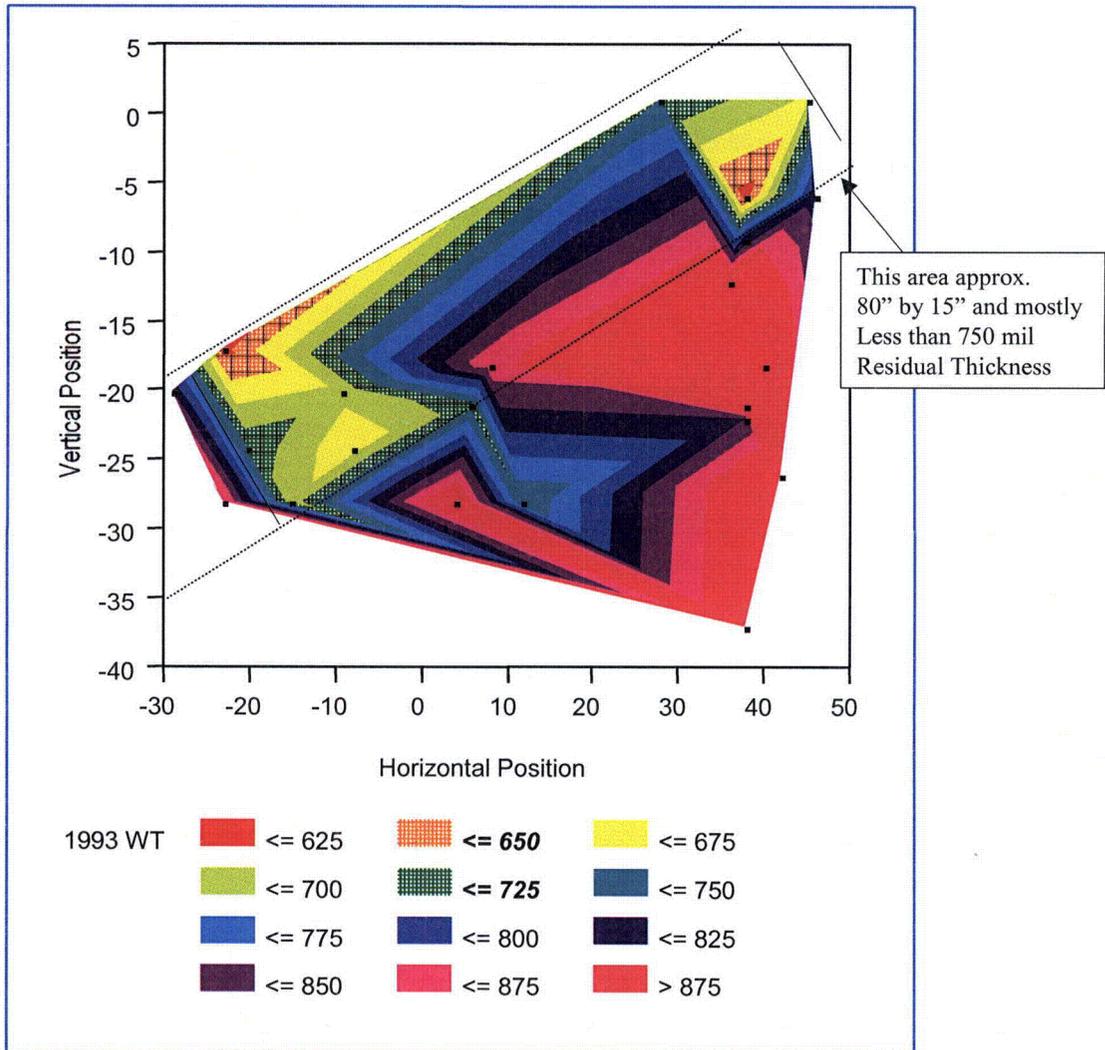
Figure 4

Bay 13 Remaining Wall Thickness
External UT Measurements 1992/1993

Contour Plot for Bay 13 1992/1993 External UT Data

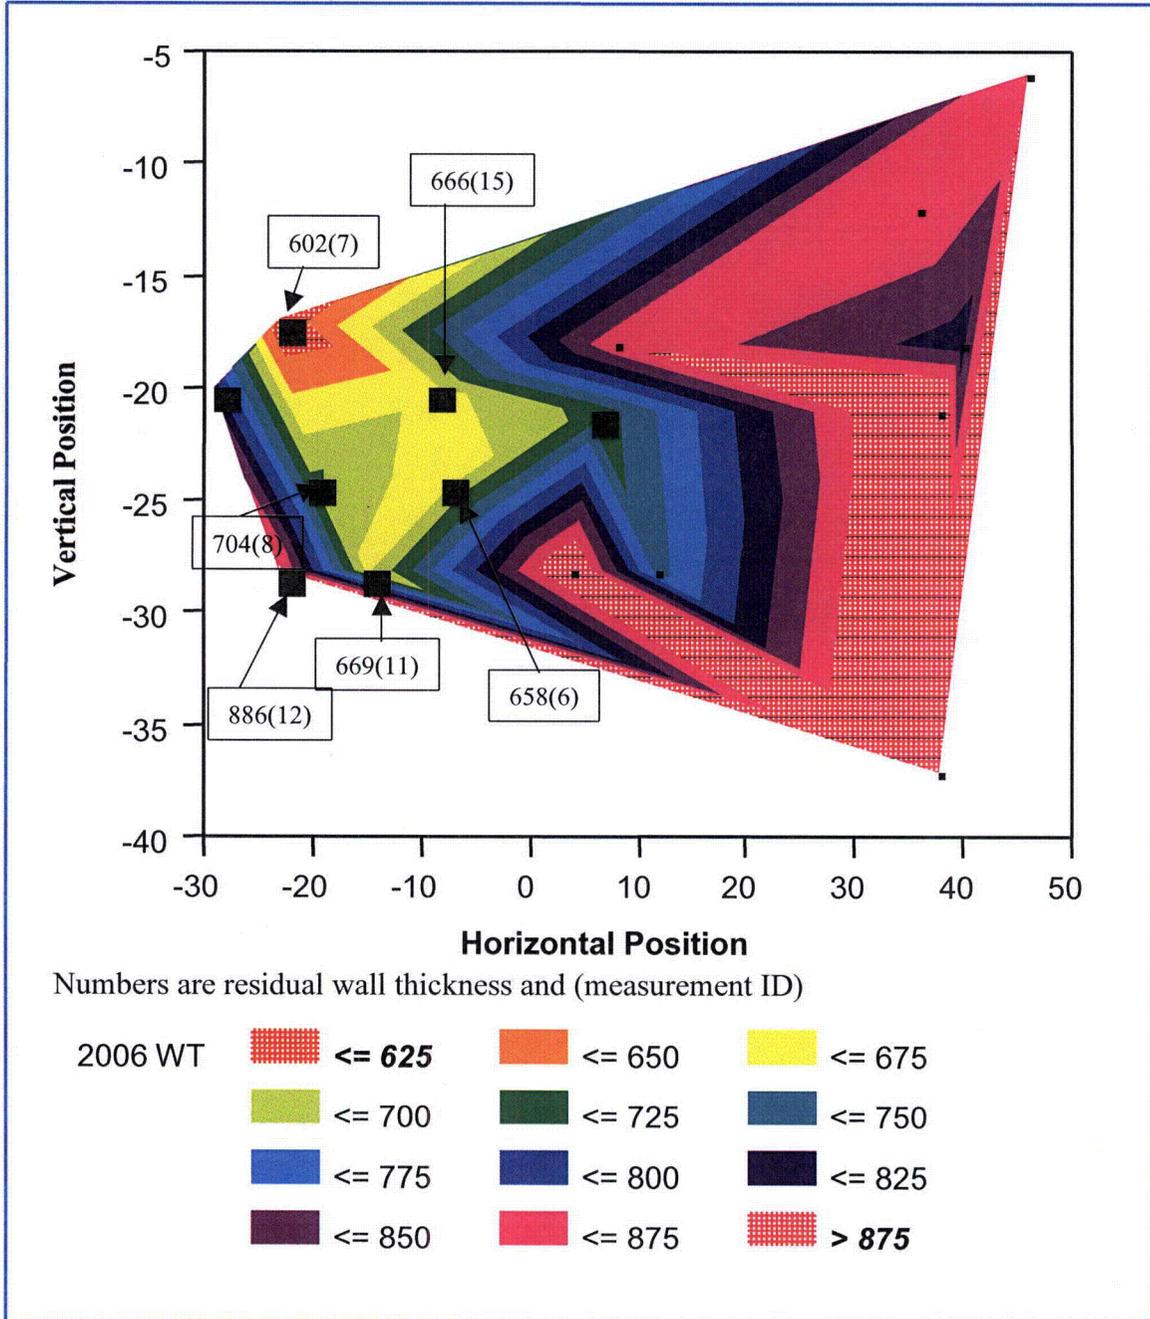
Figure 5

Bay 13 Remaining Wall Thickness
External UT Measurements 2006

Bay 13 Contour Plot 2006 UT Data

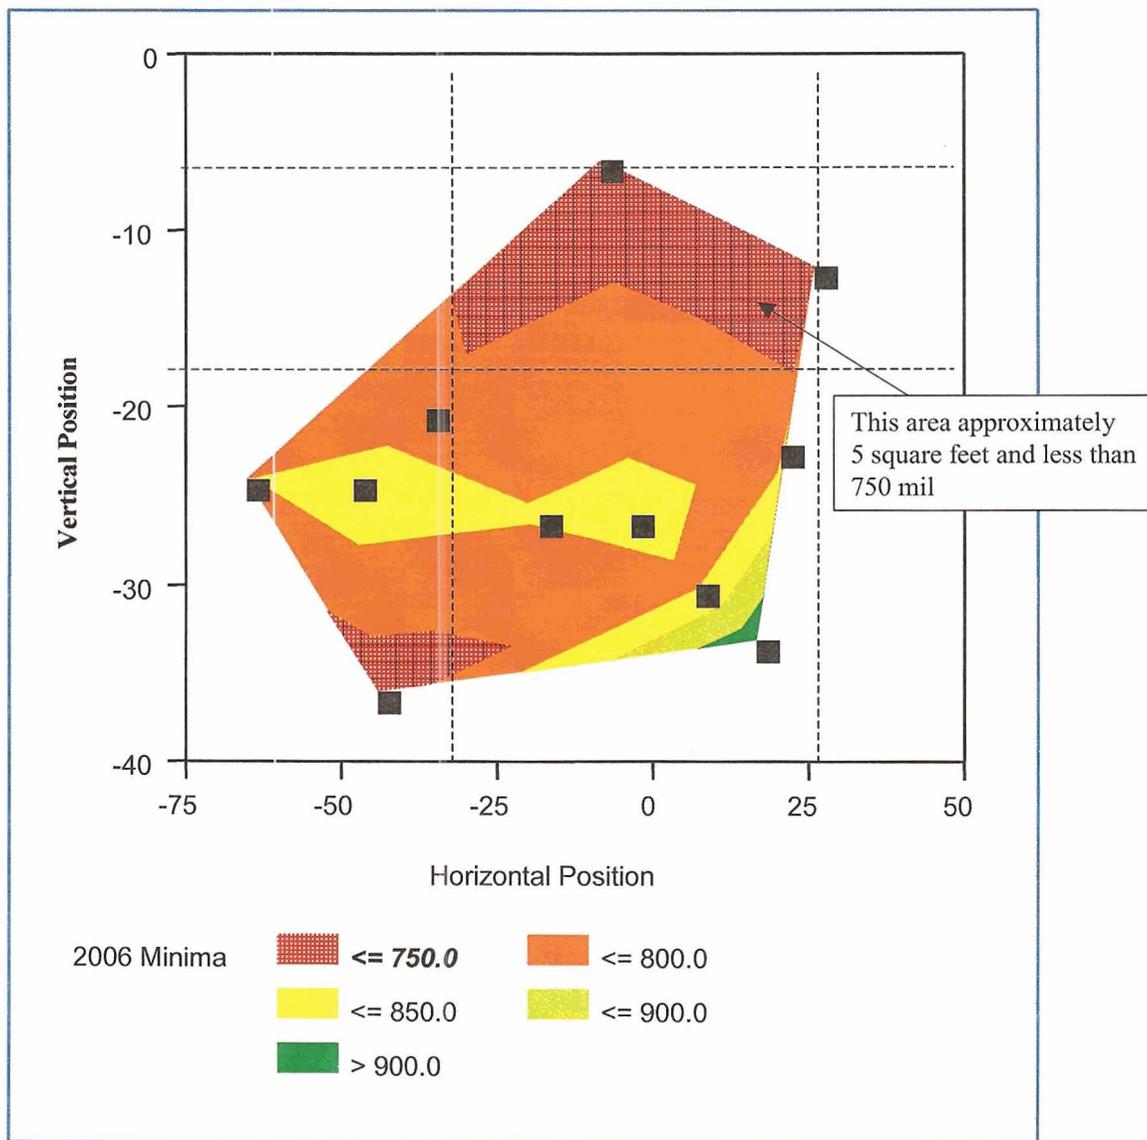
Figure 6

Contour Plot for Bay 15 2006 External UT Measurements

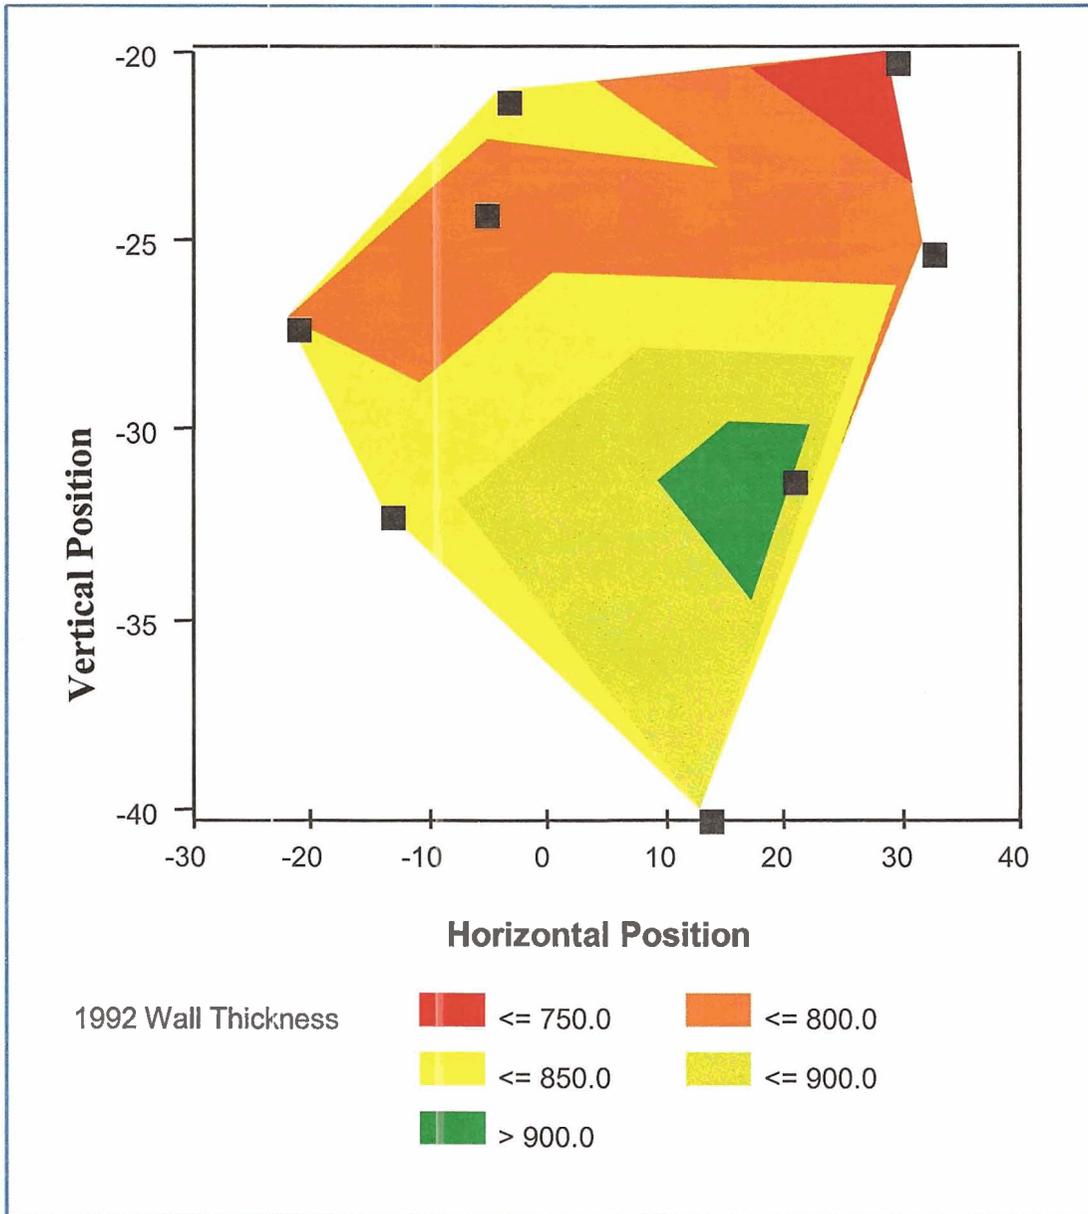
Figure 7
Contour Plot for External UT 1992 Data Bay 11
