Corro-Consulta
Rudolf H. Hausler
rudyhau@msn.com

MEMORANDUM

Subject: **Update of Current Knowledge Regarding the State of Integrity of OCNGS Drywell Liner and Comments Pertaining to Aging Management Thereof**

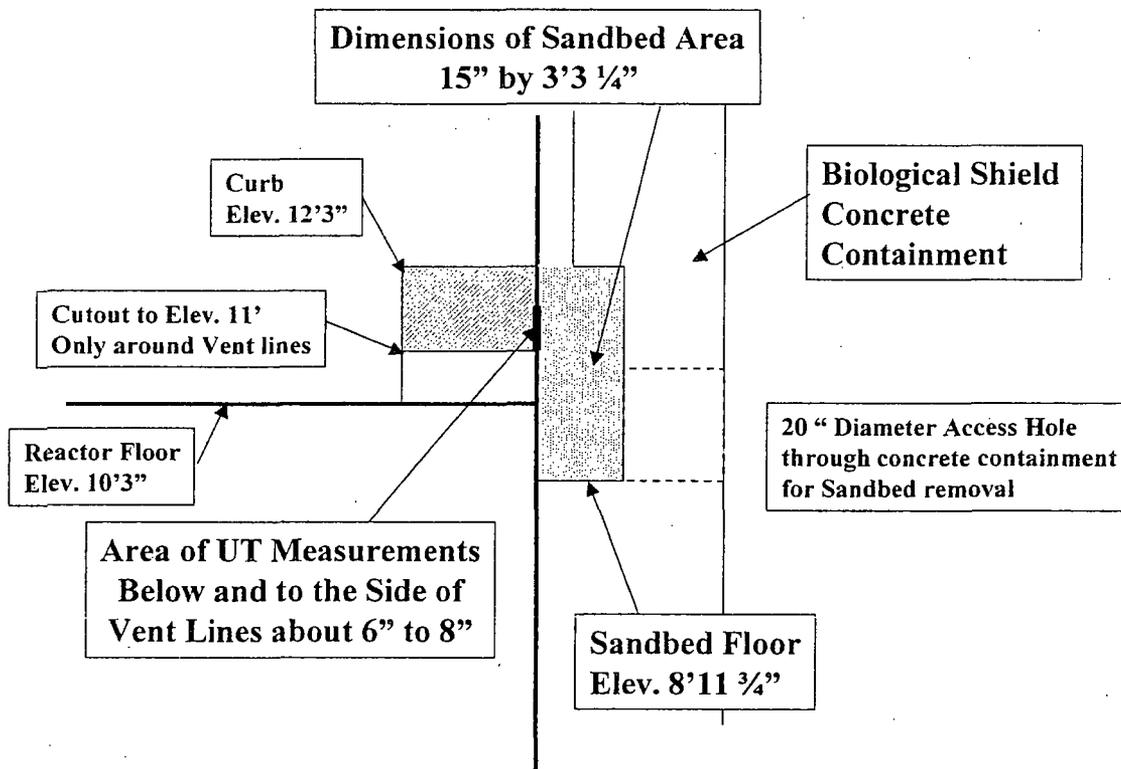
Figure 1

After corrosion had been found in the sandbed area a concerted effort was made to assess the corrosion rate in order to project the life of the structure. The tools in this effort were ultrasonic measurements (UT) at well-defined locations. In order to assure repeatability of the measurements, a template was constructed containing 49 openings for placement of the UT transducer. The 49 openings were spaced 1 inch apart over a 6 by 6 inch square. This 6 by 6 inch grid was placed repetitively at the inside of the drywell liner just below the vent pipe where the inside curb was lowered from about 2

feet to just over 9 inches (see Figure 1). In this manner, every bay was monitored systematically at intervals over the past 20⁺ years.¹⁾ In 1992 the sand was removed from the sandbed, and all steel surfaces as well as the sandbed floor were coated with an epoxy resin. UT measurements using the 6 by 6 inch grid performed in 1992, 1994, 1996 and 2006, always at exactly the same position, indicated that within the accuracy of the test (measuring procedure) the continued corrosion was at most small. That should not be surprising because a) the outside steel surface was now coated, b) water would not accumulate against the vessel at the location where the measurements were made because of the drains in the sandbed floor, and c) if corrosion were to commence it would most likely be at imperfections in the coating near the sandbed floor where indeed, standing water could be present (see discussion below).²⁾

Schematic Cross Section through Sandbed Area
(not to size)

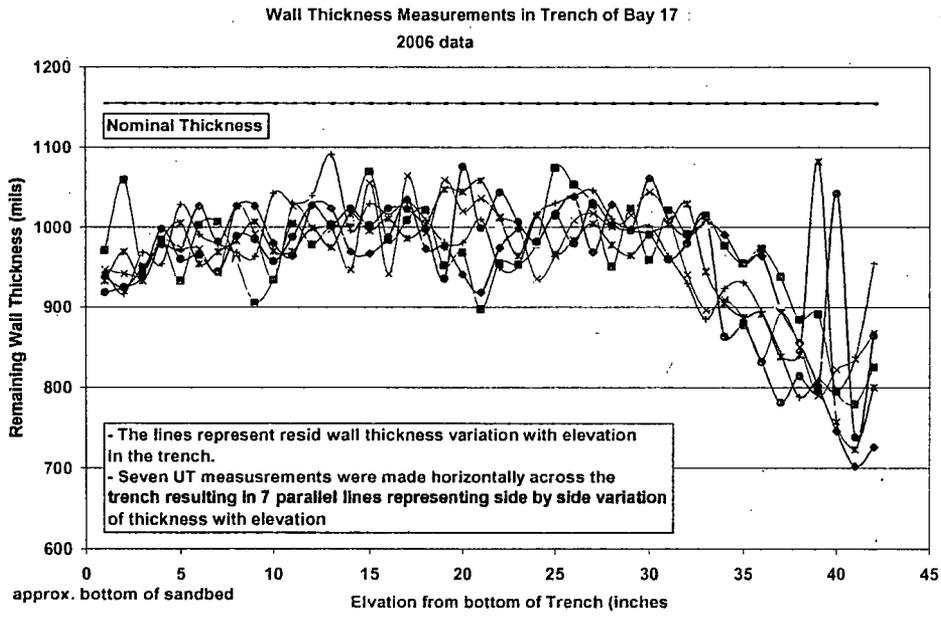
We take issue with this statement. In support of this contention, an effort was made to show graphically the remaining wall thickness observed in all of these various locations. Thus Figure 2 shows, by way of example, the remaining wall thickness from the 2006 UT measurements made with the help of 6 by 6 inch grids as a function of elevation in the **trench of Bay 17**. It is understood, as is described in Ref. 3 that 6 such grids were placed one on top of the other in the trench in order to capture the corrosion from the bottom to the top of the sandbed. Hence, if the bottom of the trench had the elevation about 9 feet, then the top of the 6 grids would have had an elevation of about 12 feet, which according to Figure 1 corresponds to the top of the sandbed and is at least 9 inches higher than the top of the grid used for UT measurements from the inside. (Note, none of these elevations is terribly accurate, however, the top of the trench measurements were definitely lower (deeper pits) by a good margin than the inside grid measurements). Figure 2 plots all individual 2006 measurements from the trench in bay 17. The 6 traces represent the variation of the wall thickness in the horizontal direction while the traces themselves extend from the bottom of the trench (left hand side) to the top of the trench (right hand side). The

undulations of the 6 traces, which are at times (at the same elevation) in synch and at other times out of phase clearly depict the nature of the “golf ball type” surface described in AmerGen literature (Ref. 1 pg. 4). Where the undulations are in synch one can estimate that the extent of the pit at that location extends over an area larger than just one inch in diameter³⁾. It should also be noted that the average amplitude of the undulations in Fig. 2 are of the order of 0.1 inch, i.e. the roughness of the surface at this point is only of that order of magnitude. AmerGen estimated the “roughness” of the surface to be rather of the order of 0.2 inches (Ref. 5 pg. 5).

The most striking observation is that the corrosion is most severe at the top, almost uniform in severity over most of the depth of the sandbed and again somewhat more severe at the very bottom.

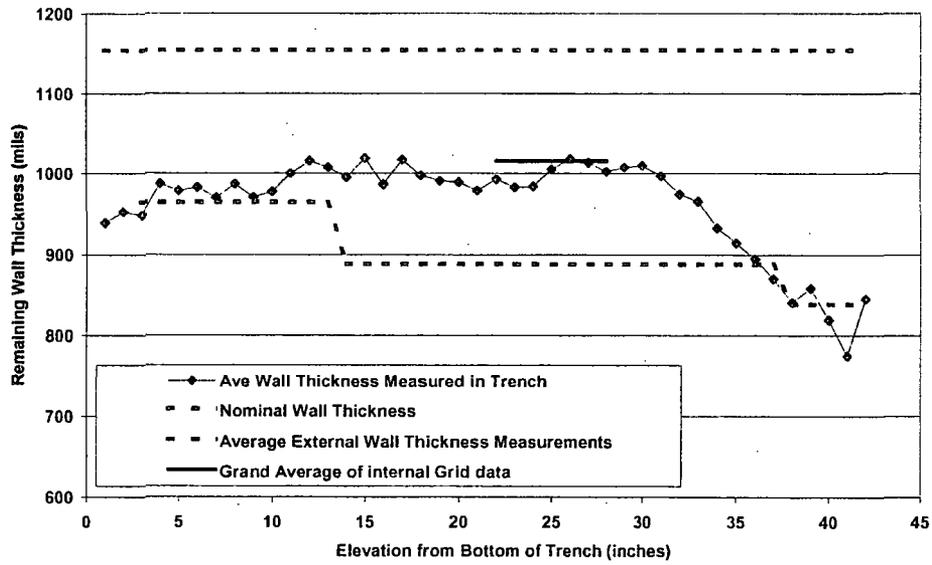
In Figure 3 an effort is being made to compare the average remaining wall thickness from trench measurements (averaged over the horizontal direction) with the average of the 6 by 6 grid measurement from the inside and the direct UT measurements from the outside. Also graphed in this figure are the averages of the outside measurements for the three zones for which data are reported (Ref. 5). What one can see is that the averages for the grid and the trench data overlap quite well at the same elevation. However, the average outside measurements are significantly lower at comparable elevations.⁴⁾ This is probably because the choice of location for the external measurements was deliberately biased towards thin spots.

Comparison of Various Thickness Measurements in Bay 17
2006 data

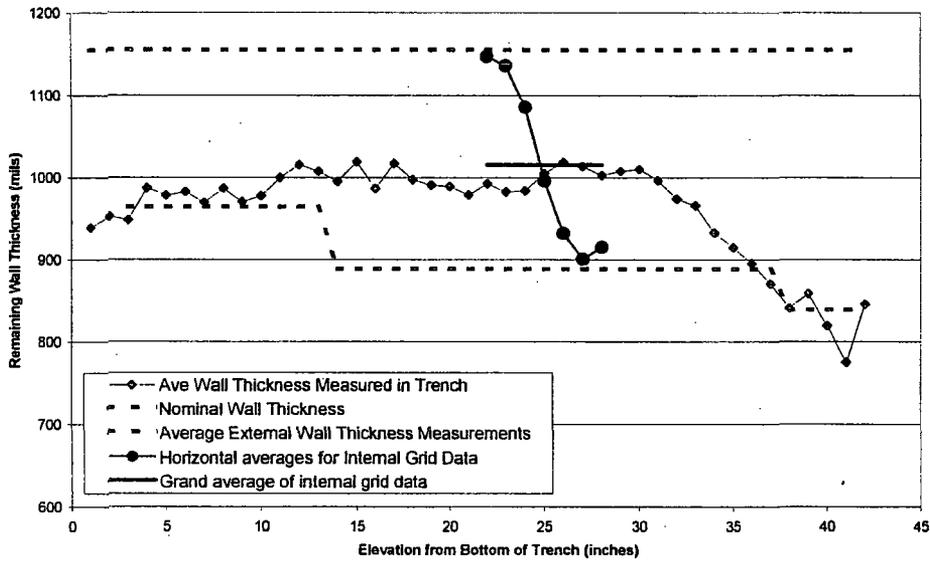
Finally in Figure 4 we see the spread of the 6 by 6 inch inside grid measurements superimposed on the averages of the other measurements.

Conclusion: What the superposition of the UT measurements in Bay 17 demonstrates is that wall loss ranges from zero to 33 percent, however, only the trench and outside measurements come close to represent the most severe corrosion at the highest elevations. It should also be remembered that the grid measurements at the inside curb cutout as well as those in the trench are only 6 inches wide. One does not have, therefore any indications as to how far serious corrosion may have spread laterally around the circumference of the bay.

Comparison of Various Thickness Measurements in Bay 17
2006 data

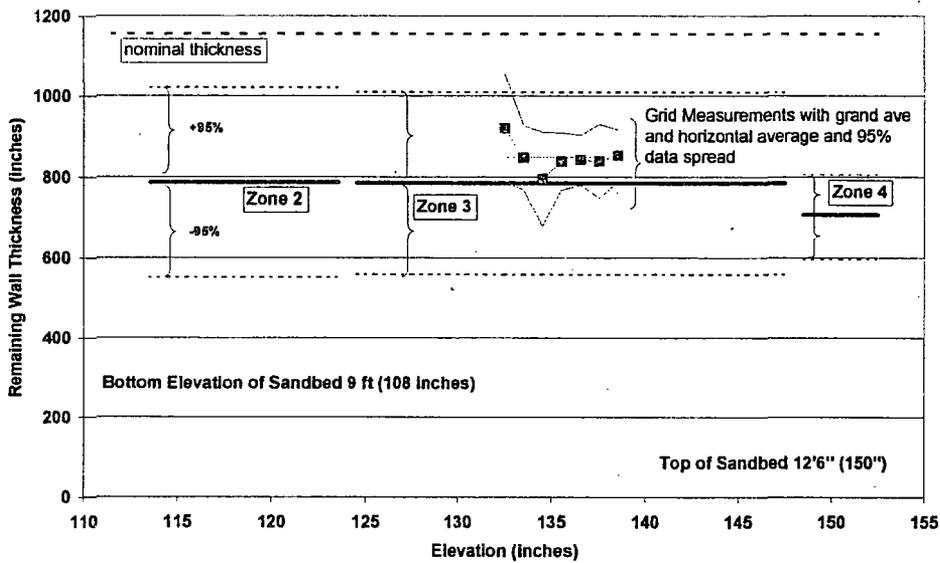
Figure 5 shows an analysis of the available 2006 data for Bay 13. Bay 13 is probably the second worst corroded bay apart from Bay 1. The averages for the external measurements for each zone are fairly similar, as are the 95% limits for the data spread. There is a 95% percent probability for the deepest penetration to be of the order of 48% of the original wall thickness. The superposition of the internal grid data shows a higher average and a narrower distribution of the data spread. Again one recognizes that the internal 6 by 6 inch grid measurements do not represent the worst corrosion degradation.

External 2006 UT Measurements in Bay 13
averages and 95% limits of data spread

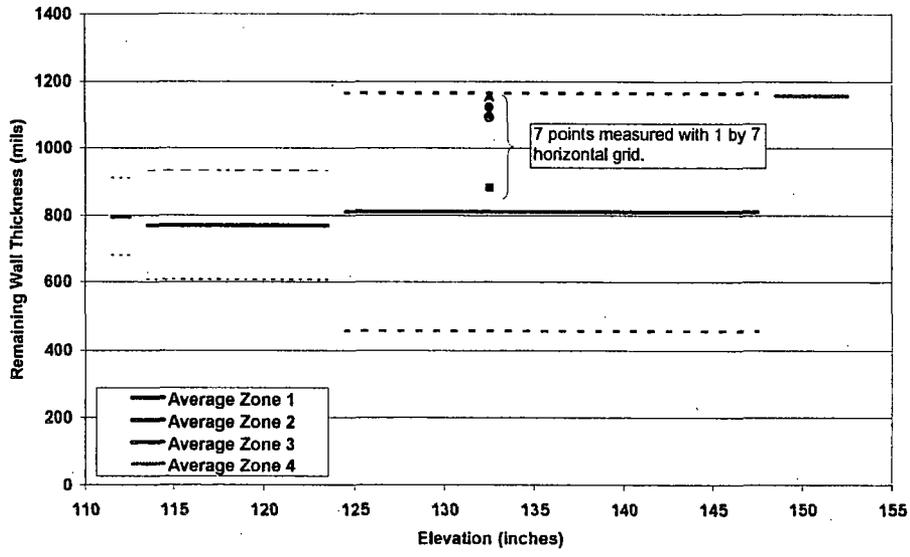
Finally in Figure 6 we show the distribution of the external measurements for Bay 1. One observes that the 95% lower limit of the data spread is around 40% of the original wall thickness, or indeed at a remaining wall thickness of 450 mils, which is 0.04 inches below the required sandbed thickness for the Design Pressure and Temperature. Because the external sampling in Bay 1 was designed to capture the thinnest points, this is a conservative estimate of the minimum wall thickness. However, given the need for a very high degree of confidence that the drywell shell is ready to withstand accident pressures and the uncertainty created by the sparse data set, I believe that a conservative approach is required in this case.

External UT Measurements 2006 in Bay 1
Averages and 95% limits of data spread

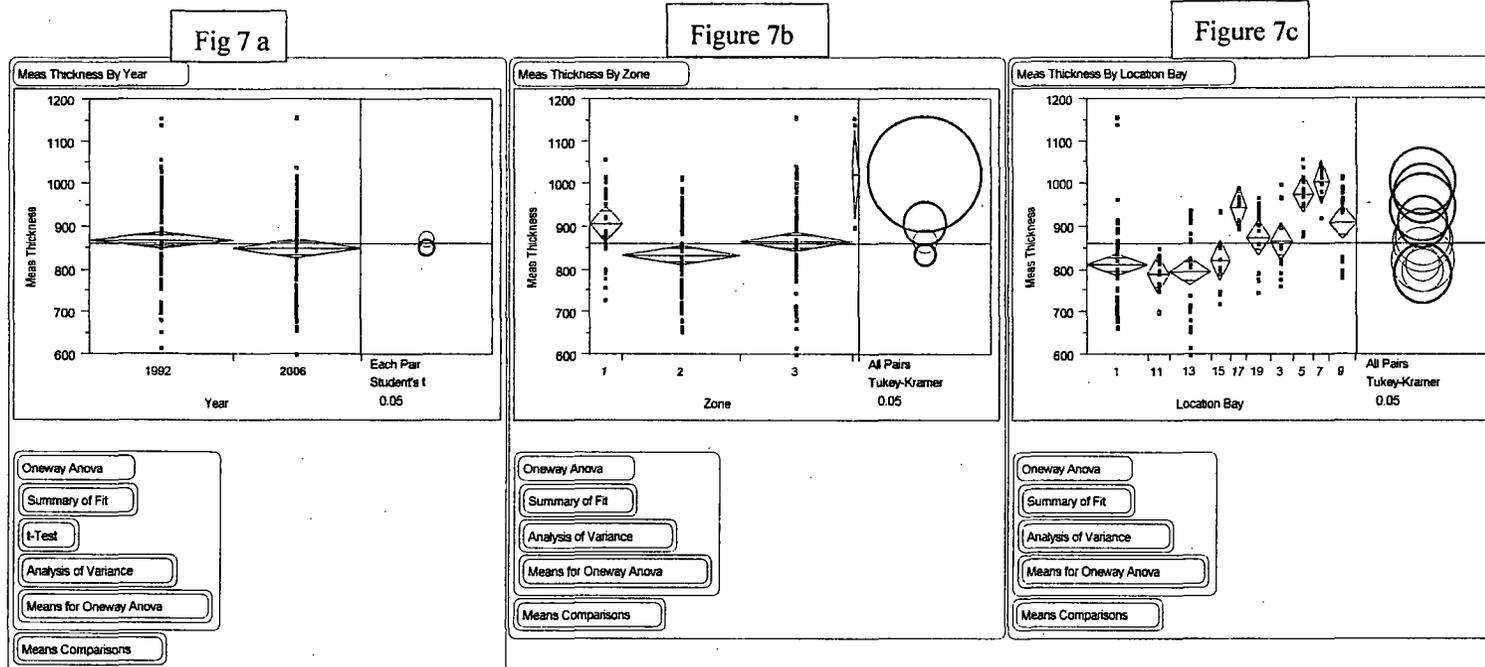
Figure 7

It was found that there is no significant effect of the time (Fig.7a). While there is a decrease of 19 mils between 1992 and 2006, this difference is not statistically significant within the variability of the data. The differences between the zones, however are significant. Zone 2 is by far the most corrosive zone. When the bays are compared, one finds as expected that some bays have experienced little corrosion in contrast to others. The importance of these observations is obvious: they point again to the fact that the intensity of corrosion is a clear function of elevation and bay. Hence, averaging data and generalization may lead to doubtful conclusions.

Statistical Analysis of all External UT Measurements

Figure 7a: Comparison between measurements I 1992 and 2006 show no significant difference. The means from 1992 and 2006 show a bias of 0.018 inches, but the bias is statistically not significant despite of the many data points. Fig. 7b: The comparison between the "zones" (elevations) is significant. Zones 1 is significantly different from zones 2 and 3. For zone 4 there are not enough data for statistical significance. Fig. 7c: Some bays, red ones, are significantly different from the black ones.

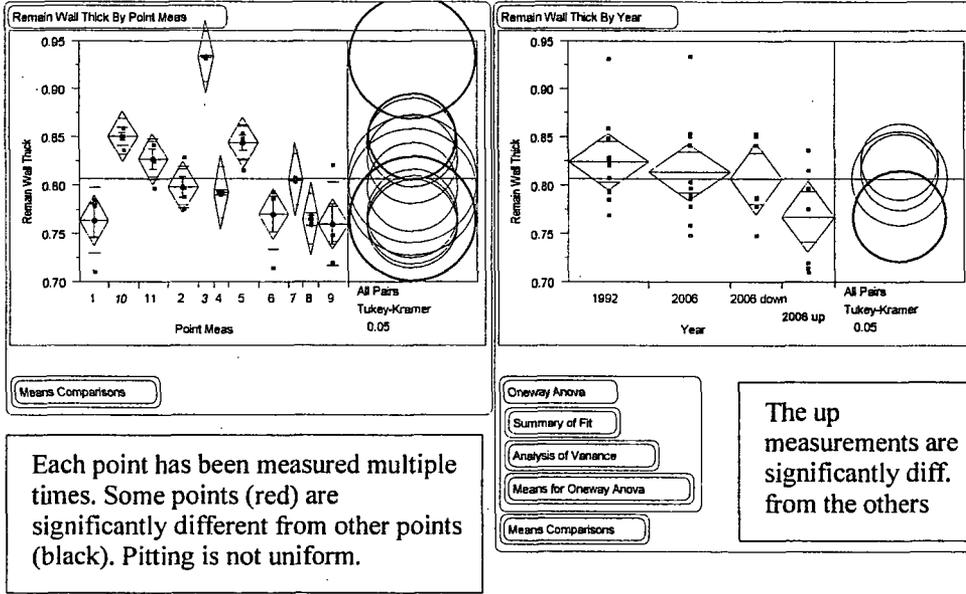
In 2006 the validity of some of the external UT measurements was explored by measuring around the nominal original locations. These data were statistically evaluated in Figures 8, 9, 10 for Bays 15, 1 and Bay 19. The additional data collected in Bays 19 and 15 had been identified as “up” or “down”, hence additional data sets

Figure 8: External UT Measurements in Bay 15

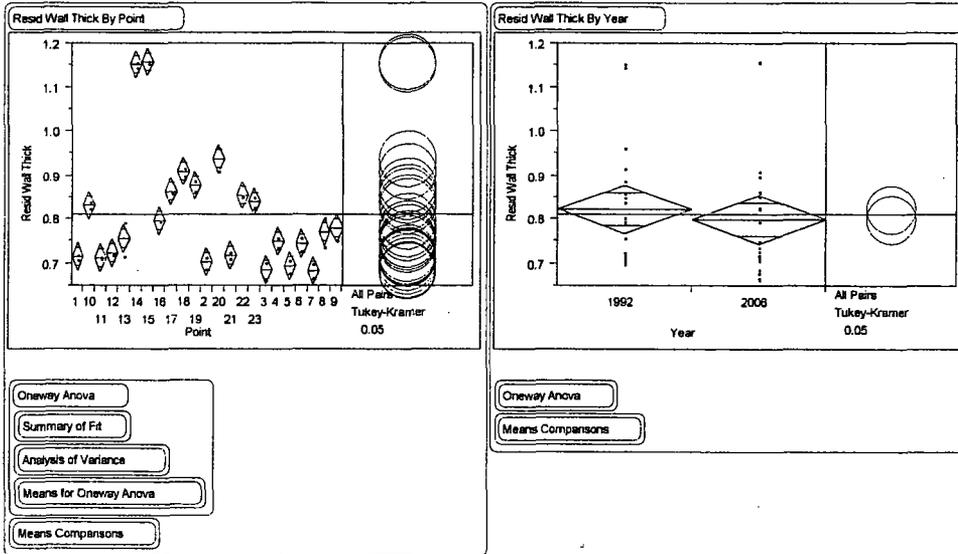
Figure 9: External UT Measurements in Bay 1.

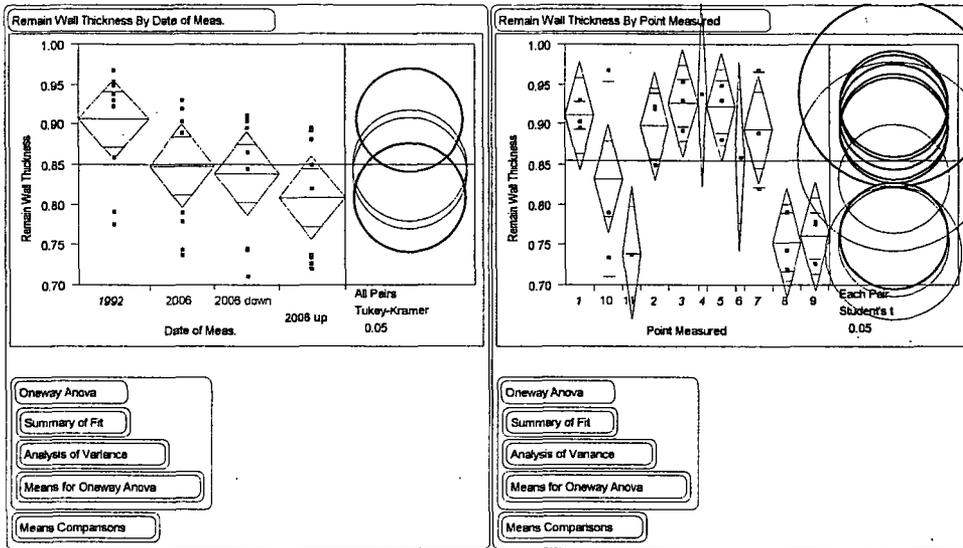
identified as 2006 up and 2006 down were compared with the original 2006 data. It turns out for Bay 19 for instance that the UT penetrations identified as 2006 up were significantly lower than the measurements of 1992 with a probability of better than 95%. The difference between the 1992 and 2006 up data is 0.1 inch. Similarly for Bay 15 one finds that the 2006 up data are significantly lower than the original 1992 data by about 0.06 inches, although this difference is not significant at the 5% level. For Bay 1 there is practically no difference between the 2006 and the 1992 data sets, because of the two or three measurements in the non-corroded areas. Summarizing these results in Table 1, one finds that the lower 95% confidence limits for Bays 1, 15 are marginally within the 0.736-inch limit. Since one does not know exactly how extensive the "cancer of corrosion" in the sand bed area really is, it is very difficult to put this interpretation in perspective with the assessments made by AmerGen relative to areal criteria for thinned areas (see discussion below).

Figure 10: External UT measurements in Bay 19

Again one finds that the “up” measurements are significantly lower from the 1992 measurements.
