**CORRO-CONSULTA**  
Rudolf H. Hausler  
rudyhau@msn.com

**Memorandum**

**Subject: Review of Fitness for Service Assessment of Oyster Creek Dry Well  
on the Basis of Extended Data Analysis**

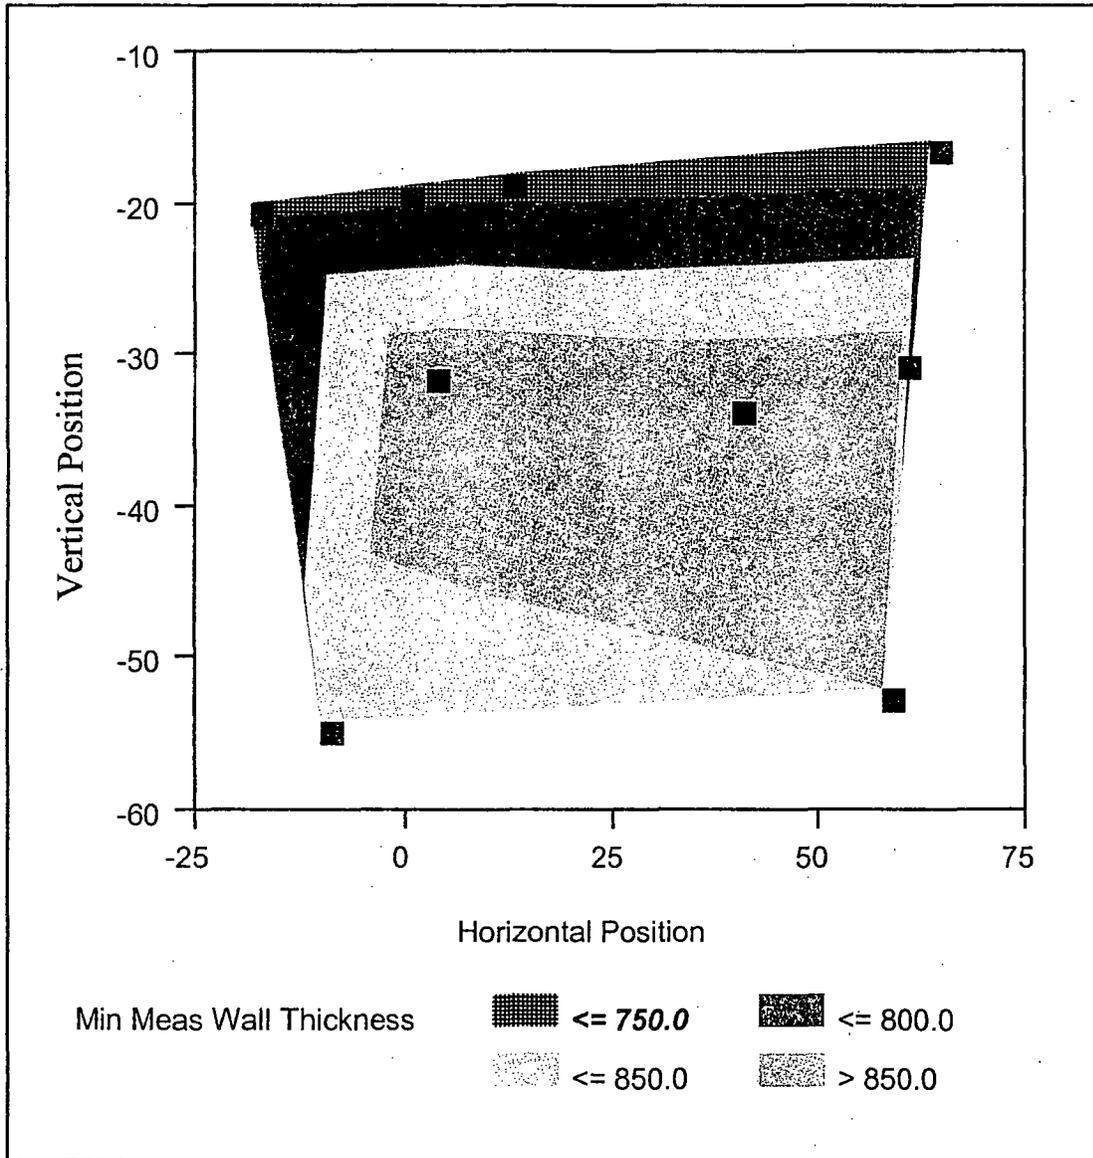
The advantage of this evaluation is that one can see all the available data in a quantitative presentation. Thus, one can see in Figure 1 that an area exists at elevation -20 (20 inches below the reference point) where the remaining wall thickness is less than 750 mils, or less than the criteria for general thinning at 95% confidence. This area extends from 20 inches on the left (-20 inches) to about 60 inches on the right (+60 inches), or about 7 feet. The width of this area in Fig. 1 is maybe 4 to 5 inches, however, because measurements were not extended toward lesser elevations (from the reference point) one simply cannot estimate how much further the serious the corrosion may extend in Bay 19.

**Figure 1** mentioned previously shows a heavily corroded area in Bay 19 at elevation  $-20$ . The extent of this area is highly uncertain because it was not further defined by additional UT measurements toward higher elevations ( $>-20$ ). Indeed, one could find here an extended bathtub ring area.

Bay 19 External 2006 UT Measurements, Minimum Values

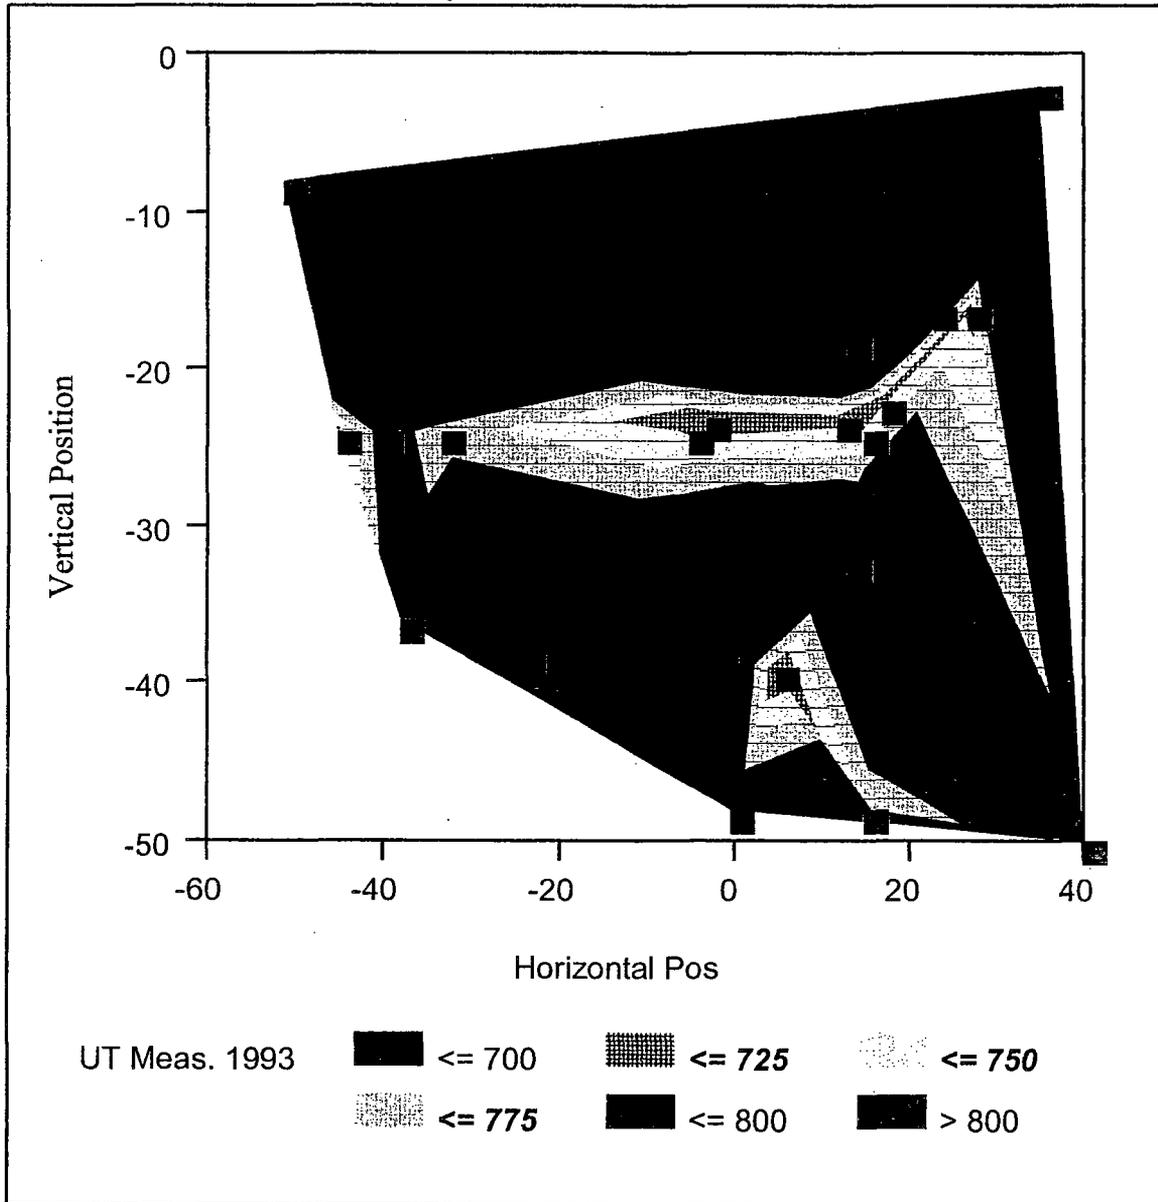
**Figure 2**  
**Bay 1 Remaining Wall thickness**  
**External UT Measurements 1992/1993**

AmerGen discusses the bathtub ring in Bay 1 (See also Figure 2) as one single area using 1992 and 2006 data for which the *evaluation thicknesses* had been determined (See discussion of evaluation thicknesses above). AmerGen finds that in this area the average of 11 data points, which is around 4 square feet in area, is 0.766 inches and 0.765 inches for the 1992 and 2006 measurements, respectively. Considering the uncertainty of the measurements, +/- 27 mils, there is at least a 5% probability that the remaining margin is of the order of 2 to 3 mils, assuming that areas larger than one square foot in extent must average 0.736 inches or more.

The data used for the analysis are contained in Tables 1 and 2 for Bays 1 and 13 as extracted from AmerGen documents. Presumably, these were the most corroded Bays. Figure 2 shows a contour plot for Bay 1 obtained with the data from 1992. The dimensions of the points in the plot are 2.5 by 2.5 inches. Again, one needs to remember that the specific shape of the contours depends not only on the residual wall thickness measured at the locations indicated, but on the density of measurements as well. (For instance, an additional measurement at coordinates h (-20) v (-25) could completely alter the contours and in all likelihood extend the area of wall thickness below -750 mils <sup>4)</sup>).

Nevertheless, it appears in Figure 2 that in the so called “bathtub ring” an extensive area exists with wall thicknesses between 700 and 750 mils (0.75 inches). This area extends well over 52 inches (4+ feet) and is about 5 inches wide. In view of the fact that UT measurements are at best accurate with a standard deviation of about 45 mils, (95% confidence limits +/-90 mils), this area could well be more extensive.

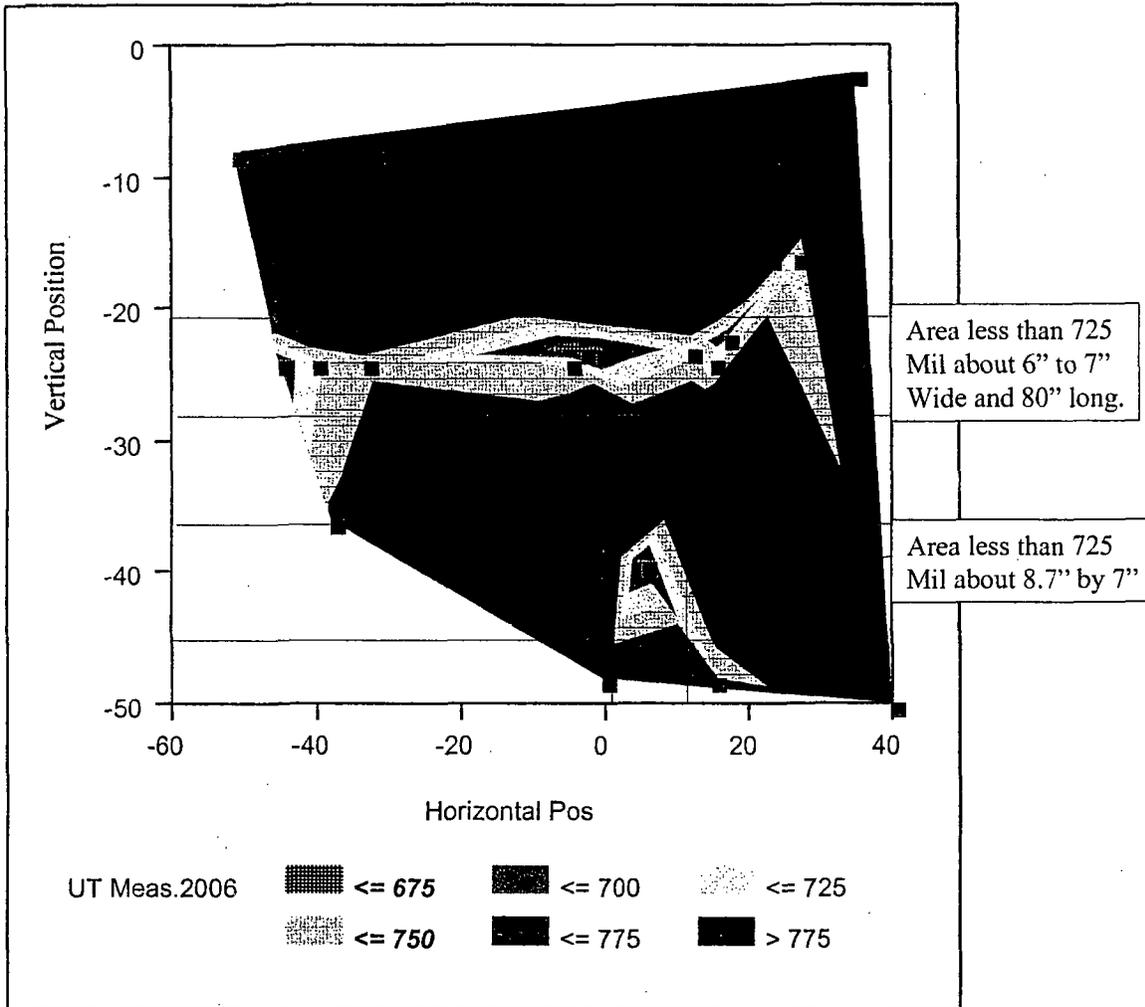
Figure 3

**Figure 3** shows the contours for Bay 1 obtained with the data from the 2006 inspection. The general shapes are the same as in Figure 2 except that here we have sizeable areas with residual wall thicknesses below 725 mils. The unexpected thing is

that these areas seem to extend on the left beyond  $-40$  inches but no measurements are available to verify whether AmerGen did in fact manage to capture all of the most corroded areas as claimed.

Based on Figure 3, together with an assessment of the accuracy (reliability) of the data one must conclude that there is a good likelihood that the entire bathtub ring area extending from  $40$  to  $-40$  inches on the horizontal axis and from about  $-30$  to perhaps  $-20$  inches on the vertical axis is below the  $0.736$  inch criteria for general thinning and is, much larger than the one square foot acceptance criterion. (Of course, since this area is the most corroded, it will taper off to higher wall thickness on both sides of the vertical axis). The corroded area is indeed shaped quite irregular, but one could venture a guess that the contoured areas below  $750$  mils are of the order of  $4$  to  $7$  square feet all together. This estimated area does not include the area to the left of  $-40$ , which probably contains additional area below  $0.750$  inches.

Bay 1 Remaining Wall thickness  
External UT Measurements 2006

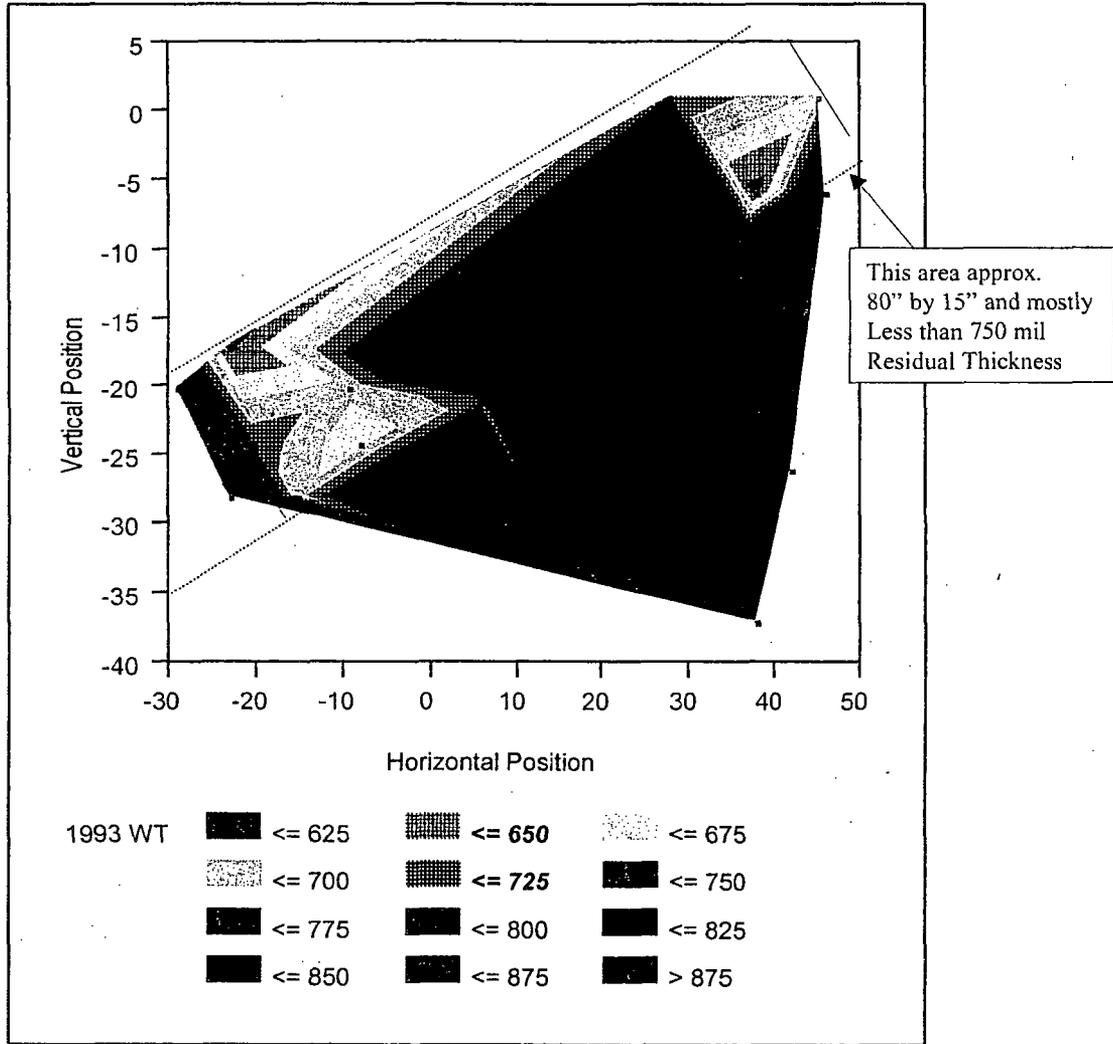
Figure 4

**Figures 4 and 5** show the contours for Bay 13, 1992 and 2006 data, respectively. Here large areas exist with wall thicknesses below  $700$  mils and at least two seemingly unconnected areas where the residual wall thickness is less than  $650$  mils. It could be argued that those heavily corroded areas are less than  $1$  square foot and therefore are still acceptable according to the  $636$  mil criterion. However, the heavily corroded area on the left hand side ( $-20, -20$ ) has not been further explored. One therefore does not know whether it might extend further. Similarly, the area on the right ( $(40, -7)$ ), clearly showing a fairly deep pit, was not further explored and was not even measured in 2006. While in Bay 1 the bathtub ring was at elevation  $-20$  to  $-25$  (from the reference point) in Bay 13 there is no clearly prominent bathtub ring. This may be because it was not there, but it may also be because the measurements were not extended toward elevation  $-15$  and  $-10$ . We are therefore left with a great uncertainty as to the true extension of the damage in this Bay.

**Bay 13 Remaining Wall Thickness**  
External UT Measurements 1992/1993

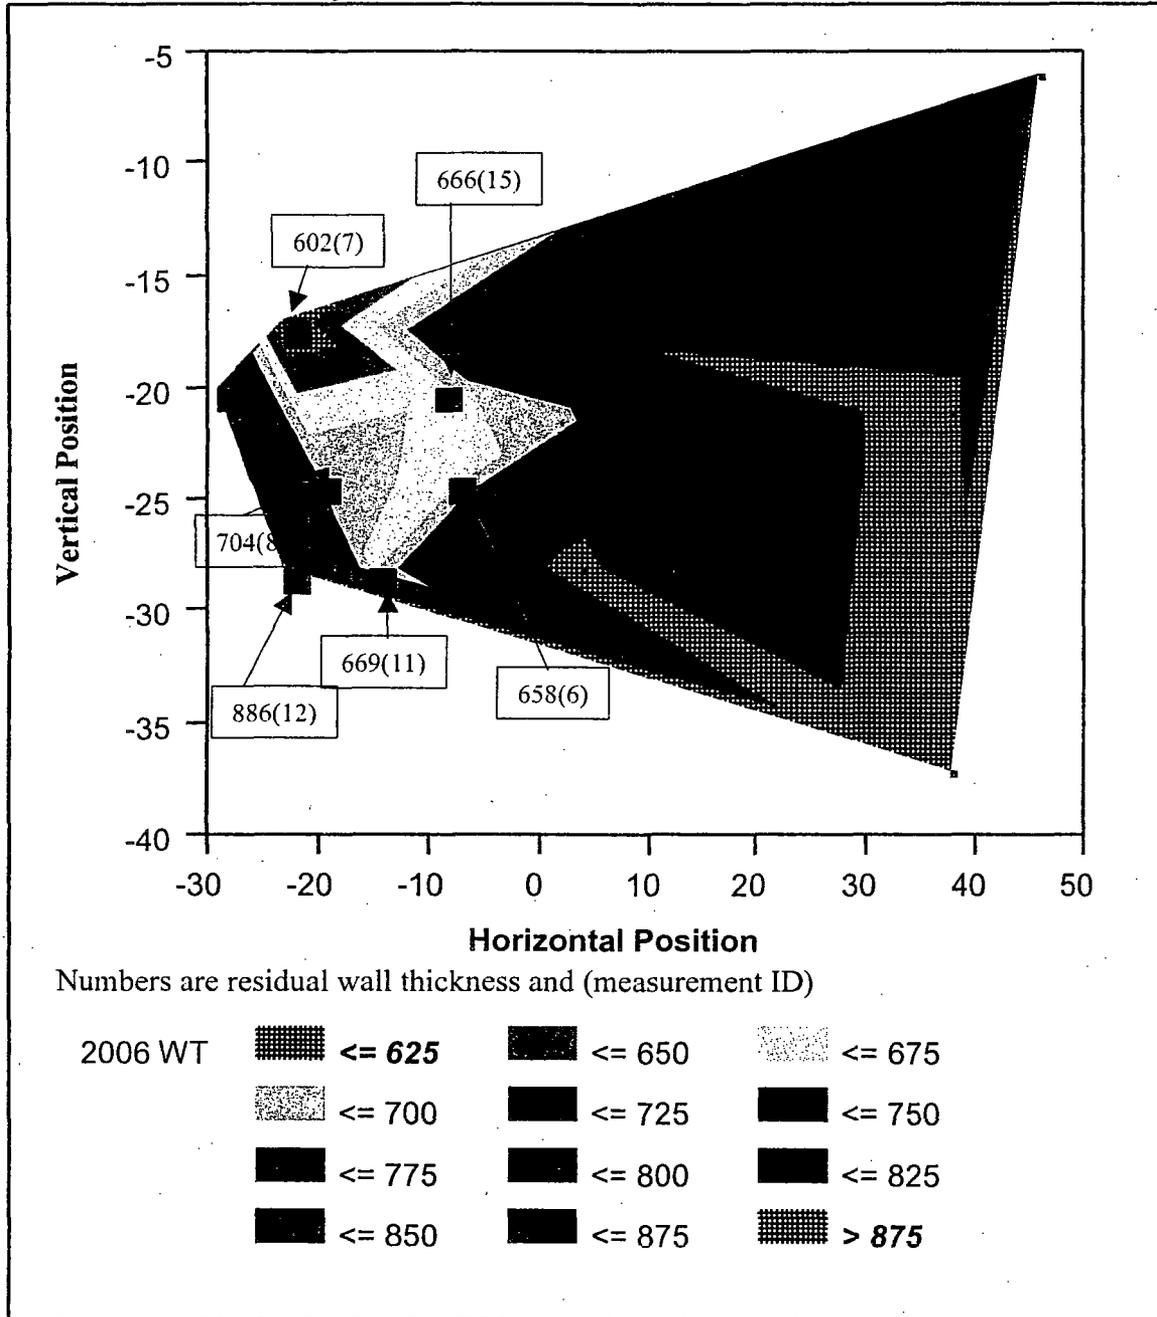
Figure 5

Bay 13 Remaining Wall Thickness  
External UT Measurements 2006

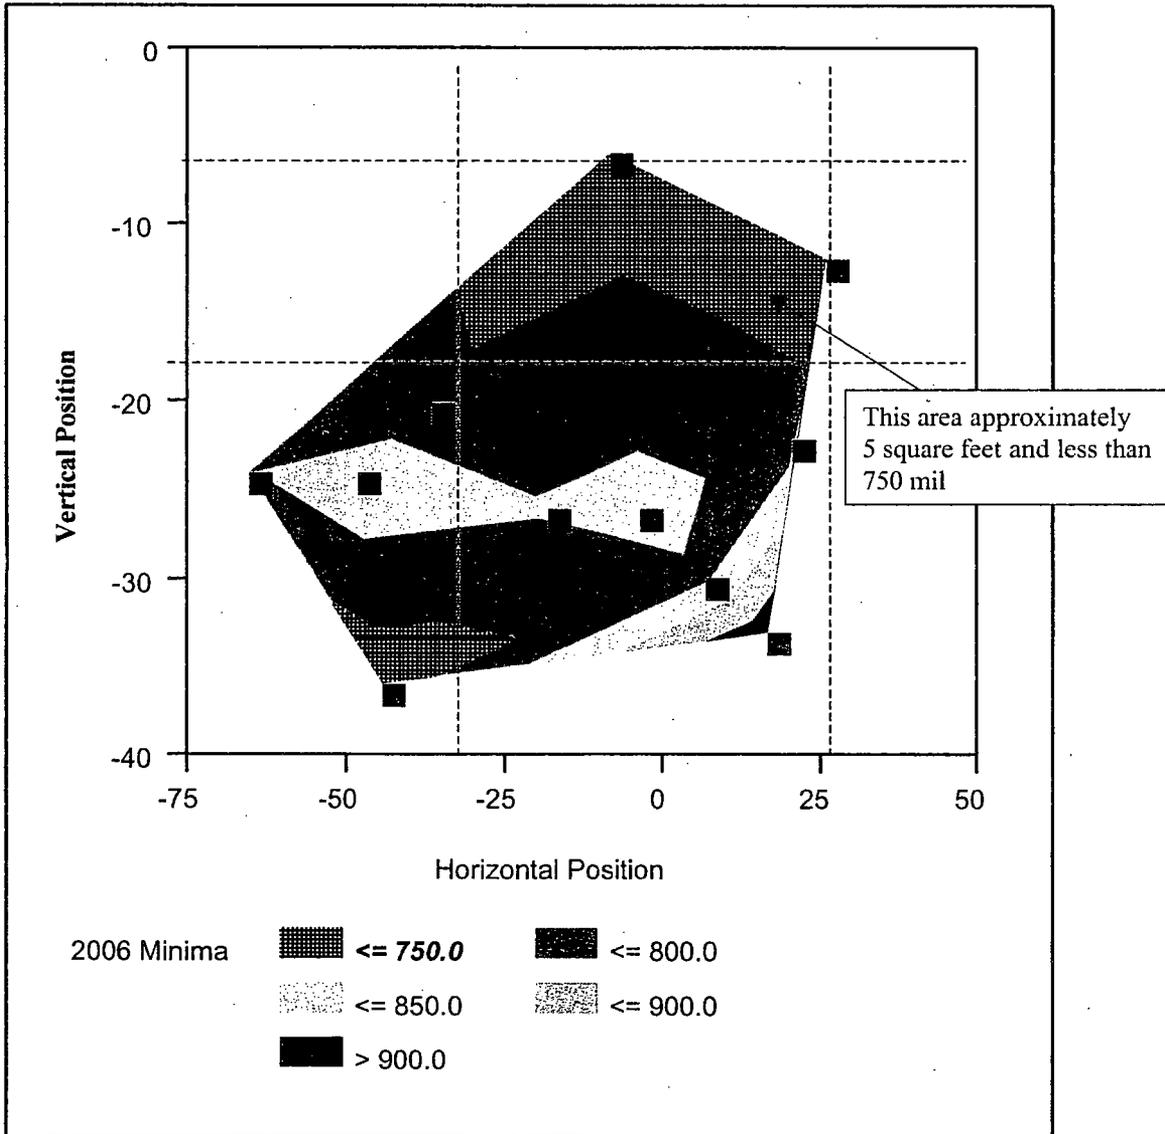
Figure 6

**Figure 6** shows the contours for Bay 15. There is a heavily corroded area at elevation  $-10$  with an extension of  $1$  ft by about  $4.5$  feet. However, this area was explored only with  $2$  measurements and was not extended beyond about  $2$  feet either side of the centerline. It appears that the majority of the measurements occurred in the non-corroded zones. Interestingly there appears some serious corrosion near the sandbed bottom, but the occurrence was not further explored either.

Contour Plot for Bay 15 2006 External UT Measurements

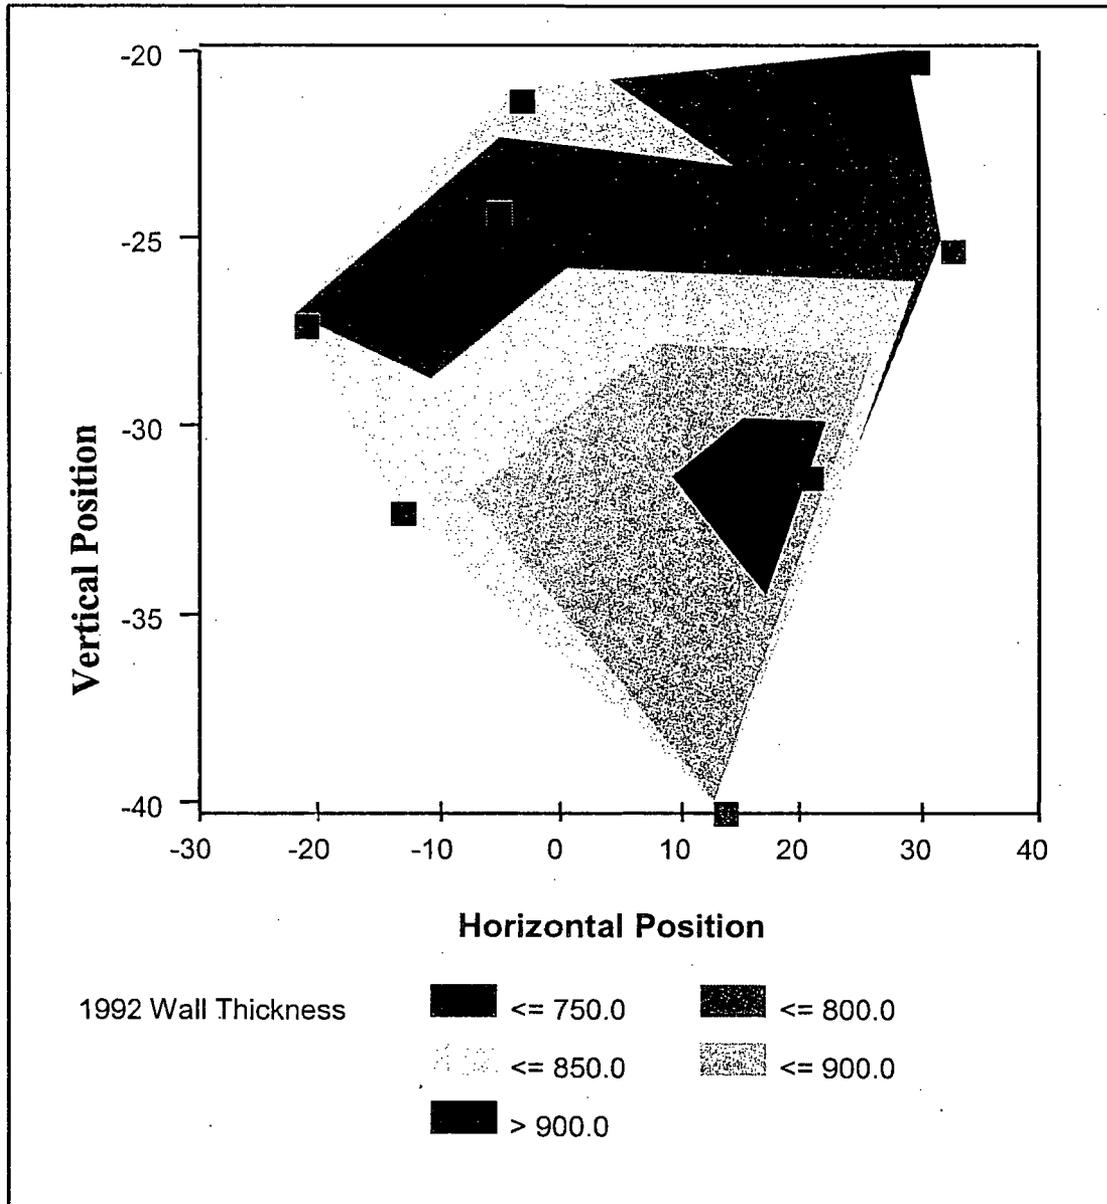
Figure 7  
 Contour Plot for External UT 1992 Data Bay 11

**Figure 7** shows the contours for Bay 11. Again there is a suggestion of severe corrosion at elevation  $-20$  and no further exploration into the bathtub ring area. Once again, the extent of this area is highly uncertain because it was not further defined by additional UT measurements.
