Subject: Oyster Creek Nuclear Generating Station (OCNGS)
Docket No. 50-219
License No. DPR-16
Oyster Creek Drywell Containmentment

**GPUN Detailed Summary Addressing Water Intrusion
and Leakage Effects Related to the Oyster Creek Drywell**

WATER INTRUSION

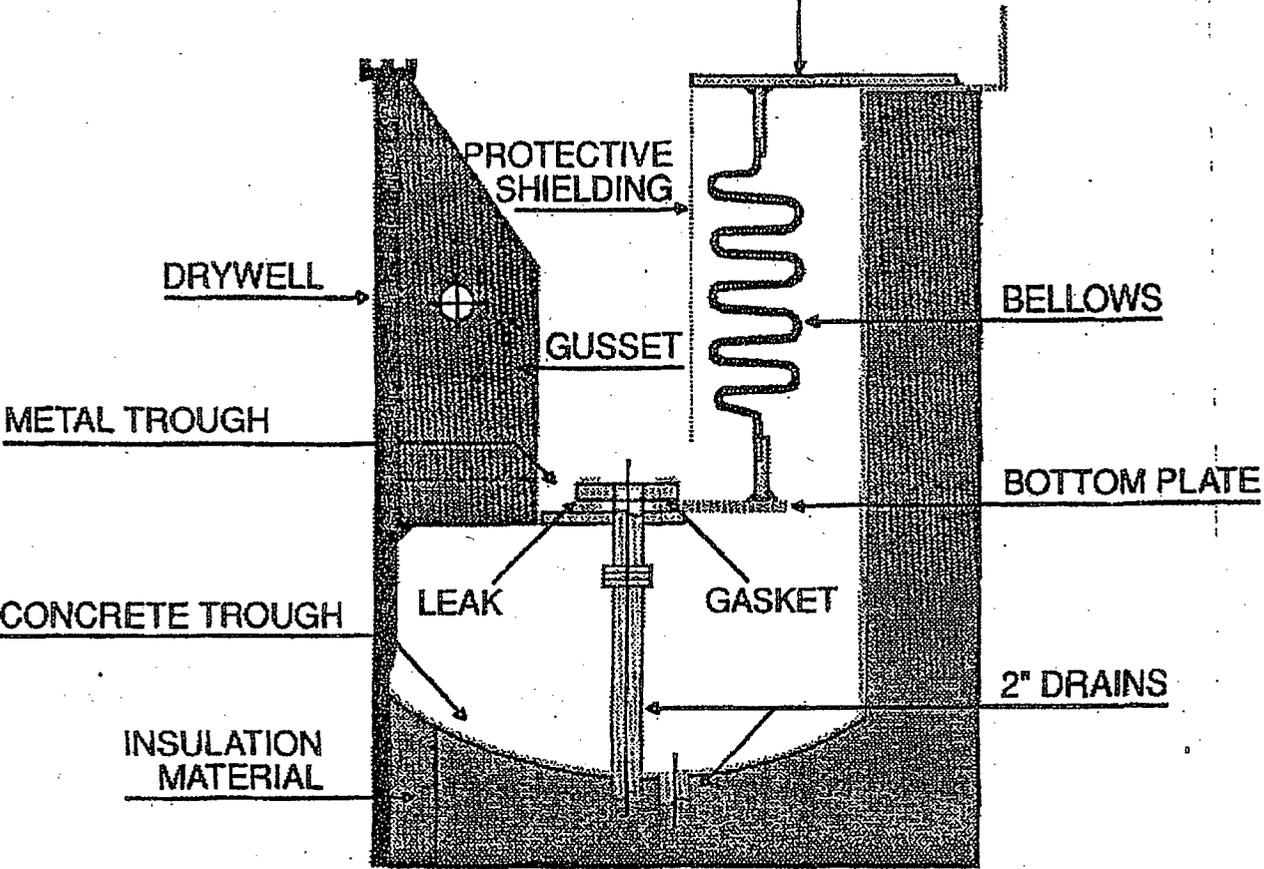
DRYWELL TO CAVITY SEAL

The bellows allow for expansion between the drywell and the refueling cavity and are made of stainless steel. They were repeatedly tested using helium (external) and air (internal) without any indication of leakage. Any leaks from the refueling bellows would wind up in the concrete trough, which has a leakage detection/collection system. No leakage has been observed for the last two refuelings.
