U.S. NUCLEAR REGULATORY COMMISSION

Report Nos: 50-390/99-08, 50-391/99-08

Facility: Watts Bar, Units 1 and 2

Dates: August 15 through September 25, 1999

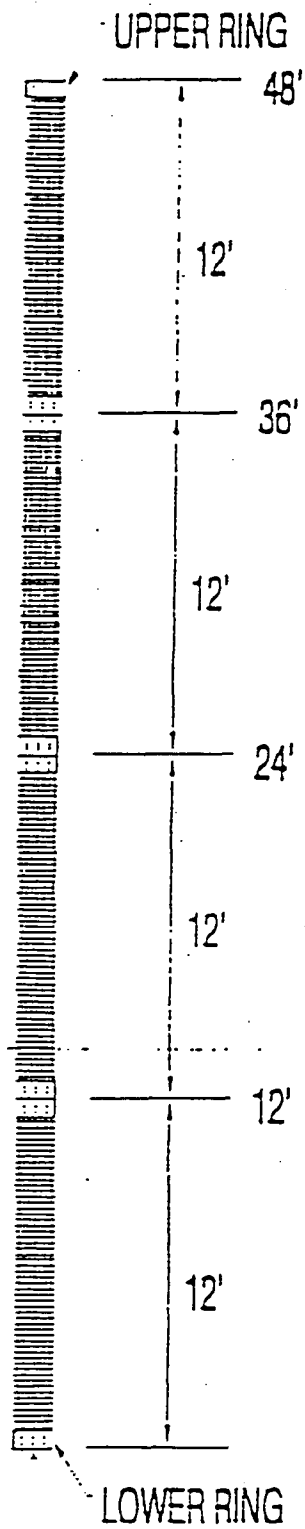
FIGURE 1 - ICE BASKET COLUMN - ELEVATION VIEW

Prior to initial operation of WBN, ice condenser basket screws and screw heads were observed in the ice condenser melt tank. This led to concerns about the integrity of the ice condenser basket joints. The licensee at WBN evaluated these concerns and concluded that although some screws were broken or damaged during installation, the number of screws or screw parts was small compared to the total number of screws. The licensee at WBN concluded that the joints were not significantly degraded due to the loss of some screws or screw heads.

In addition to the preceding, the staff has the following observations regarding the TVA report. The licensee found one upper ring with two missing screws and one ring with four missing screws. The licensee determined that the probability of finding a ring with two missing screws was approximately 2×10^{-5} and the probability of finding a ring with four missing screws was approximately 5×10^{-11} . The fact that the licensee found one ring with two missing screws and

one ring with four missing screws suggests that these events may be common mode effects not covered in the statistical analysis conducted by the licensee. However, in discussions with the licensee, they stated that the rings with two and four missing screws were not representative of the intermediate rings since the screws were missing as a result of weighing operations.

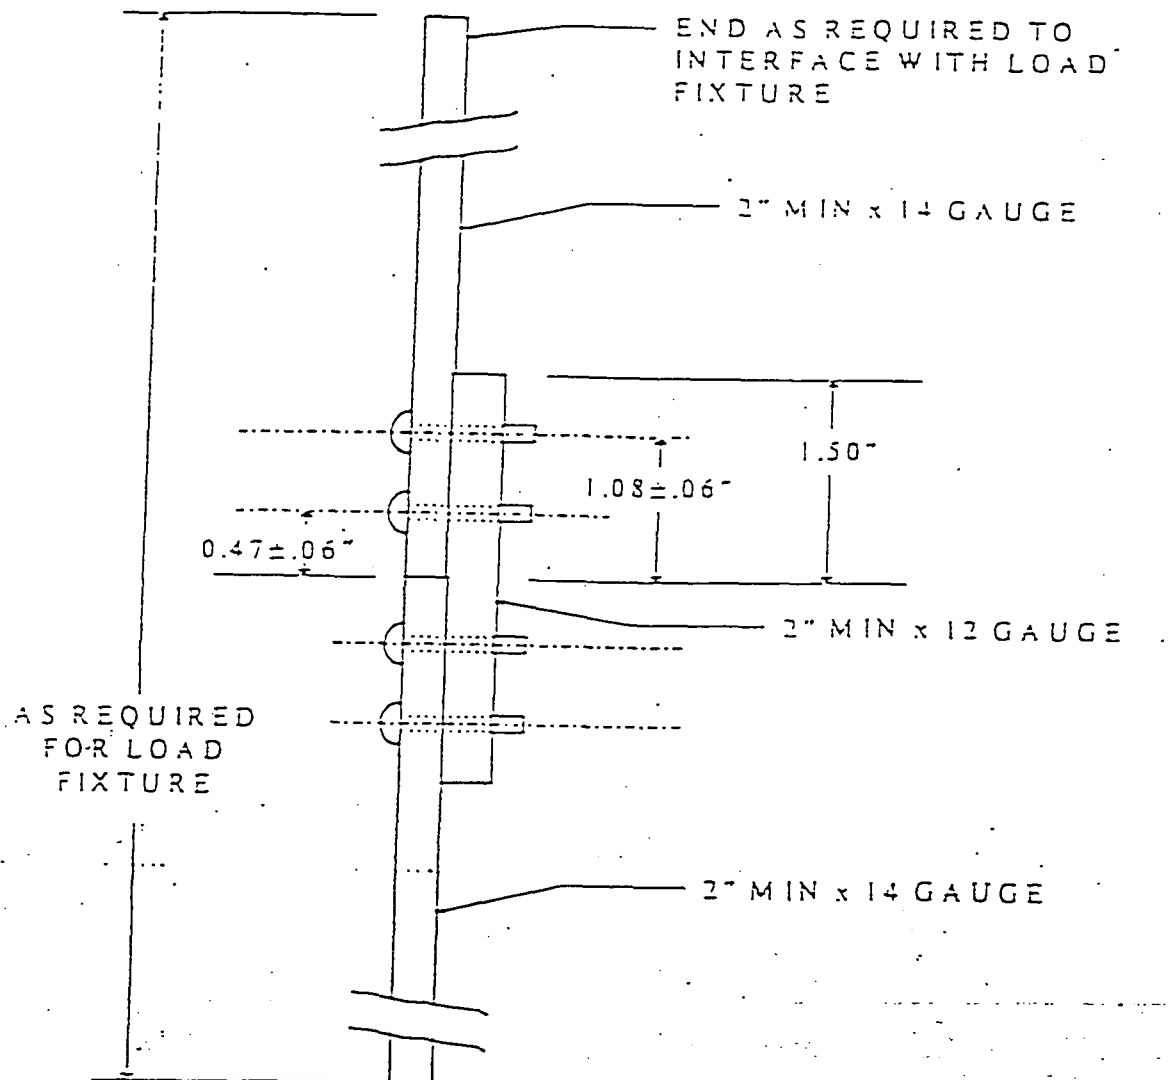
FIGURE 2 - TEST SPECIMEN SIDE VIEW

The licensee at WBN conducted shear tests on splice joint specimens containing two screws on each side of the splice as shown in Figure 2. Five splice joint specimens were assembled using screws randomly selected from the WBN warehouse and 20 specimens were assembled using screws randomly selected and removed from the ice condenser baskets. The maximum loads were determined by applying a shear load to the specimen and measuring the maximum load required to break the joint. The results were fairly consistent with the exception of one outlier that failed at a significantly lower load compared to the other results.

The licensee calculated the maximum accident load per splice sample based on the loads being redistributed in a 12 screw accident loaded joint with two screws missing. The maximum load required to resist an accident was calculated. The measured and required loads were compared and the licensee pointed out that even the outlier could support in excess of the maximum accident load.

The licensee observed an outlier in the sample of 20 tests with no explanations why the outlier occurred. The licensee stated that the maximum failure load for the outlier exceeds the acceptance criteria and that the outlier could support design and accident loadings. Therefore, no additional action is required by TVA with regard to the outlier.
