Tennessee Valley Authority, Post Office Box 2000, Spring City, Tennessee 37381-2000

JAN 29 1996

WATTS BAR NUCLEAR PLANT (WBN) - RADIATION MONITORING SYSTEM  
ASSESSMENT, SUPPLEMENTAL INFORMATION

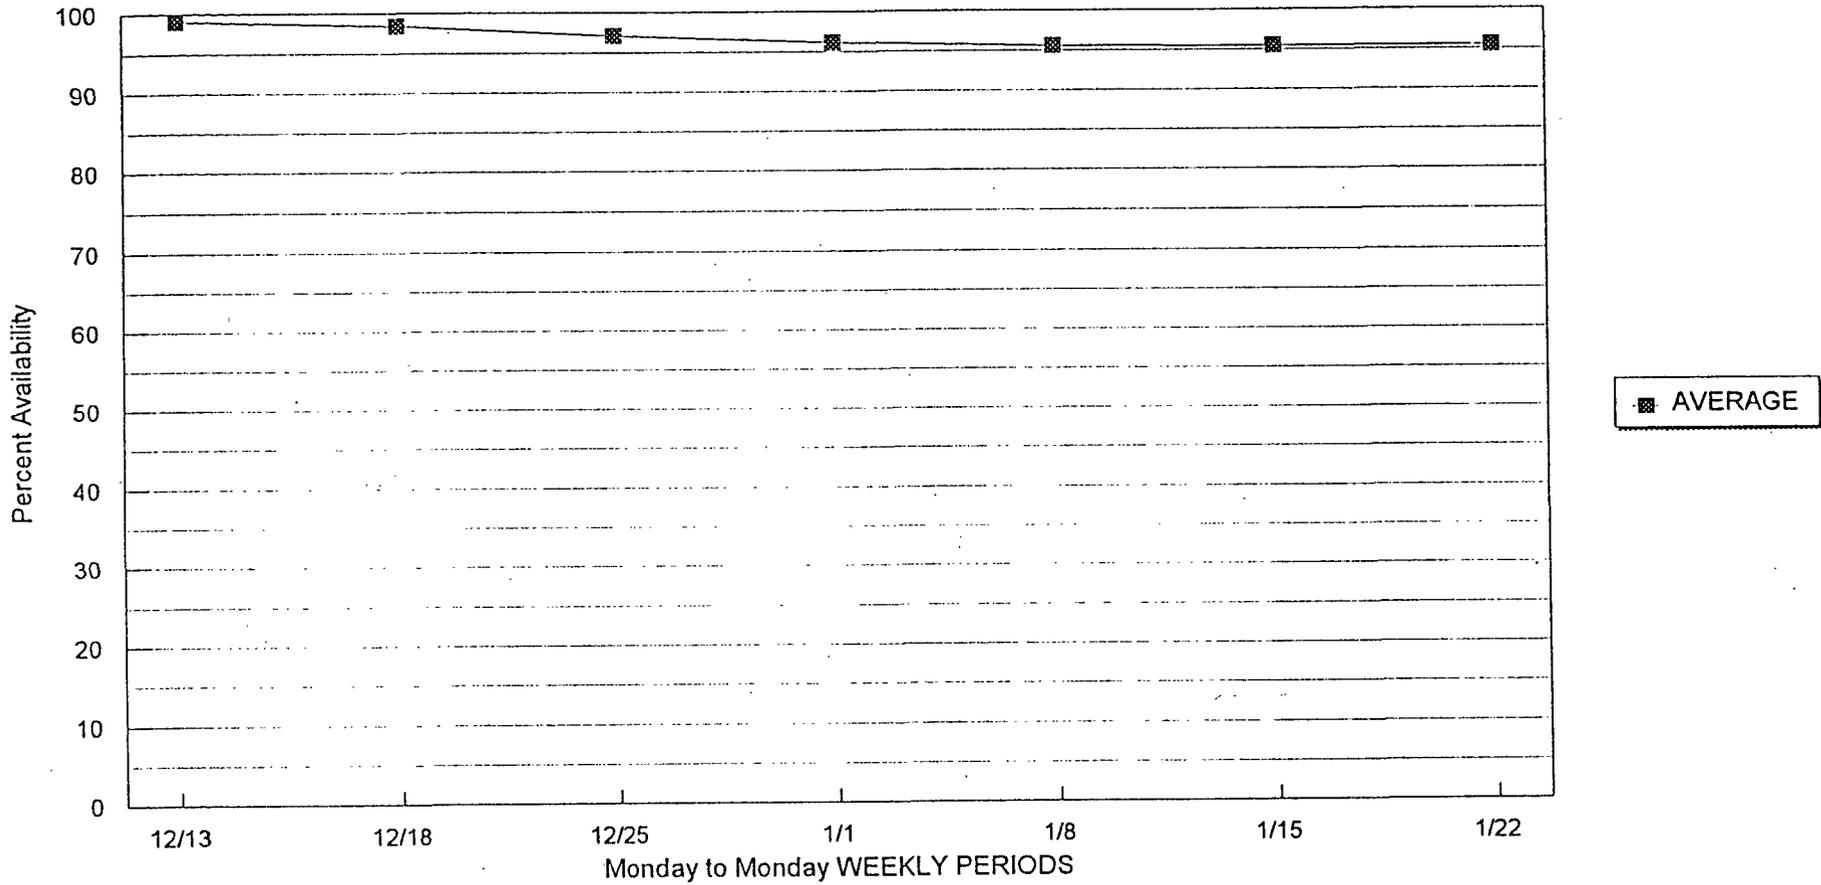
GRAPH 3  
ODCM MONITOR UNAVAILABILITY

Principal cause for downward trend is the unavailability of monitors 1-RE-90-119, 1-LPR-90-120, and 121 to correct electronic noise issues.

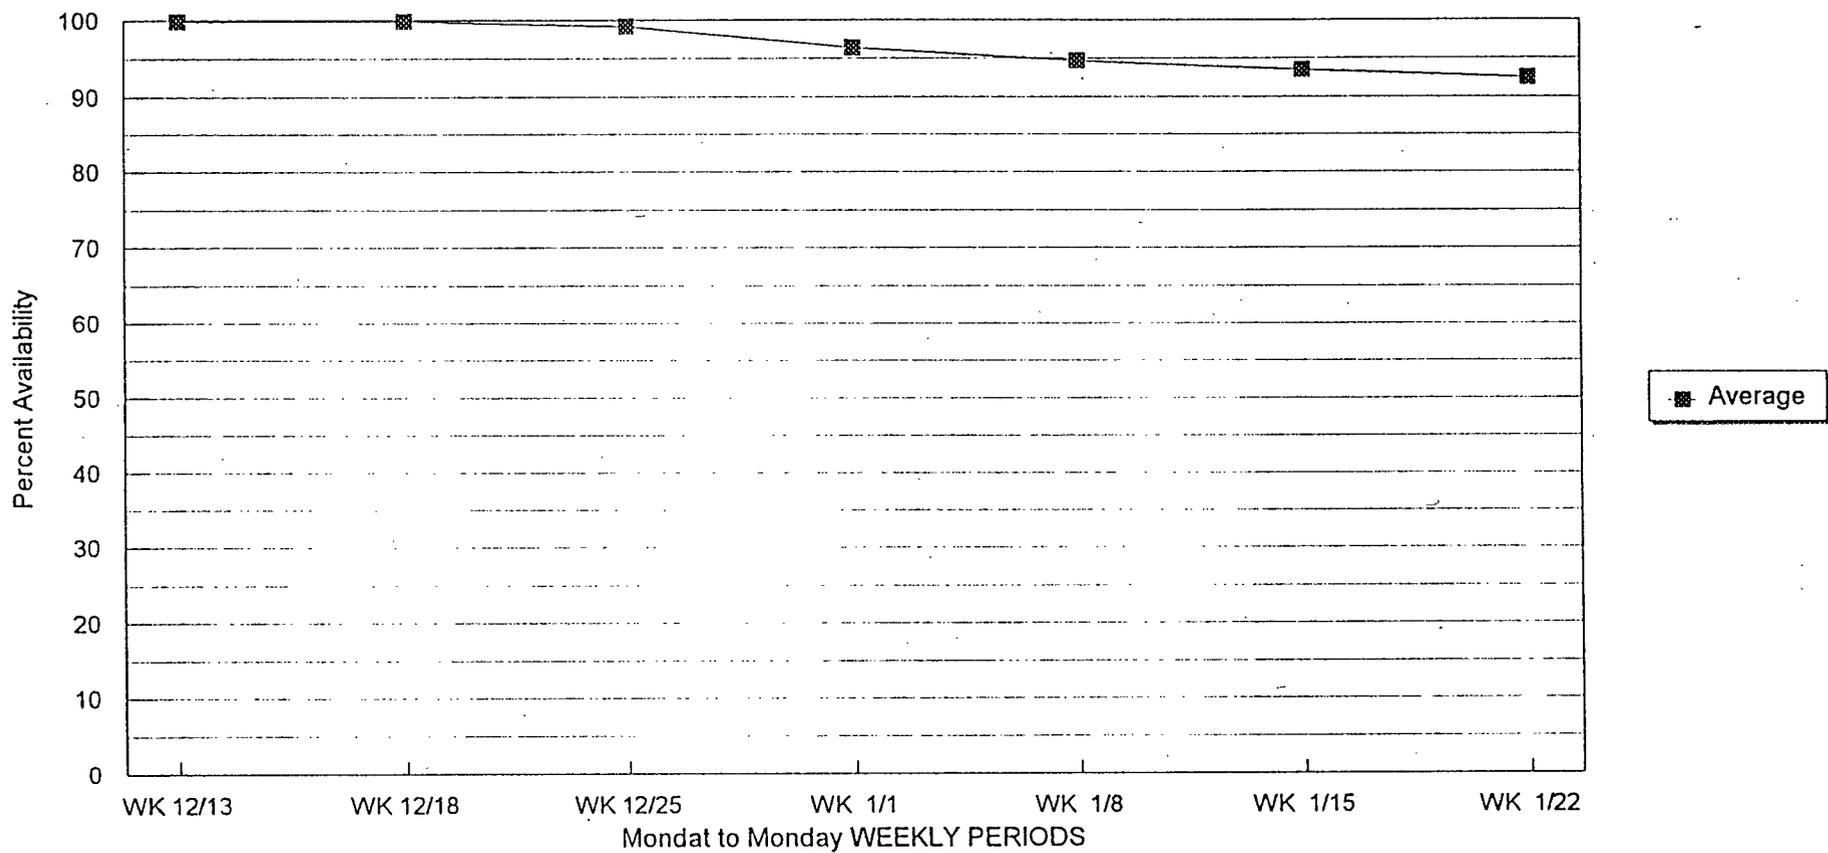
# ODCM Monitors

Principal cause for downward trend is the unavailability of monitors 1-RE-90-119, 1-LPR-90-120, and 121 to correct electronic noise issues.
