Palo Verde Nuclear
Generating Station

**Subject: Palo Verde Nuclear Generating Station (PVNGS)
Units 1, 2, and 3
Docket Nos. STN 50-528, 50-529 and 50-530
License No. NPF 41, NPF 51 and NPF 74
Licensee Event Report 2007-004-00**

4. TITLE
Inadequate Surveillance Test Procedure Resulted In Failure To Meet Surveillance Requirement

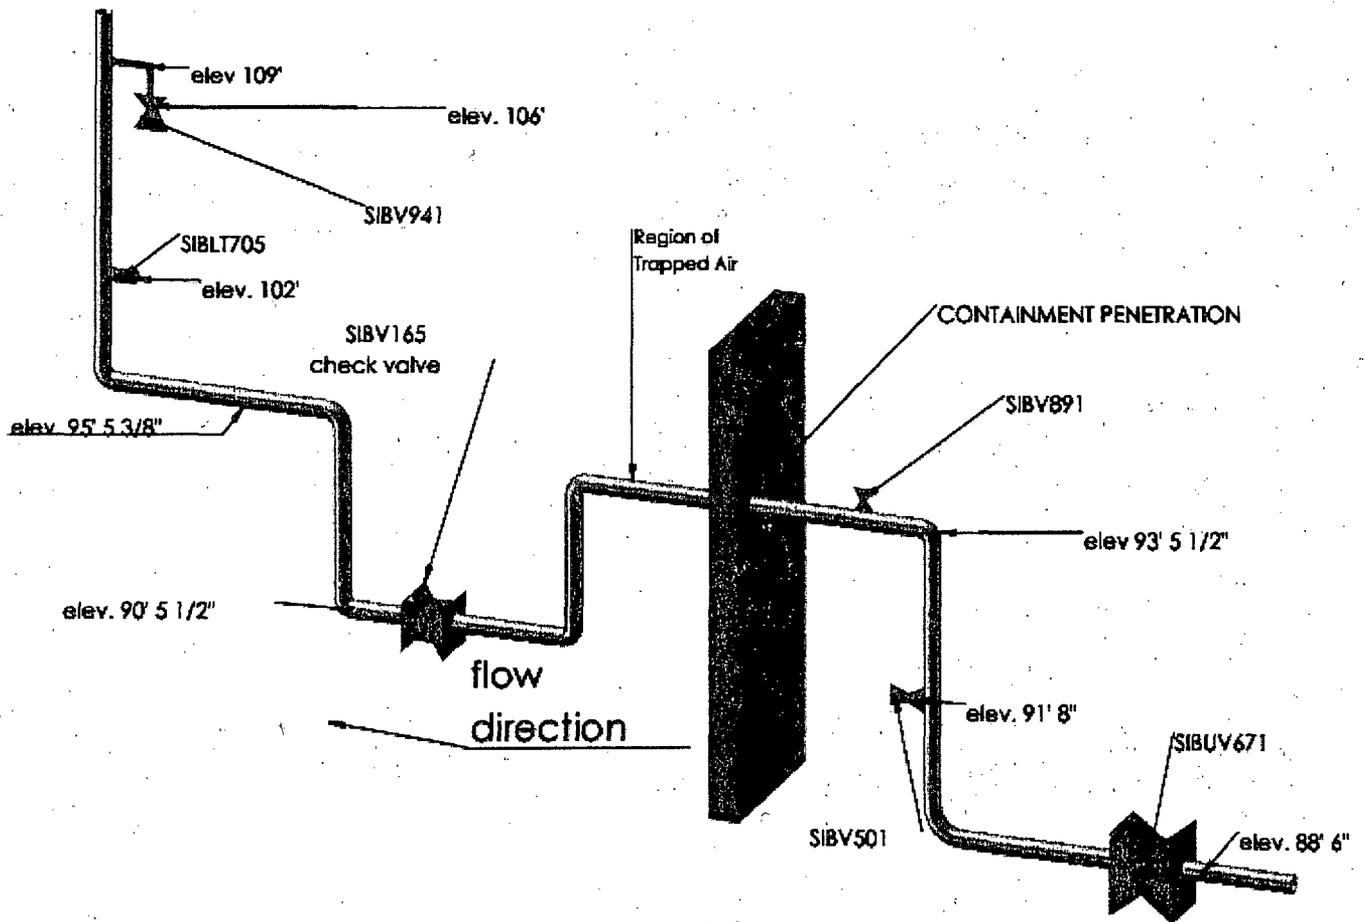
CS "B" CONTAINMENT PENETRATION AND PIPING CONFIGURATION

Palo Verde Nuclear Generating Station TS SR 3.6.6.2 requires CS piping be maintained full of water to the 113 ft level in the CS header. The requirement to fill the header to the 113 ft elevation ensures that the spray flow is admitted to the containment atmosphere within the time frame assumed in the safety analysis. This level also serves as an assumption in analysis for dynamic loading (water hammer) consideration in system design. The CS initial fill process following an outage (from a drained down condition) has been performed utilizing Procedures 40OP-9SI04, "Safety Injection System Venting," and 40OP-9SI02, "Recovery from Shutdown Cooling to Normal Operating Lineup." The following figure represents the piping arrangement of the "B" CS piping near the Containment penetration.

On August 11, 2007, the Safety Injection System Engineer was reviewing Unit 1 plant data and noticed that as Containment Building atmospheric pressure increased the level in the CS header decreased, indicative of air entrapment in the header volume. The System Engineer notified Unit 1 Operations personnel of the suspicious indications, and on August 11, 2007, at 23:15 hours Unit 1 Operations personnel declared the "B" CS System inoperable due to suspected voiding in the header, and entered TS Limiting Condition for Operation (LCO) 3.6.6. Engineering personnel performed system troubleshooting including Ultrasonic Testing (UT) analysis and determined that a section of the header did contain a void in the portion identified in the drawing above as "Region of Trapped Air". Therefore, the header was not "full of water" as required by the TS. Operations personnel filled and vented the header in accordance with procedure 40OP-9SI02. On August 12, 2007, at 16:09 hours the "B" CS System was restored to operable status and TS LCO 3.6.6 was exited.

The voided volume in Unit 1 was determined to be approximately 55 gallons and was located downstream of the outboard CS Containment Isolation Valve (CIV). The effect it would have on CS operation following an accident was evaluated and it was concluded that the condition would yield no significant effect from this decrease in Containment Spray header level/volume based on the volume of the void, the location of the void (downstream of the outboard CS header CIV, SIB-671) and the flow capacity of the CS pump (3890 gpm rated flow). The delivery of water to the spray nozzles would have been delayed as a result of the identified void by as much as 1.5 seconds assuming a maximum Containment Building atmospheric pressure of 60 psig. This would have had no effect on the ability of the CS system to perform its designed safety functions.

Additionally, this void did not present a water hammer concern since it was located in the discharge side of the CS pump and the discharge piping is open to the Containment Building atmosphere without obstruction. This would preclude any water hammer event. The void would have been simply flushed out into the Containment atmosphere.

The direct cause of the void in the CS header was that the Unit 1 "B" CS Header was not properly vented during the fill and vent process on July 1, 2007. The root cause of this condition was ineffective use of operating fundamentals during performance of the pre-job briefing, resulting in failure to identify the potential for air entrapment during the fill and vent process on July 1, 2007. Contributing to this root cause was a procedural deficiency in procedure 40OP-9SI02, which in section 4.7.7.15, directed personnel to "Unlock and throttle open SIB-V891 as needed to vent the Containment Spray Header." In utilizing the words "as needed" the direction was unclear, in that operations personnel concluded that the entire step was optional, rather than the words "as needed" applying only to the extent valve SIB-V891 could be intermittently throttled. Operations personnel involved with the pre-job briefing believed that the CS header had not been drained during the outage, and as such would not require any fill and vent to be performed.

The Unit 1 "B" CS header was filled and vented and then verified through ultrasonic testing (UT) to be filled. Both "A" and "B" Train CS headers in each Unit were evaluated to assess their current condition for compliance with TS SR 3.6.6.2. In order to confirm that CS

STP 40ST-9SI13 was revised and reissued on September 21, 2007, to require performance of UT analysis of each CS header, between the containment isolation valves, to verify that the header is full. The STP was completed on September 23, 2007, for the "A" train of CS for all three Units and for the "B" train in Units 1 and 2 on October 6 and October 8, 2007, respectively, thereby satisfying SR 3.0.3. Unit 3 entered Operating Mode 5 for its 13th Refueling Outage on September 29, 2007, and therefore the requirements of SR 3.0.3 were no longer applicable. As previously stated, UT had been performed on the "B" train of CS for Unit 3 on September 10, 2007, and performance of the revised STP including UT will be completed prior to restart of Unit 3 following the refueling outage.
