SUBJECT: Concerns Entergy's Vermont Yankee generating facility

Response to the Vermont Congressional Delegation Letter Dated September 21, 2007

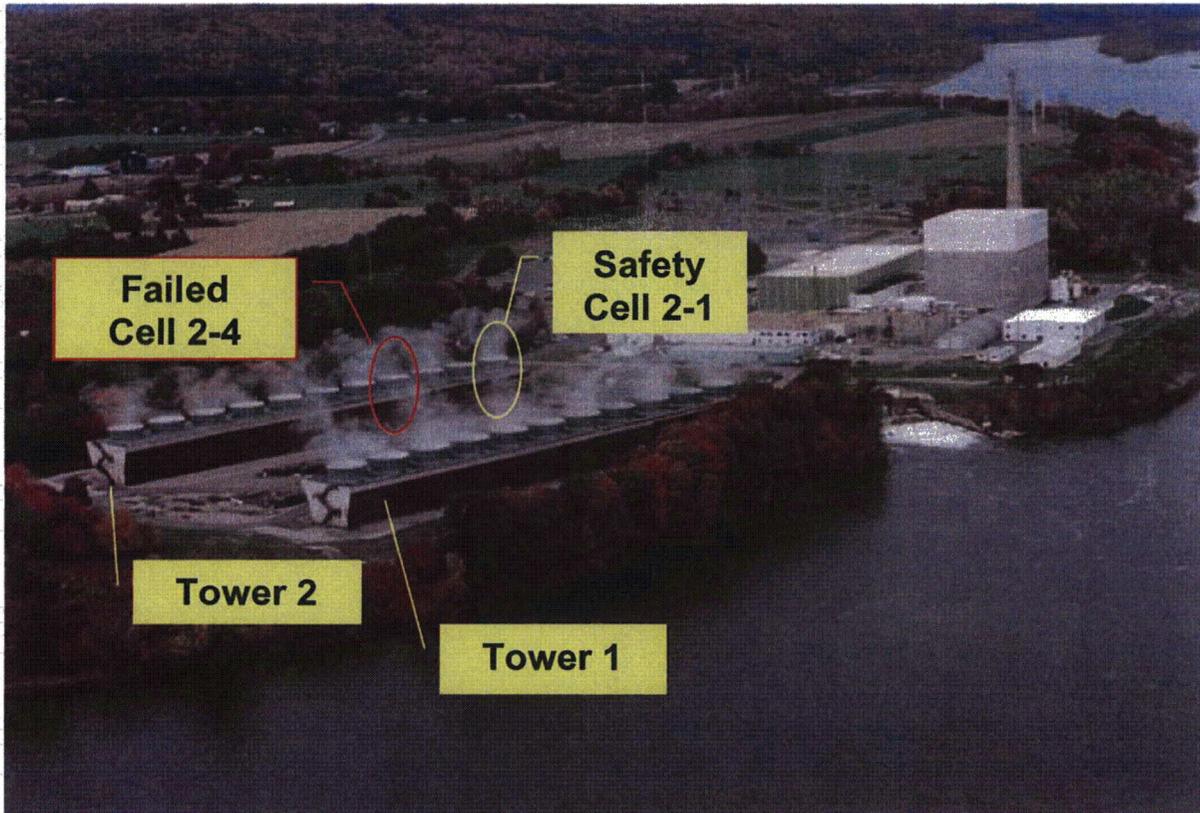
This is an aerial view of Vermont Yankee's two cooling towers. The plant is to the right. Cooling cell 2-4, which experienced the structural failure on August 21, 2007, is fourth from the right on the tower farthest from the river, tower 2. The safety-related cooling cell 2-1 is located at the right end of tower 2. Cooling tower 1 is in the foreground. A diagram showing the interior design of the cooling towers can be found on page 12.

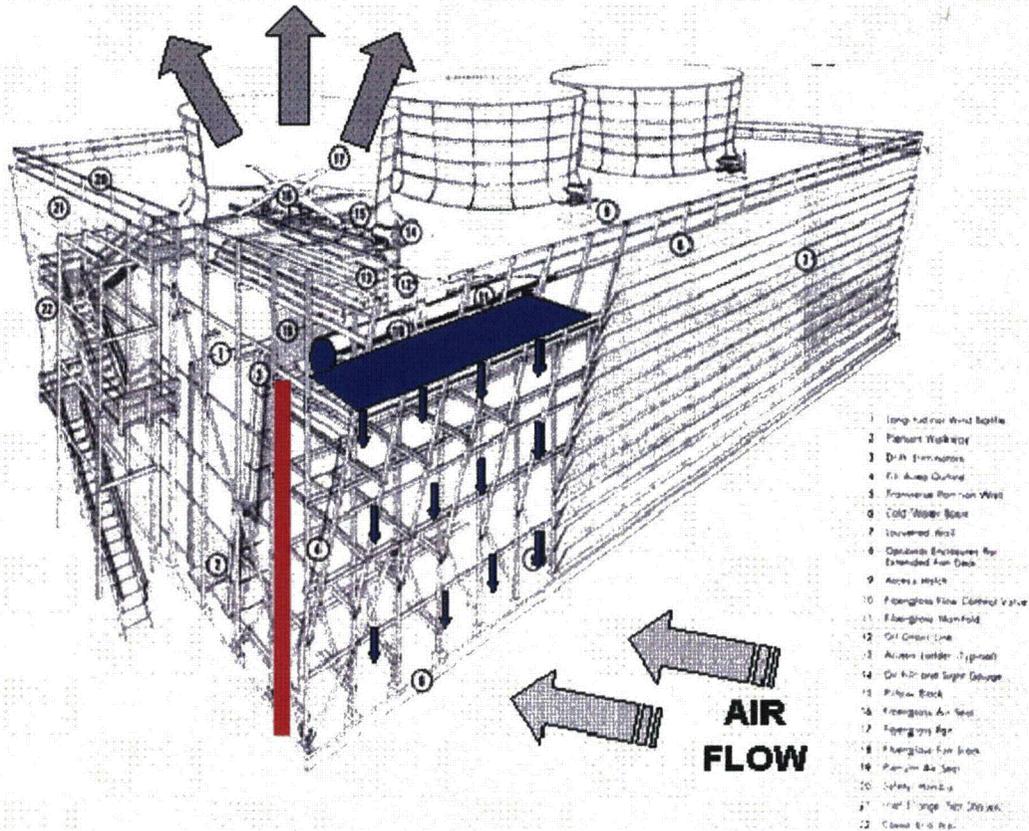
How it Works

Our root cause evaluation identified the sequence of the failure as starting with the failure of one of the 4X4 vertical timber columns (see diagram on page 12) designed to support a 54-inch distribution pipe (see blue pipe in diagram) and a distribution deck (located just beneath pipe in diagram). This failure caused the water distribution deck to sag creating a partial separation of one of the joints in the distribution header pipe at the top of the structure. The increased water loads on the distribution deck excessively stressed other internal support columns that subsequently failed. Our evaluation identified several areas contributing to the root cause. The vertical support beams that failed initially may have been stressed by iron salt attack, fungal attack and/or over-tightened bolts at spliced connections that caused splitting of the wood that was the cause of the structural failure. Also, while the cooling tower design allowed a certain level of visual inspection of the interior supporting columns, the plastic fill material made it difficult to assure a full 100 percent inspection. Although the VY inspection program had been developed and improved over the years to exceed the manufacturer's recommended program, our evaluation has identified that the cooling tower inspection program needs improvements in method and schedule of inspections.

This diagram represents the internal structure a typical cooling cell in Vermont Yankee's cooling towers. The columns and supports are 4X4 pressure treated Douglas fir beams.

The pipe and deck are supported by three rows of vertical timber support columns, designated as "A", "B" and "C". The red line indicates the "B" row, which is where the first structural failure occurred on August 21, 2007.
