SUBJECT: Response to Third Request for Additional Information Regarding Relief Request 3-43 for Temporary Repair to Service Water Pipe

**INDIAN POINT 3 RELIEF REQUEST 3-43, REVISION 2 REGARDING
TEMPORARY NON-CODE REPAIR TO SERVICE WATER PIPING**

18" Service Water supply line number 408 to the Containment Fan Cooler Units (FCU). This line is one of two lines which supplies Hudson River water to the FCUs which are used to remove containment heat during normal plant operation and following a design basis accident.

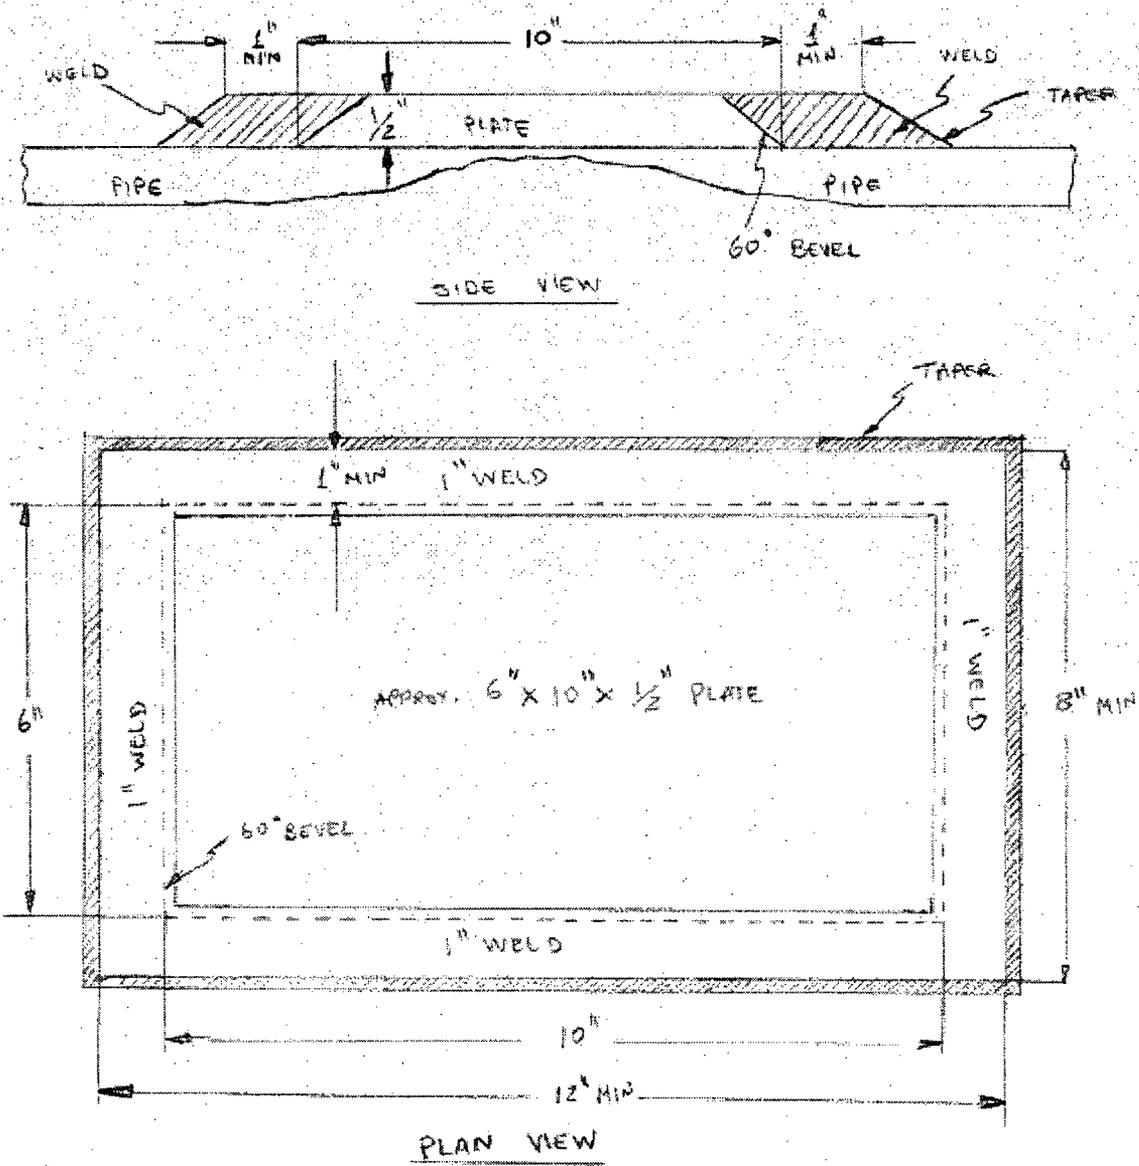
INDIAN POINT UNIT 3
RELIEF REQUEST 3-43, REVISION 2
PAGE 6 OF 6
FIGURE A

Inservice monitoring of the repair will be accomplished by applying a 1-inch by 1-inch grid over the area which will cover the reinforcing plate and the flat portion of the attaching weld (refer to Figure A). The intersection points in the grid will be inspected using straight beam UT. An initial baseline UT will be performed after installing the repair. Subsequent UTs will then be performed to verify that the structural requirements of the original construction code are maintained through the remainder of the current operating cycle. The UTs will be performed monthly for the first quarter and if no unexpected degradation is identified, UTs will then be performed quarterly for the balance of the duration of this relief request. To determine unexpected degradation, UT of the repair plate, attaching weld and surrounding base material (i.e. elbow) will be performed and an average corrosion rate will be calculated based on the point to point comparison between the current and the previous inspections. If this average corrosion rate exceeds the predicted corrosion rate (i.e. 0.012" per year) it will be considered unexpected.
