IE Bulletin 77-05

ELECTRICAL CONNECTOR ASSEMBLIES

Trip Report by W. R. Rutherford  
Electrical Connector Assemblies

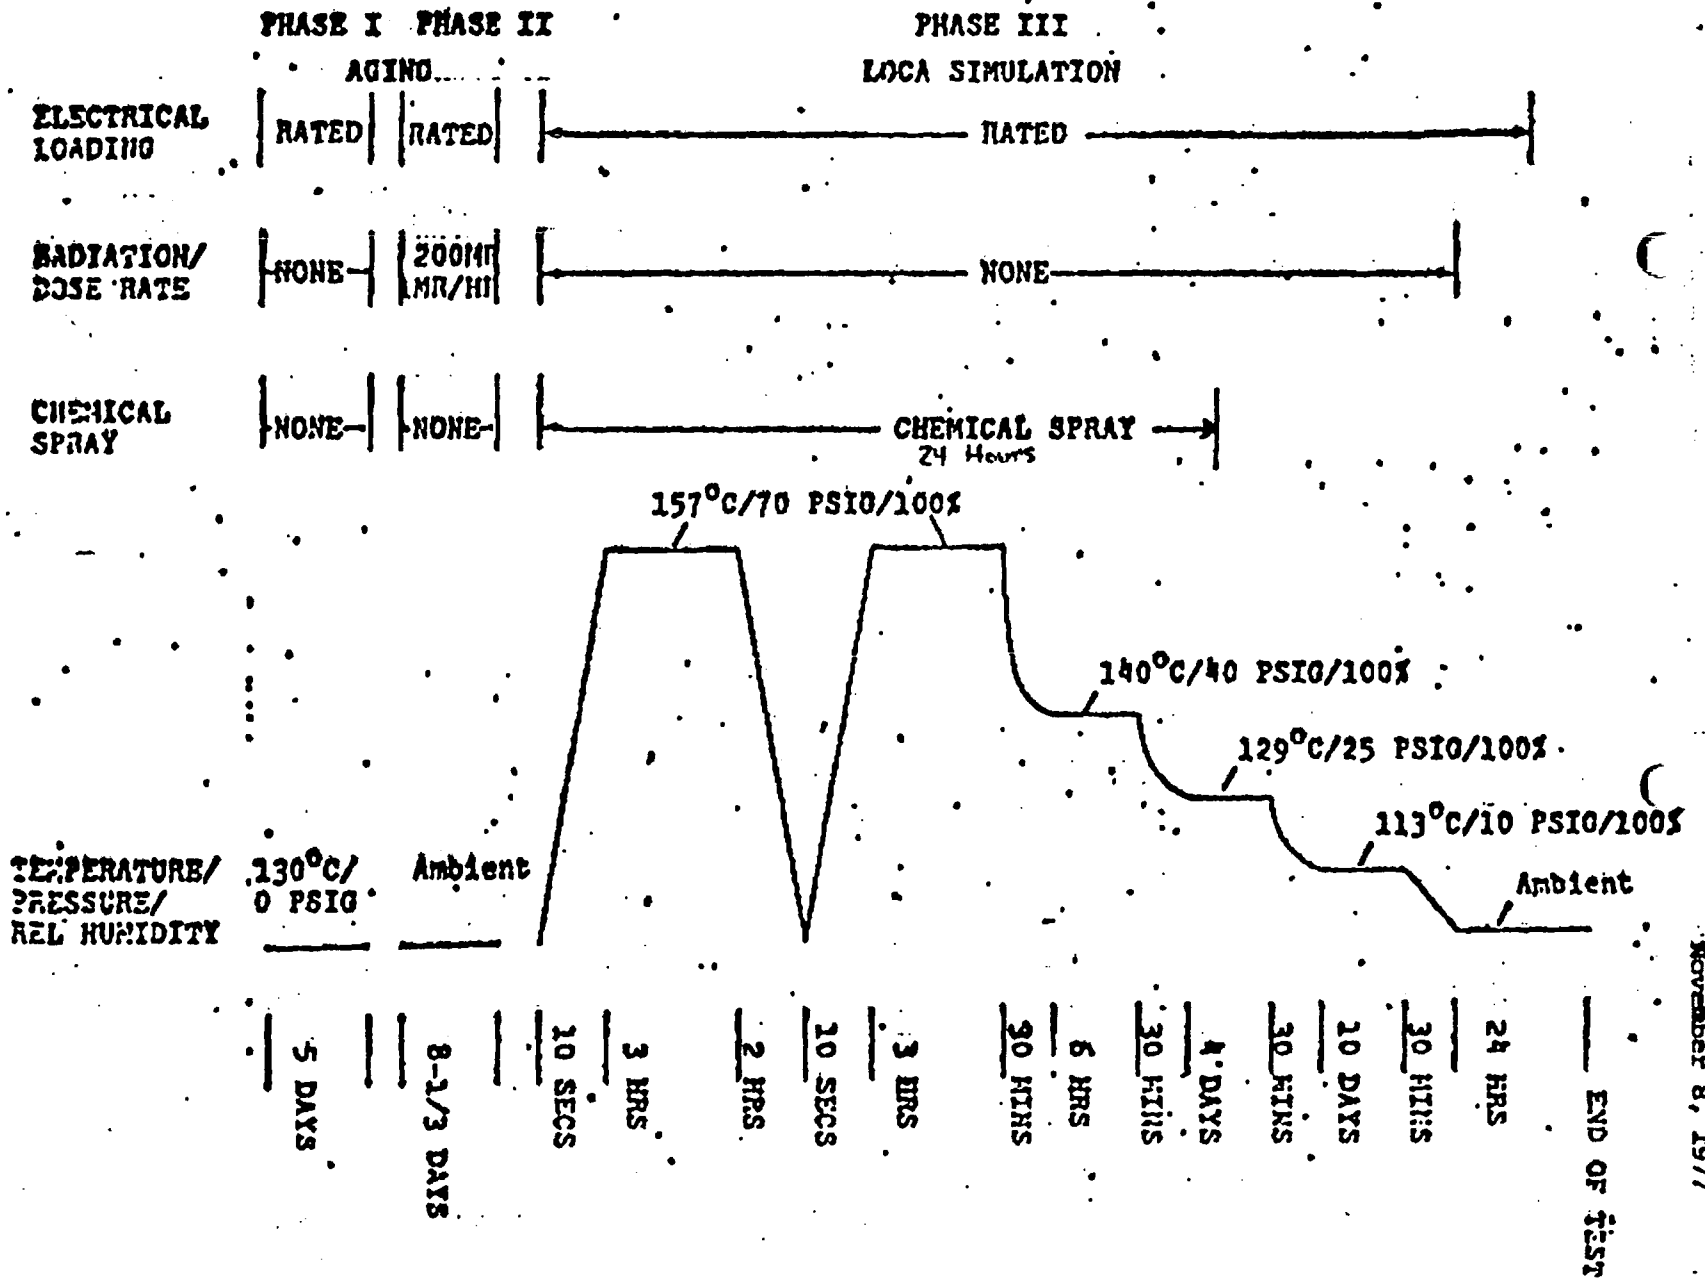
Figure 1

The three tests performed by Sandia were composed of two sequential and one simultaneous exposure to LOCA environments. In each case the equipment was exposed to radiation and thermal aging prior to operating under the simulated LOCA conditions. Figures 1 and 2 describe the test profiles for sequential and simultaneous tests respectively (Sandia tests were designed to study synergistic effects). Each of the tests satisfy the intent of IEEE 323-1974. The assemblies were electrically loaded to 20 amperes and 600 volts at the start of the tests. Insulation resistance and capacitance measurements were recorded during the tests to indicate damage.

SEQUENTIAL TEST PROFILE

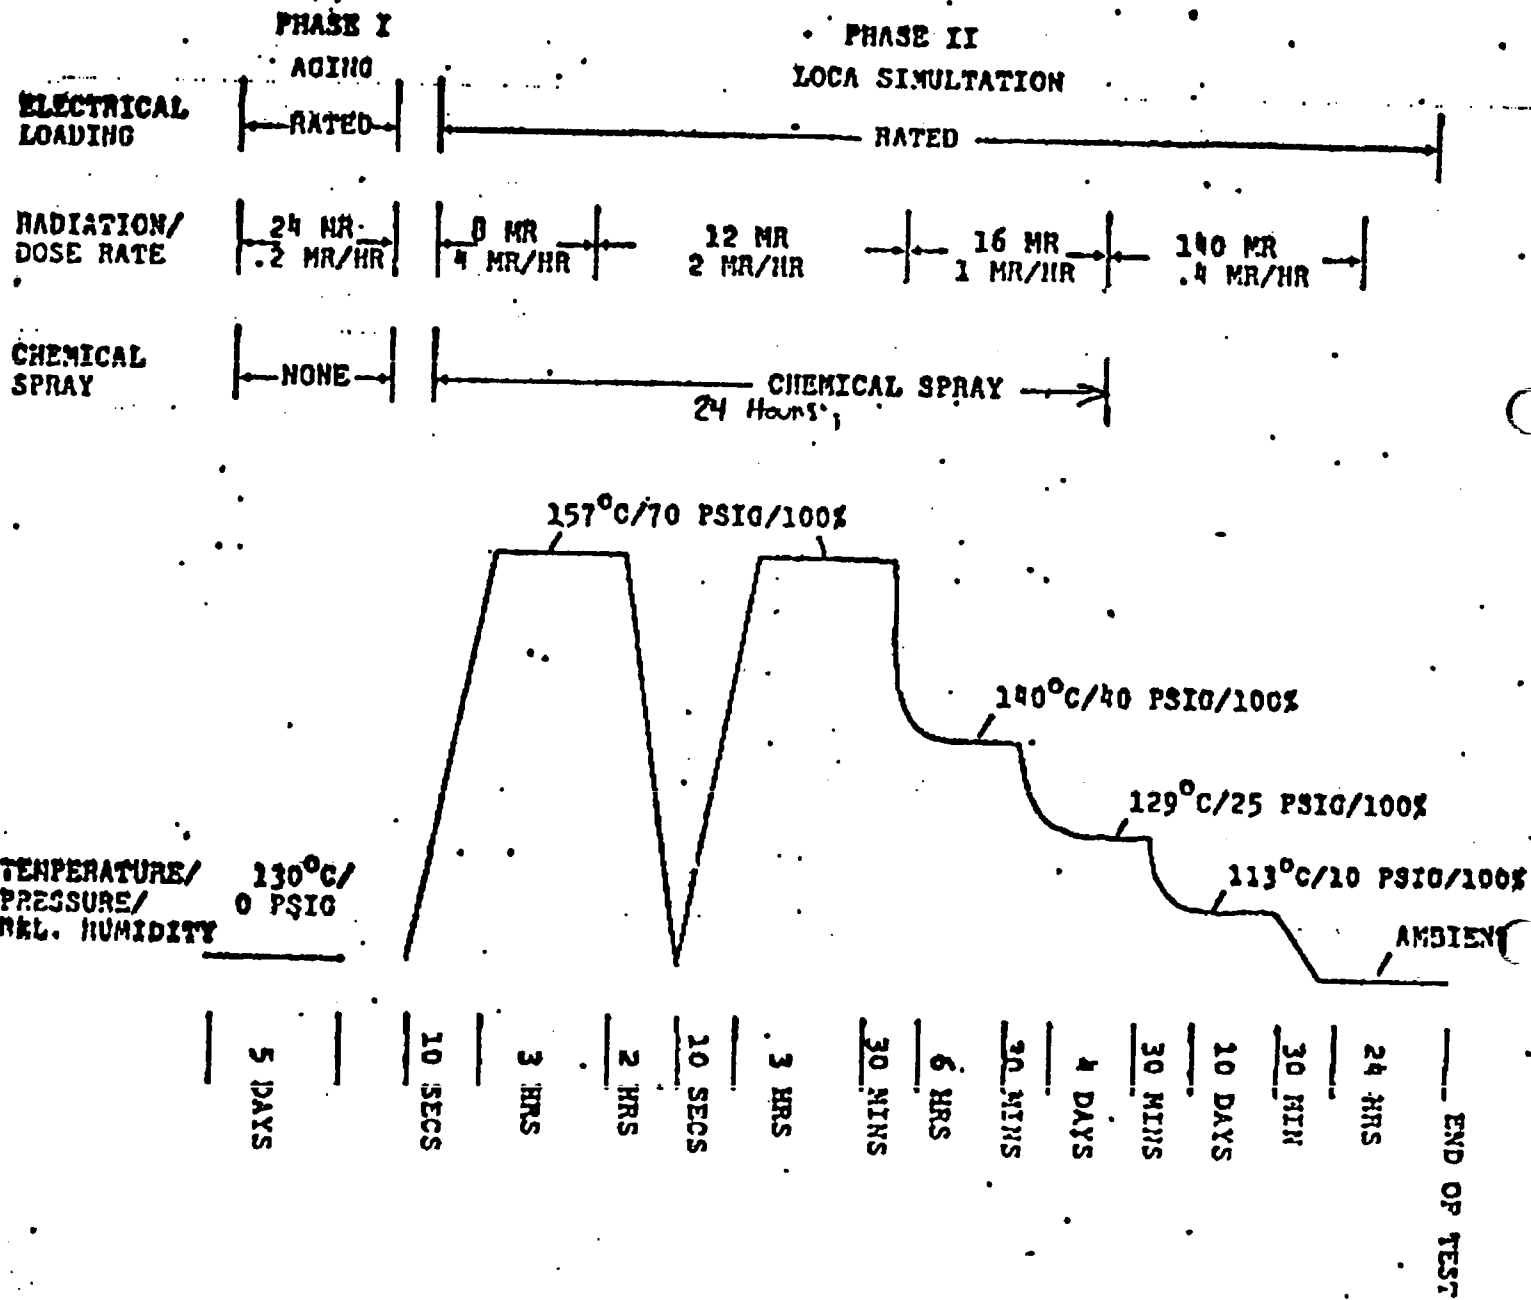
Figure 2

**SIMULTANEOUS TEST PROFILE**
