UNITED STATES
NUCLEAR REGULATORY COMMISSION
REGION II
230 PEACHTREE STREET, N.W. SUITE 1217
ATLANTA, GEORGIA 30303
APR 5 1977

Enclosure:
IE Circular 77-06
"Effects of Hydraulic Fluid
on Electrical Cables"

EFFECTS OF HYDRAULIC FLUID ON ELECTRICAL CABLES

Reference: Quad-Cities Nuclear Power Station
Docket No. 50-265, DPR-30, Unit 2

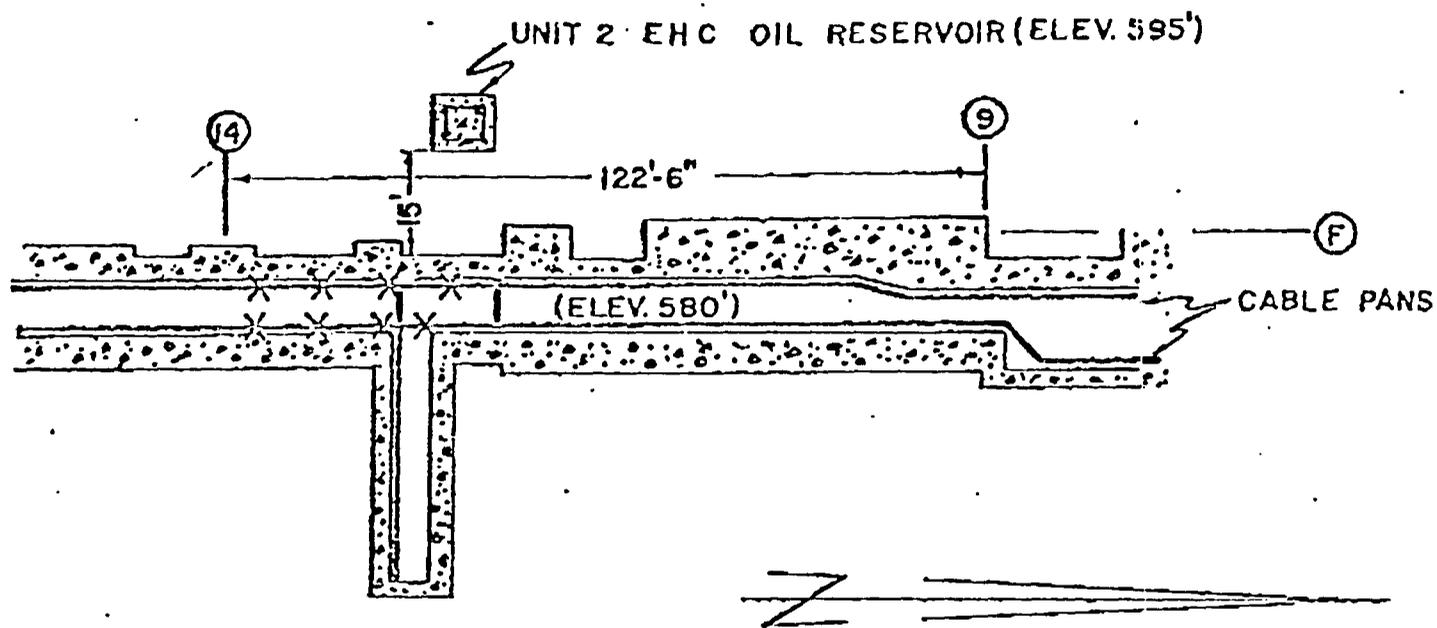
FIGURE. 1

Figure 1 shows the approximate locations where EHC fluid accumulated. Figure 2 illustrates the postulated path of EHC fluid migration from the EHC fluid reservoir to the Unit 2 cable tunnel area. The accumulation of EHC fluid around the EHC fluid reservoir foundation, and subsequent migration between the finish floor and rough slab, via small cracks in the concrete, is the postulated cause of the EHC fluid problem.

UNIT 2 CABLE TUNNEL
PARTIAL FLAN

X- DENOTES AREAS WHERE THE EHC OIL HAD ACCUMULATED
REFERENCE DRAWING - SARGENT & LUNDY M-5

At the present time, all the cables in the affected area of the Unit 2 cable tunnel are being protected from the continuing EHC fluid leakage. The leakage has subsided and once it has stopped the ceiling area will be cleaned and a protective sealer will be applied to prevent any possible leakages.

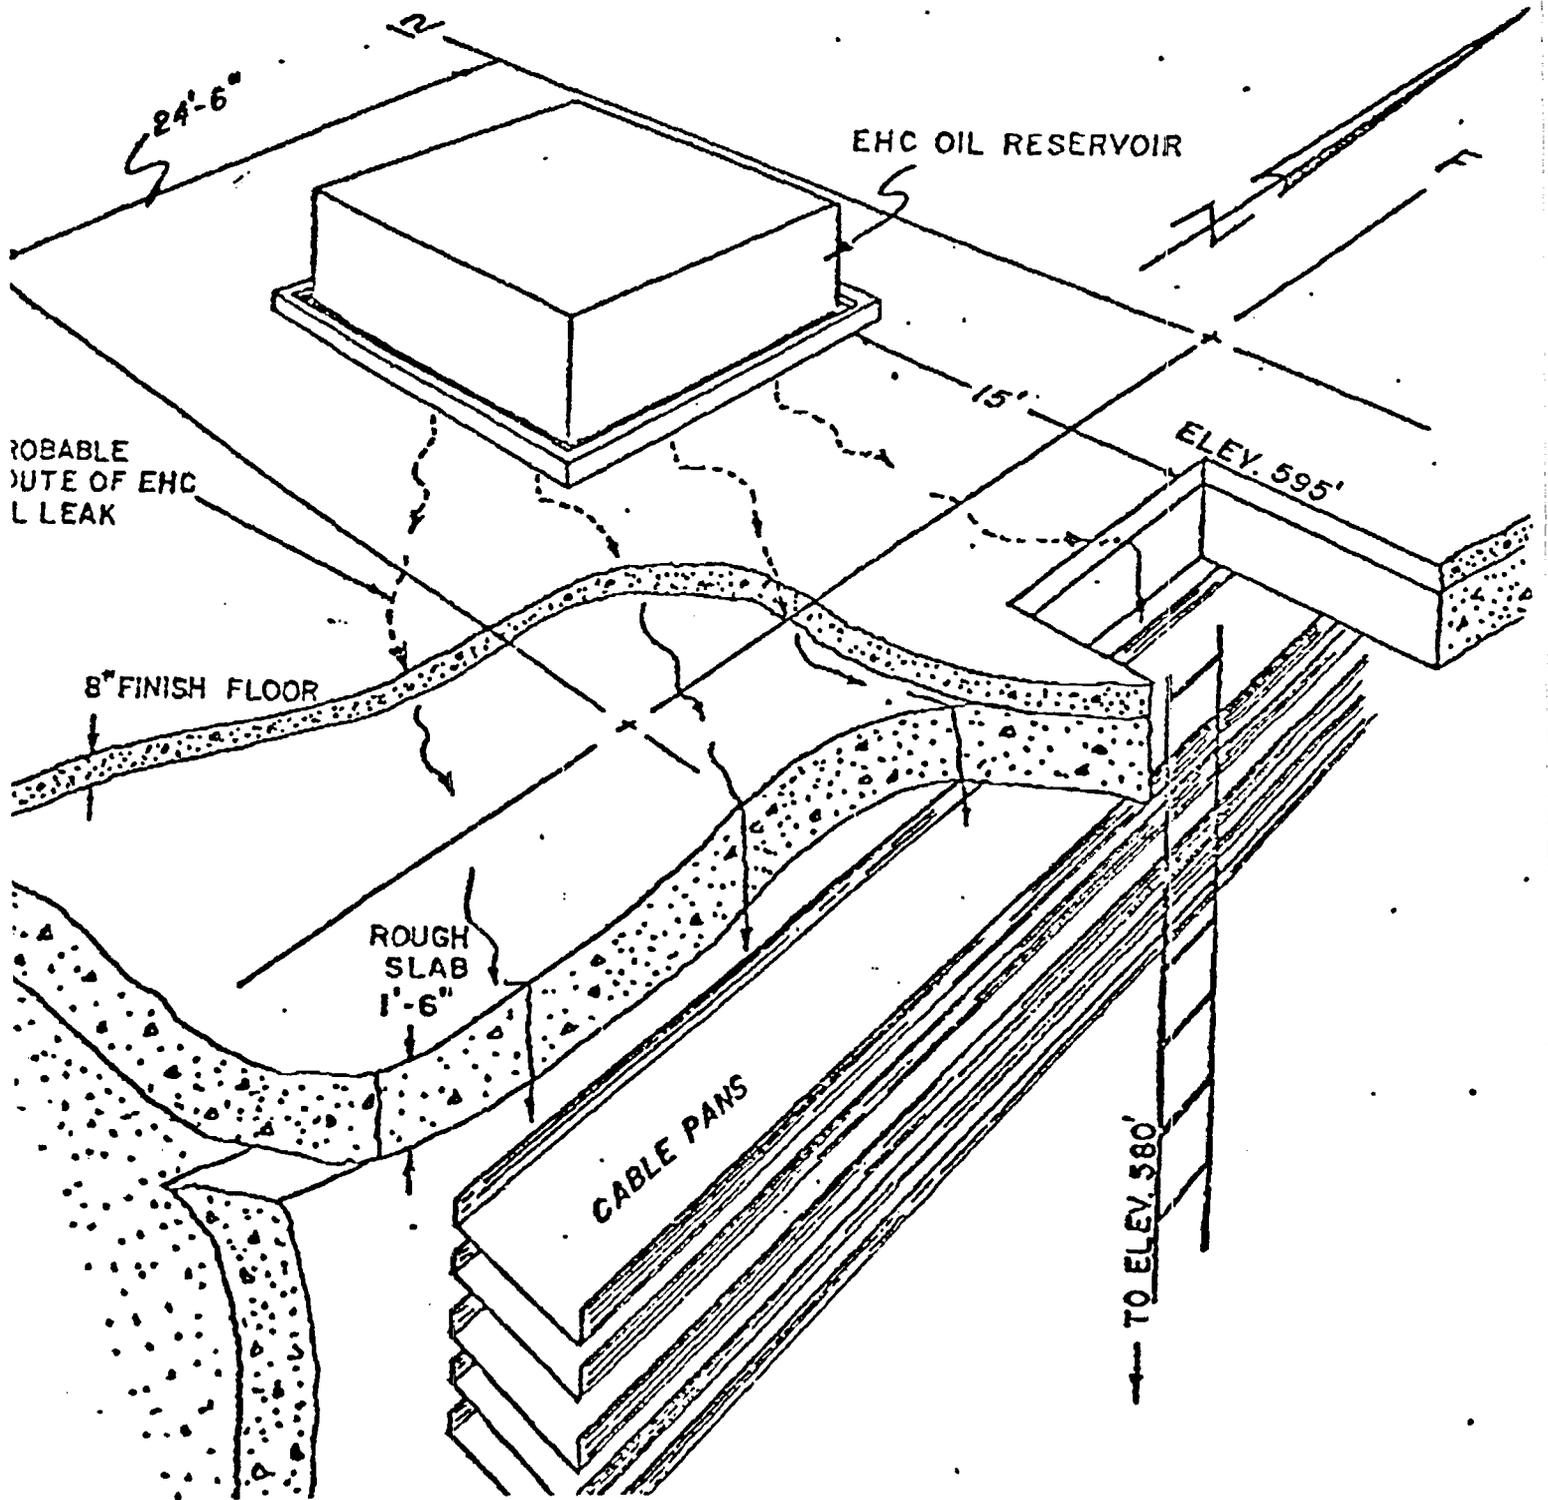
FIGURE. 2

The rough slab serves as the ceiling in the Unit 2 cable tunnel and minor small cracks in the ceiling served as a leak path out of the concrete and onto the cable trays and floor. Portions of cables within these trays thus became saturated with the EHC fluid.

The upper cable trays did not contain all of the EHC fluid, even though the pans in the cable tunnel were of solid bottom construction. This was because the EHC fluid had leaked through the cable pan connecting joints and thus all the cable pans below were subjected to the EHC fluid. The cables closest to the bottom of the cable pans were most affected by the EHC fluid because these cables were in constant saturation with EHC fluid.

UNIT 2 CABLE TUNNEL
CUT-AWAY

The EHC fluid reservoir foundation must also be sealed with the same protective sealer once leakages have been resolved. The sealer has been ordered from the Carbolite Company, type 187 HFP, which is a recommended EHC fluid sealant.
