UNITED STATES
NUCLEAR REGULATORY COMMISSION
REGION II
230 PEACHTREE STREET, N.W. SUITE 818
ATLANTA, GEORGIA 30303

IE CIRCULAR 77-03
Date: March 3, 1977
Page 1 of 2

FIRE INSIDE A MOTOR CONTROL CENTER

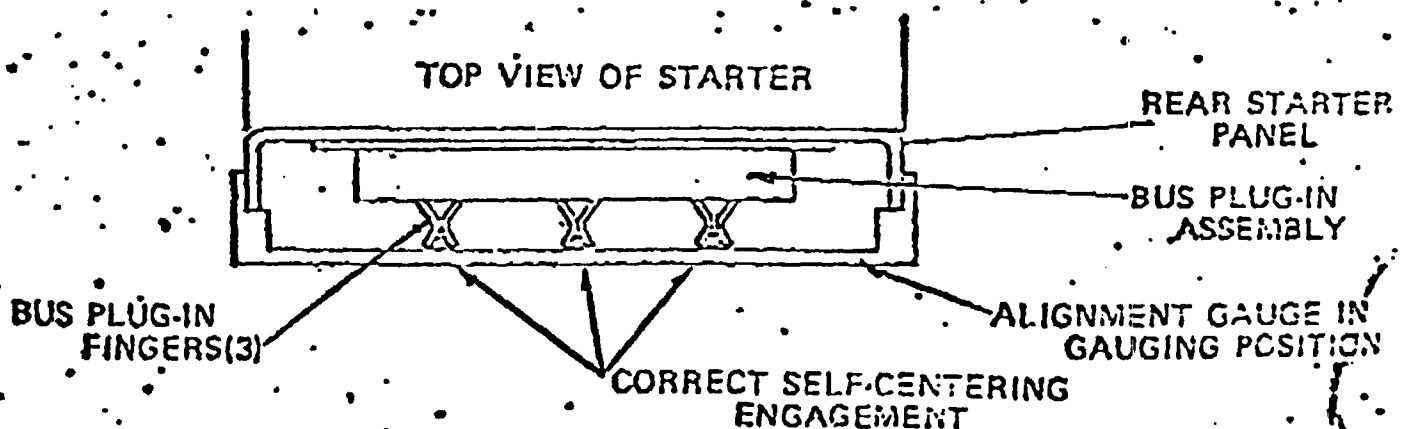
- (2) Seat the stops on the inside of the ends of the alignment gauge against the flanges of the starter mounting panel as illustrated.
- (3) The 1/4" round bars welded to the gauge approximate the vertical bus positions in the MCC. These bars should be within the flared ends of the plug-in fingers, allowing the fingers to self-center themselves lightly around the bars. If fingers are not deformed, there will be no problem visually verifying correct self-centering engagement as illustrated below.

- (4) If the self-centering action is not properly achieved, the plug-in assembly must be repaired or replaced.
- (5) After correct gauging, the starter should be handled with care and immediately installed into the Motor Control Center.
