Nuclear Safety

Advisory Letter

Subject: Barton Model 763, 763A and 764 Transmitters With Defective External Lead Wire Connectors	Number: NSAL-06-13
Basic Components: Barton Model 763 and 763A Gauge Pressure Transmitters and Model 764 Differential Pressure Transmitters	Date: 10/24/2006
Affected Plants: All plants using Barton Model 763, 763A or 764 transmitters	
Substantial Safety Hazard or Failure to Comply Pursuant to 10 CFR 21.21(a)	Yes <input type="checkbox"/> No <input type="checkbox"/>
Transfer of Information Pursuant to 10 CFR 21.21(b)	Yes <input type="checkbox"/>
Advisory Information Pursuant to 10 CFR 21.21(d)(2)	Yes <input checked="" type="checkbox"/>
References: See page 10

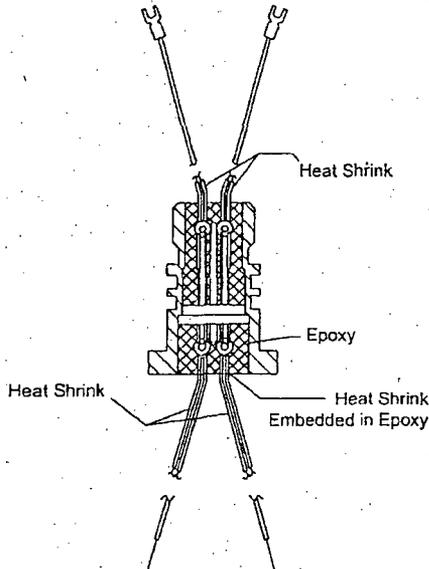
**Connector
(Pre-June 1982)**

This Configuration should NOT be subjected to the inspection/bend test!

Connector assemblies manufactured prior to June of 1982 were assembled with heat shrink on the external lead wires where they are embedded into the epoxy potting. This configuration is the as-tested configuration and is not subject to the concerns of this Advisory. Any connector assembly with heat shrink applied to each wire individually that enters the epoxy potting is not considered defective and need not be replaced. In June of 1982 the heat shrink on each of the two wires was eliminated as a design improvement.

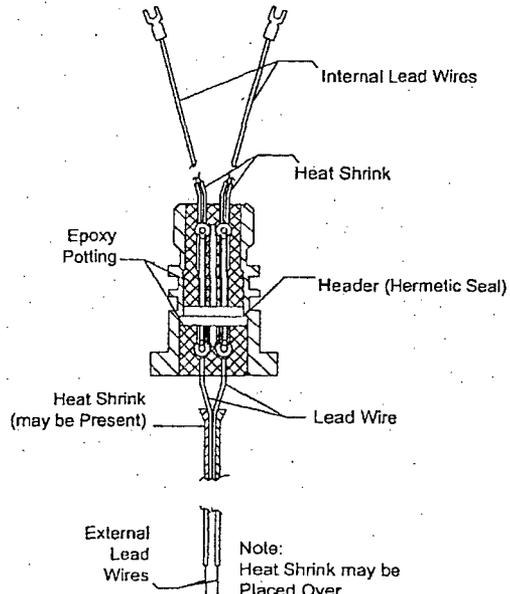
**Connector
(Post-May 1982)**

Westinghouse had reviewed and approved the design change that eliminated the embedded heat shrink tubing from each wire of the connector assembly. Elimination of the heat shrink tubing may have been a product enhancement that would eliminate a potential adverse environment leak path to the solder connections in the connector assembly. Westinghouse followed the same baseline design change approval process for elimination of the heat shrink tubing from the connector assembly as they had for approval of all other changes implemented on Westinghouse qualified Barton instrumentation however, in this specific instance, documentation supporting qualification can not be located. Failure to demonstrate the environmental qualification of the post-May 1982 connector assemblies, without the embedded heat shrink tubing on the individual external lead wires extending into the epoxy material, is a nonconformance.

Note:
Heat Shrink may be
Placed Over
Individual Leads

The external lead wires enter the electronics enclosure through a hermetic seal called a connector assembly. The external lead wires are soldered to the glass sealed pins of the hermetic seal and epoxy potting is used to structurally support the soldered wire connections and establish a seal to protect the solder connections from shorting that could be caused by an electrically conductive accident environment. The defect is that the insulated portions of the wires in connectors manufactured after May of 1982 may not be embedded deeply enough into the epoxy potting to provide an electrical connection that would not be affected by an accident environment. In some cases, stress during the normal manufacturing process has pulled the insulated portion of the wires from the epoxy potting leaving the conductors exposed directly to the environment. In other cases the wires have actually severed due to the stress imposed on these wire connections. It may be possible that handling of the transmitters in the field may have also caused the wire conductors to become exposed.

The resolution for these issues requires that all affected connector assemblies without heat shrink tubing on the connector assembly external lead wires penetrating the epoxy to be replaced. See the Recommended Actions section for additional information.

PRIME recommends that all connectors in transmitters manufactured after May of 1982 be inspected for exposure of the external lead-wire conductors at the surface of the connector. This inspection will necessitate that the connector be unscrewed from the transmitter following the instructions in the Installation and Operation Manual using a special connector removal/installation tool (PRIME P/N 0764-1174B). The external lead wires should be flexed during this inspection to assure that the insulated portions of the wires are securely embedded into the epoxy. The external wires can be flexed 90° such that the insulated portion of the wires touches the flange of the connector assembly. The area of the insulated wire penetration into the epoxy potting should be visually inspected for any evidence of the wire conductors while the wires are flexed. The 90° flex test should be repeated by flexing the external lead wires in the opposite direction. Any connector where the conductors of either wire are observable should be considered defective and replaced.
