**EMD**

June 27, 2007

**Subject: NRC Notification of Astro-Nuclear**

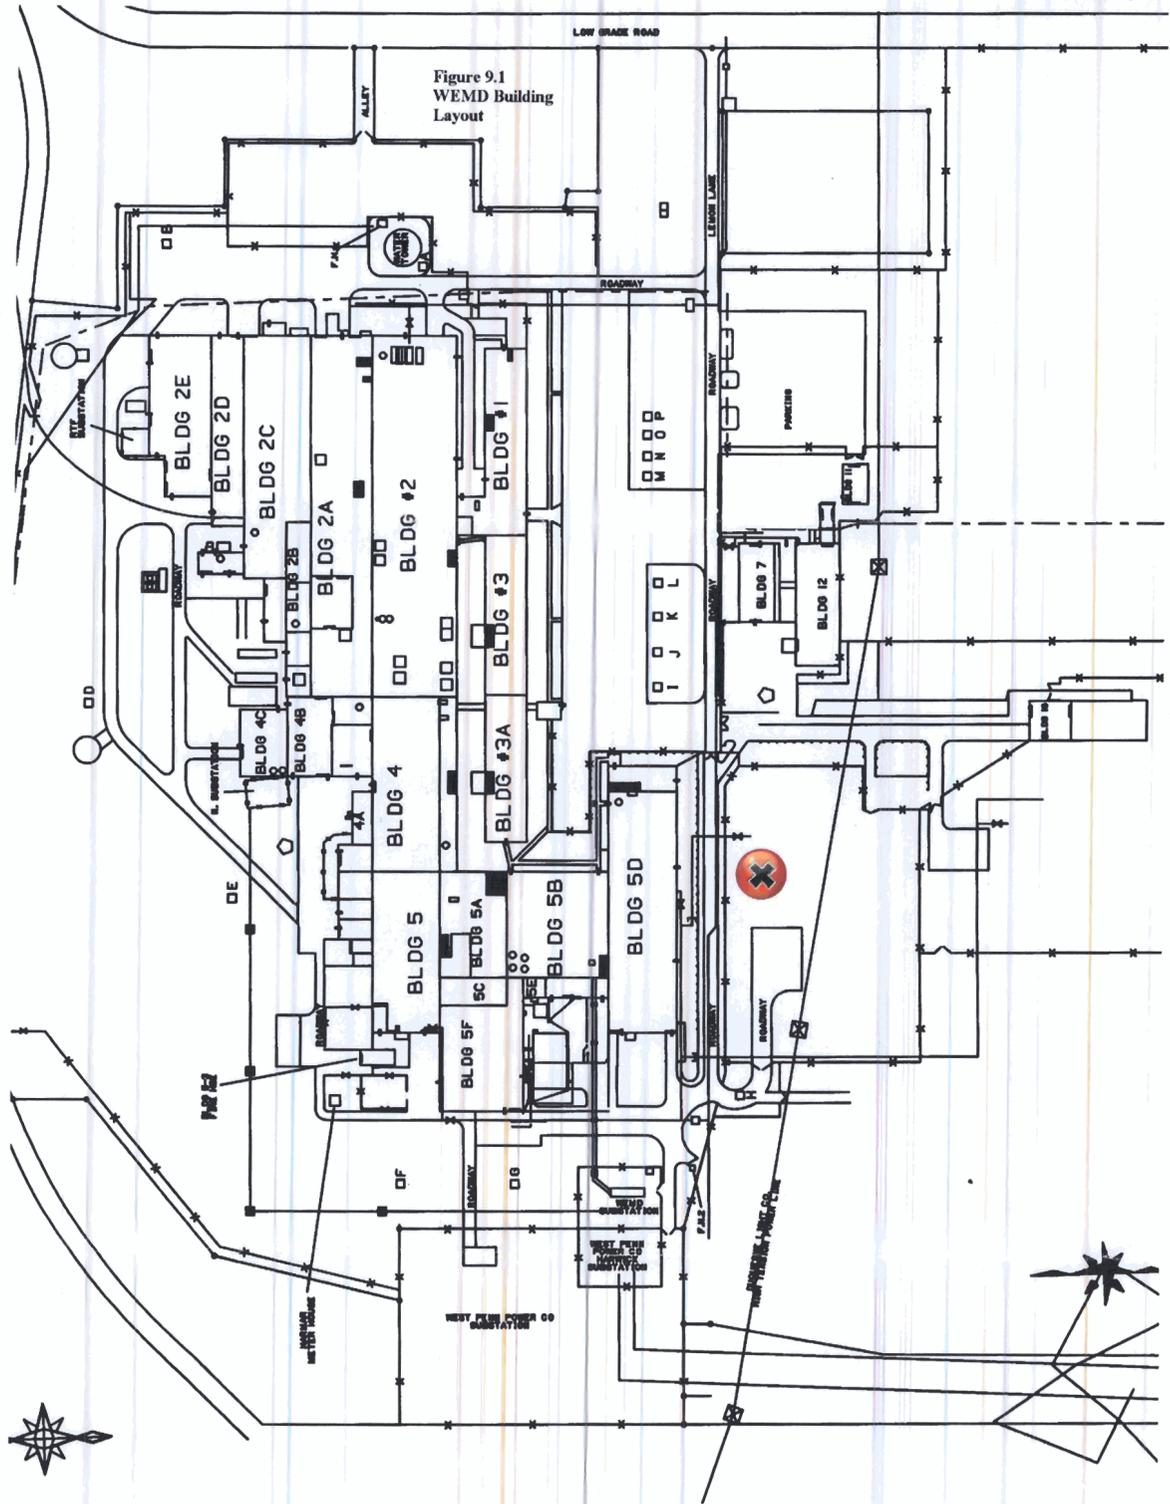
**Figure 1: Radioactive material location**

"X" Marks the location of the drain line excavation location containing radioactive material.

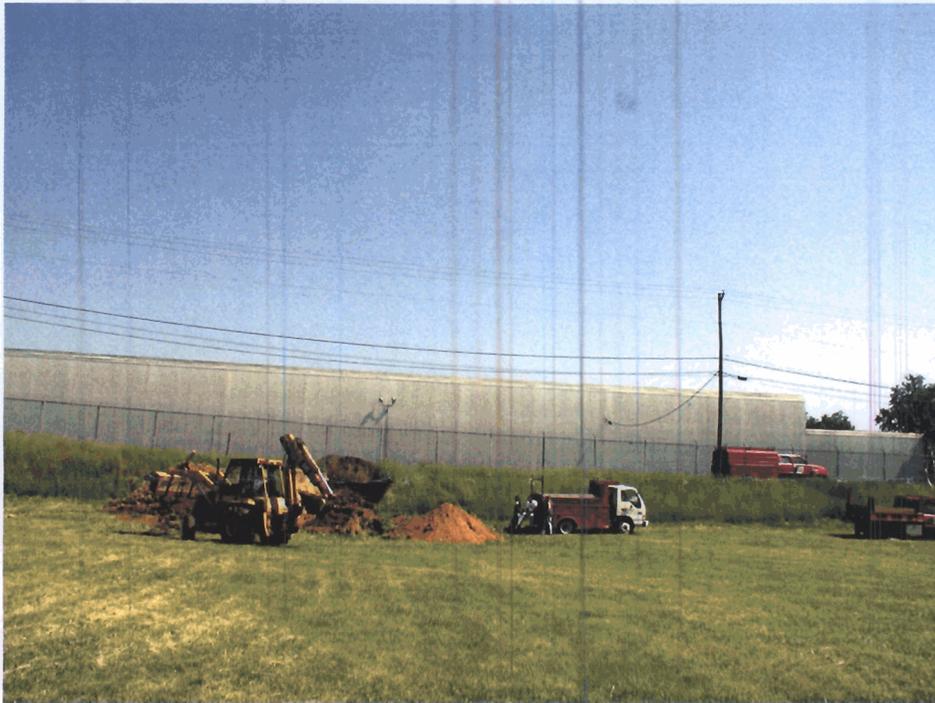
**Photo 1: Location of initial digging where contaminated drain line was encountered. Photograph is facing North. Building 5D is in the background.**

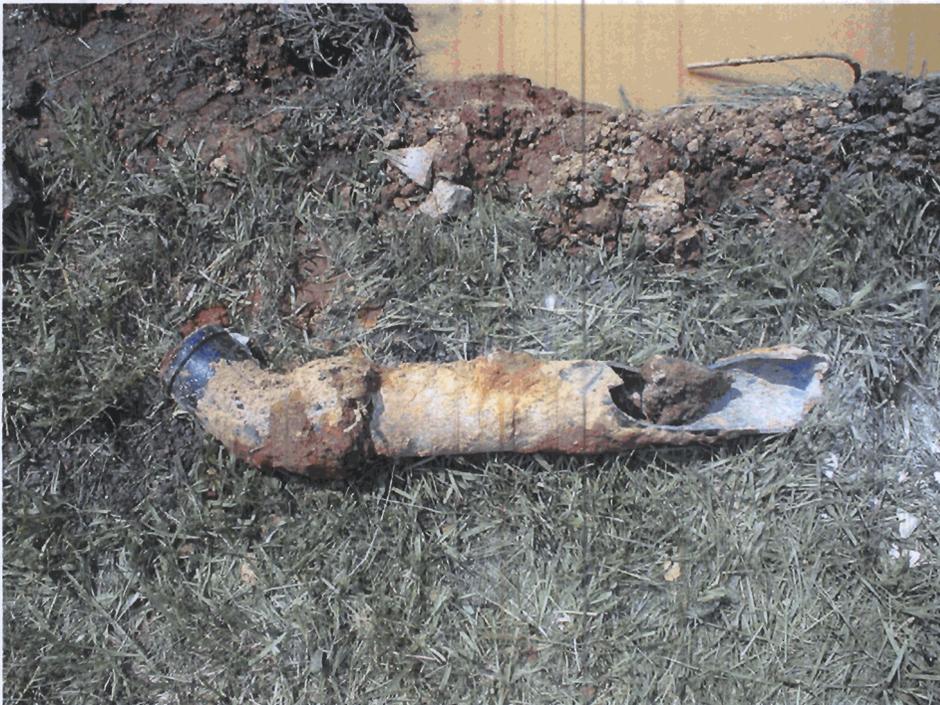
Alpha spectroscopy analysis of the residual interior pipe crud indicates a U-235 enrichment of approximately 30 percent. Surveys were conducted to record the condition of the area prior to back filling. Documentation of the location and depth of the piping were also completed. This area has been added to EMD's priorities list for future characterization and potential remedial actions.

**Photo 2: Excavated piping had been oriented in a vertical position below ground. Photos shows the pipe segment that was broken off and its contents.**
