WATTS BAR NUCLEAR PLANT UNIT 2 - REPORTABLE DEFICIENCY -
CONTAINMENT ANCHOR BOLT NUTS - HO 1143 F2 - FINAL REPORT

WATTS BAR NUCLEAR PLANT UNIT 2
REPORTABLE DEFICIENCY
CONTAINMENT ANCHOR BOLT NUTS

FINAL REPORT

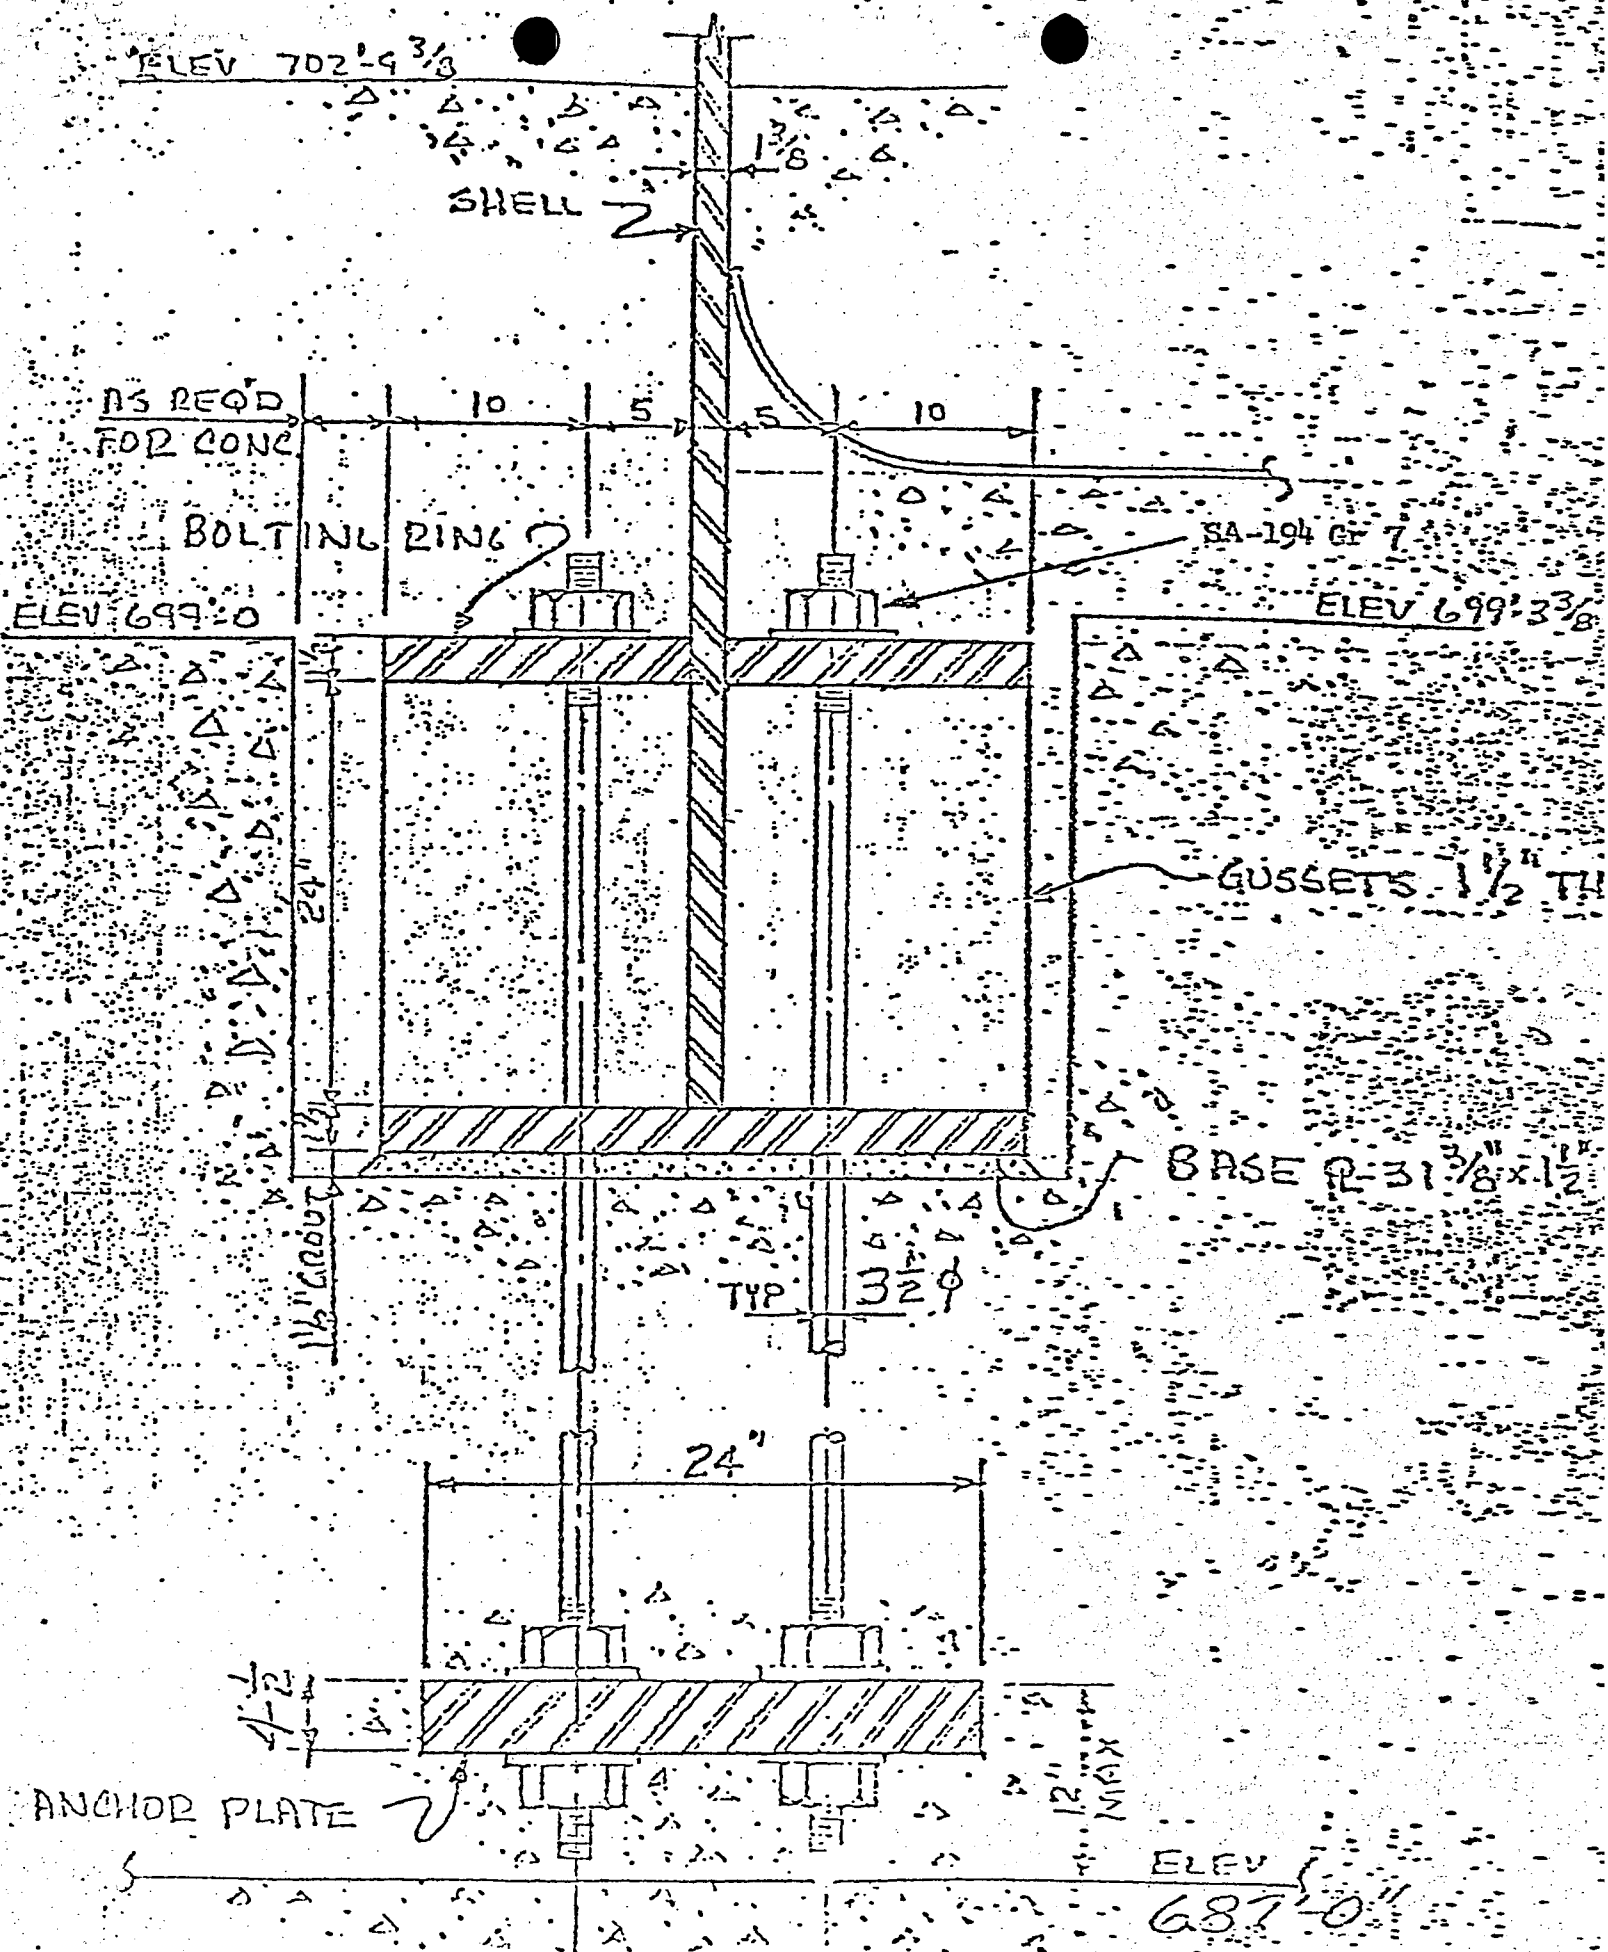
Figure 1. Final Anchorage Design

The reactor containment vessel bottom shell ring is anchored to a concrete foundation mat by 360 3-1/2-inch diameter bolts. These bolts are arranged in two concentric circles inside and outside the bottom shell ring. The bolts are located in pairs at equal distance from the middle surface of the shell ring on radial lines at 2-degree intervals. An embedded anchor plate at the lower end of the bolts is provided to transfer the bolt load to the concrete. The bolts are partially embedded, then pretensioned to 423 kips by elongating the bolts and tightening the top nuts to maintain the elongation. Finally, the anchorage (bolts, nuts, etc.) is embedded in concrete. Details of this embedded anchorage are shown in Figure 1.

During the final inspection, prior to embedment of the unit 2 reactor building structural steel containment vessel anchorage in concrete, a total of twenty top anchor bolt nuts were found with indications which appeared to be surface irregularities.

Nine of the twenty suspect unit 2 top anchor bolt nuts were determined to have minor surface imperfections. The remaining eleven nuts were removed for detailed examination. Two of the eleven were determined to have only minor surface imperfections and were released for use. The remaining nine nuts which had potentially injurious surface indications were replaced with nuts free of surface indications.
