TRANSMITTAL OF LICENSE COMPLIANCE INSPECTION AND INVESTIGATION REPORTS
10 CFR 20

Compliance Investigation Report

General Electric Company
Missile and Space Division
Re-entry Systems Department
3198 Chestnut Street
Philadelphia, Pennsylvania 19104
License Number: 37-2006-6
Type B Case: Loss of Facility

COMPLIANCE INSPECTION REPORT

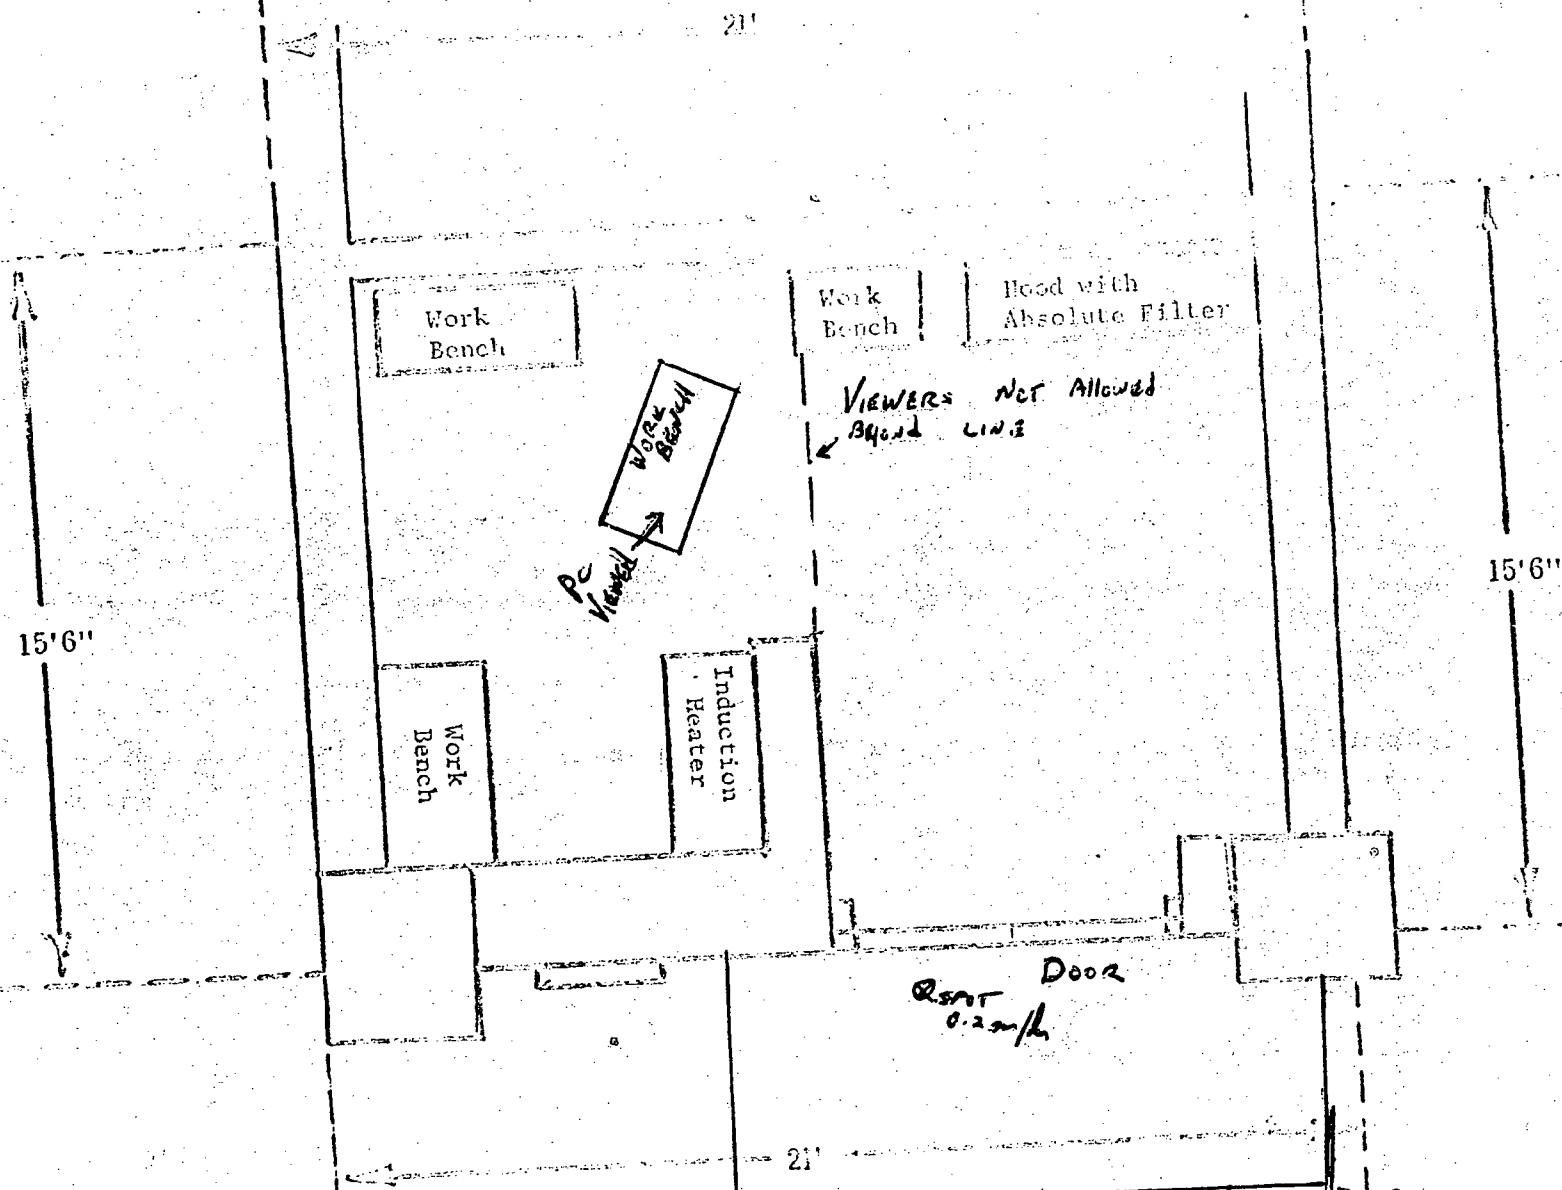
Exhibit A 1 of 1

12. Harris was aware that the assembly would be displayed to groups of interested men during the course of the next few weeks. His fire inspector escorted the groups and surveyed the engineer doing the displaying, after he left the room. No contamination was ever found on the engineer's person. The viewers are kept at a distance of 4 - 5 feet, while the engineer, dressed in paper coveralls, gloves, and shoe covers, displayed the assembly. Harris explained that each showing lasted about 10 minutes. The distance factor and protective clothing were precautionary measures. A floor plan of Room T596 showing the hood, work bench and line of demarcation is attached as Exhibit A.
