REF: Deficiency - Containment Anchor Bolt Nuts

WATTS BAR NUCLEAR PLANT UNIT 2
REPORTABLE DEFICIENCY
CONTAINMENT ANCHOR BOLT NUTS

FINAL REPORT

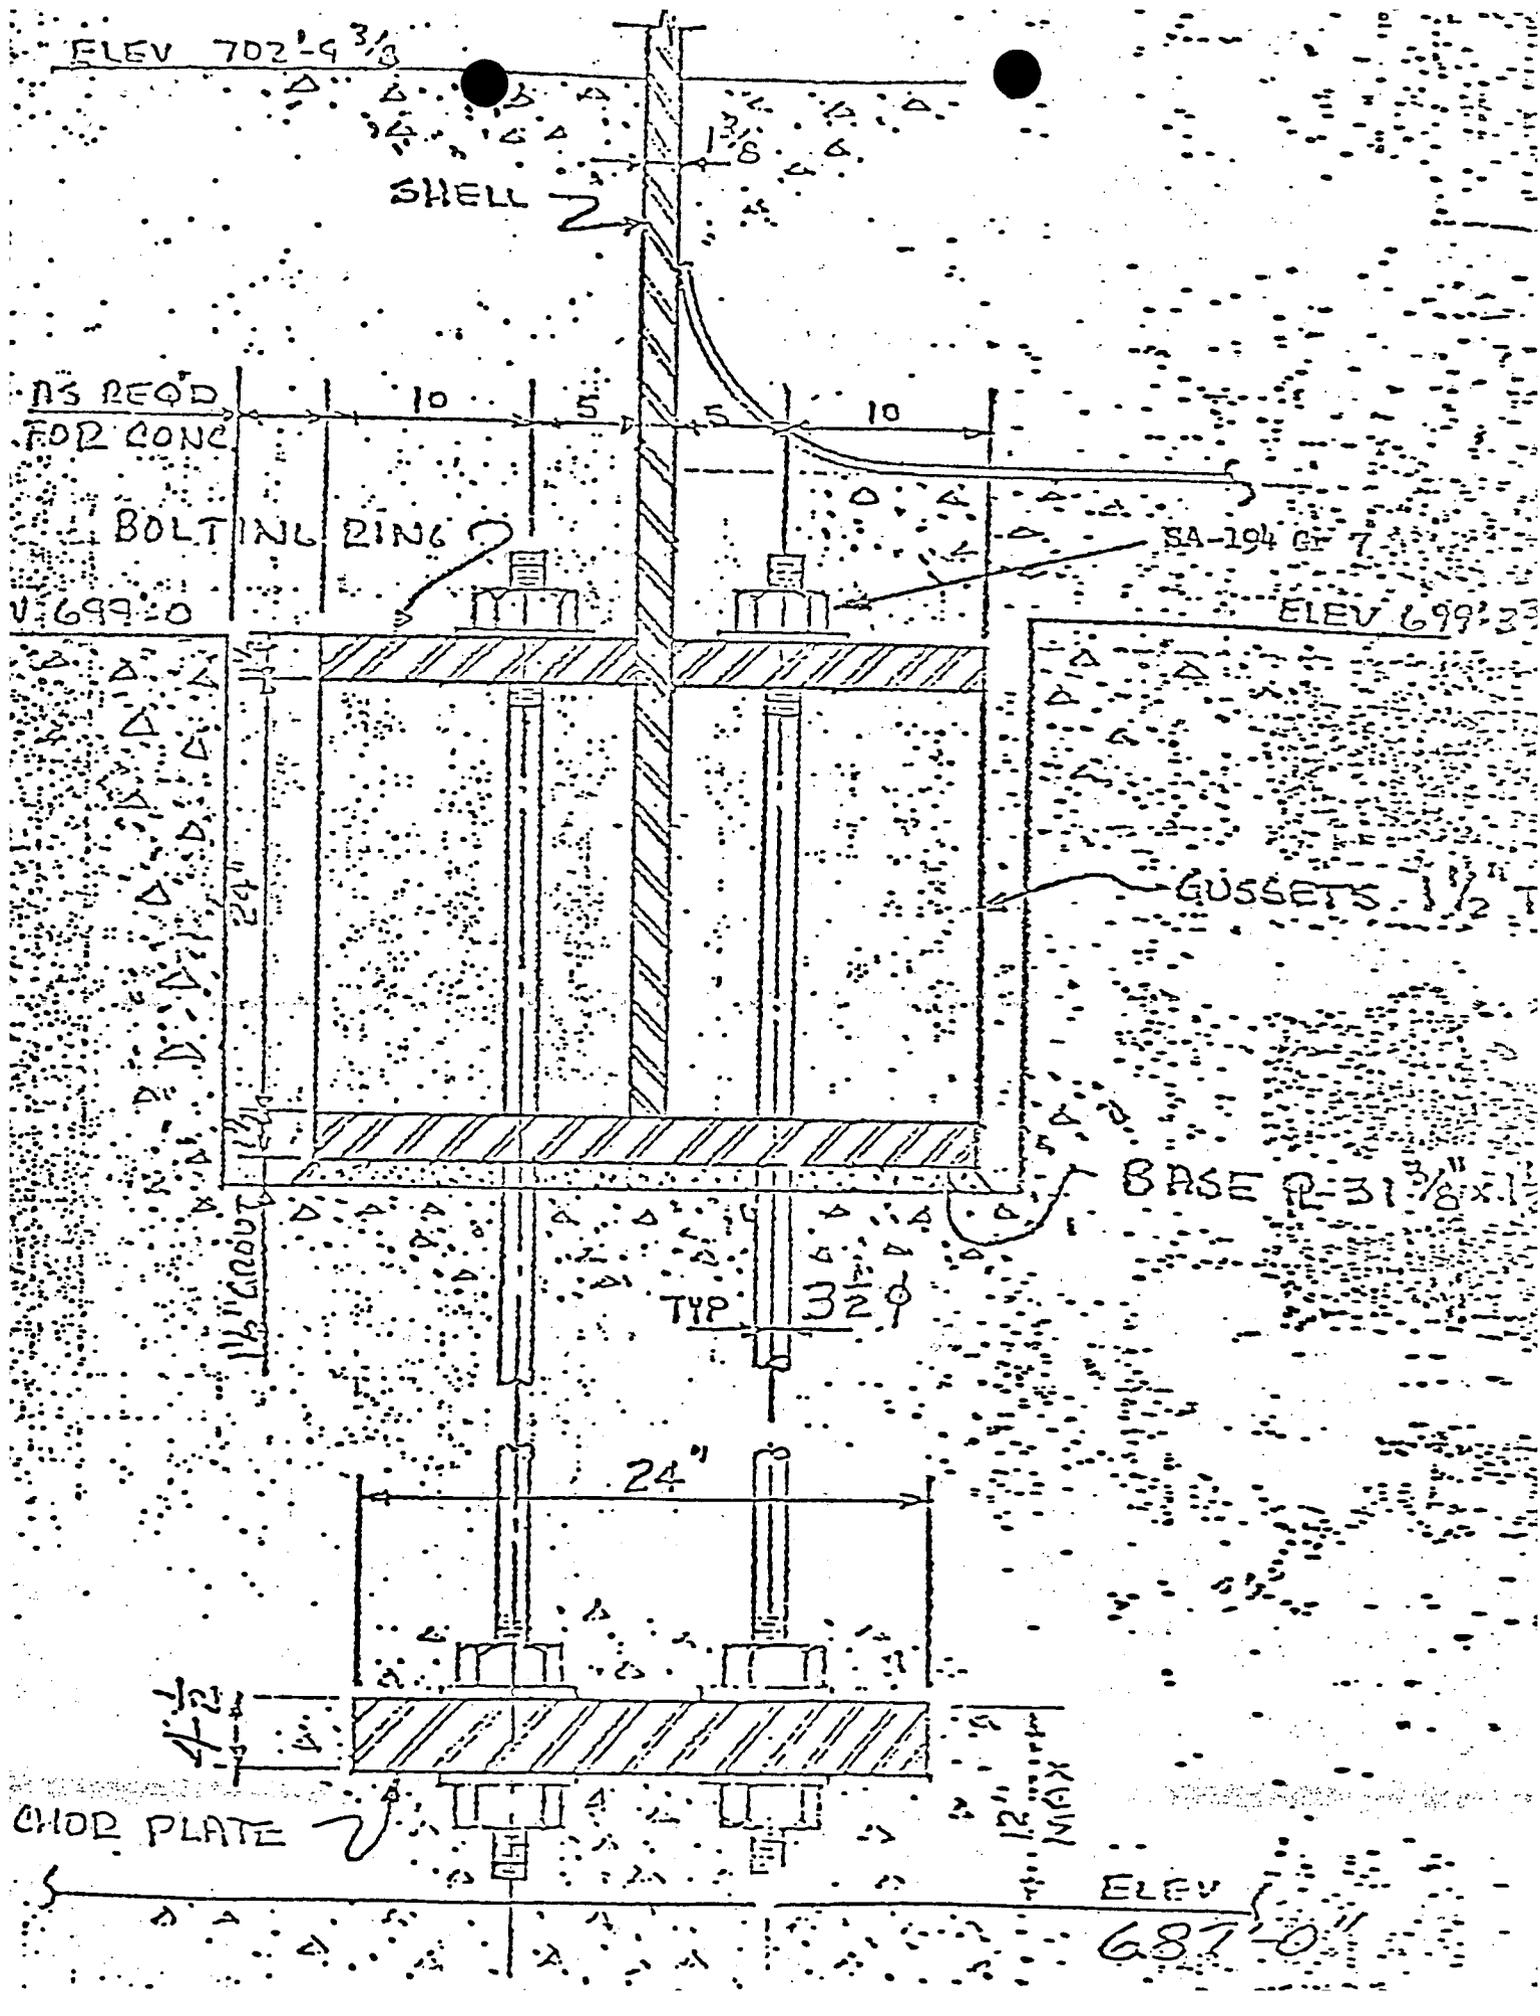
The reactor containment vessel bottom shell ring is anchored to a concrete foundation mat by 360 3-1/2-inch diameter bolts. These bolts are arranged in two concentric circles inside and outside the bottom shell ring. The bolts are located in pairs at equal distance from the middle surface of the shell ring on radial lines at 2-degree intervals. An embedded anchor plate at the lower end of the bolts is provided to transfer the bolt load to the concrete. The bolts are partially embedded, then pretensioned to 423 kips by elongating the bolts and tightening the top nuts to maintain the elongation. Finally, the anchorage (bolts, nuts, etc.) is embedded in concrete. Details of this embedded anchorage are shown in Figure 1.

During the final inspection, prior to embedment of the unit 2 reactor building structural steel containment vessel anchorage in concrete, a total of twenty top anchor bolt nuts were found with indications which appeared to be surface irregularities.

CB&I performed a chemical analysis, a hardness determination, and a metallographic examination on one of the nine nuts. The examination showed that the indications were folded metal with nonmetallic inclusions in the seams and adjoining metals. An additional two nuts, which were considered to have the worst appearing indications, were sectioned and metallographically examined with similar results. Therefore, the surface indications were considered not injurious.

Nine of the twenty suspect unit 2 top anchor bolt nuts were determined to have minor surface imperfections. The remaining eleven nuts were removed for detailed examination. Two of the eleven were determined to have only minor surface imperfections and were released for use. The remaining nine nuts which had potentially injurious surface indications were replaced with nuts free of surface indications.

Because of the discoveries on unit 2, the unit 1 top anchor bolt nuts were visually examined. Twenty-one nuts had surface indications, but only eleven nuts had potentially injurious surface indications. These eleven nuts were replaced with nuts free from surface indications.
