WATTS BAR NUCLEAR PLANT - UNIT 1 POLAR CRANE BRIDGE ASSEMBLY - DEFICIENT
END TIE WELDS - NCR 1081R - FINAL REPORT

WATTS BAR NUCLEAR PLANT UNIT 1

UNIT 1 POLAR CRANE BRIDGE ASSEMBLY - DEFICIENT END TIE WELDS

NCR 1081R - FINAL REPORT

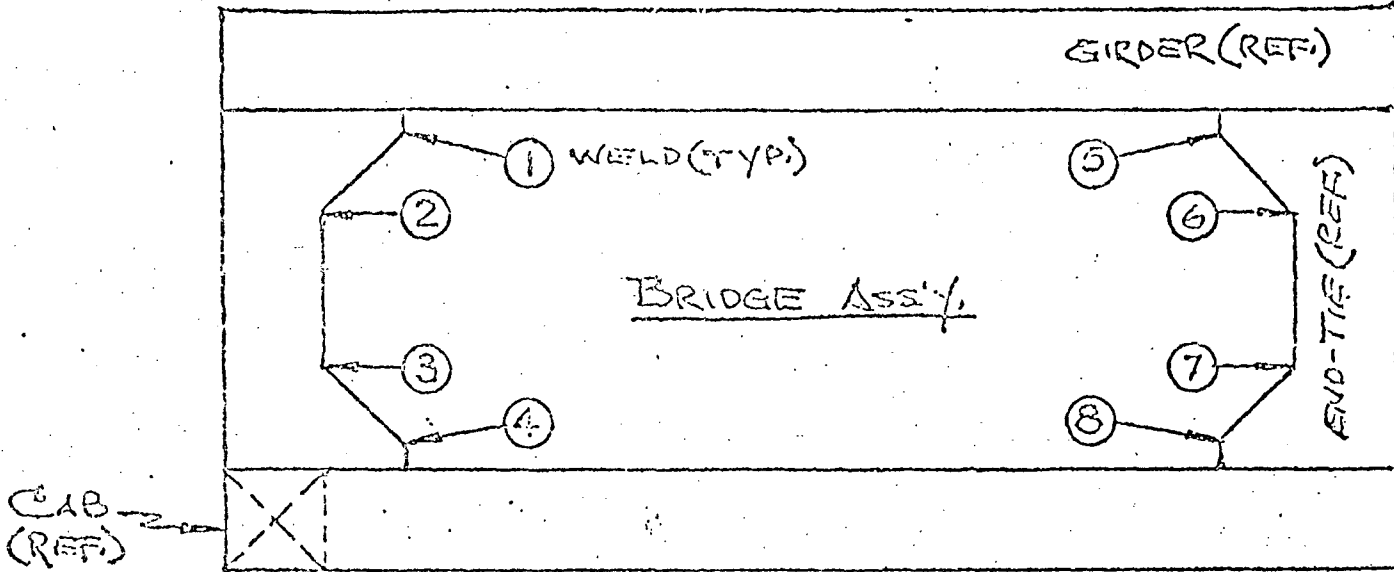
POLAR CRANE, UNIT-1
ATTACHMENT #1 TO NCR-1081R

This deficiency was discovered as a result of an inspection ordered following discovery of some deficient welds on the unit 2 polar crane at Watts Bar Nuclear Plant (see NCR 938R on Watts Bar). Four welds on the bridge assembly end ties (see attached figure) of the unit 1 polar crane do not meet the requirements of AWS-D1.1-72. These four welds contain slag inclusions and exhibit lack of fusion to varying degrees. The deficiency was due to a failure of the fabricator (Broadline Corporation) to follow welding procedures.

<u>WELD Nos</u>	<u>COMMENT</u>
③, ④, ⑦, ⑧	— WELDS REJECTED BY UT EXAM.
①, ②, ⑤, ⑥	— WELDS APPROVED BY UT EXAM.

The deficient welds in the unit 1 polar crane bridge assembly will be repaired in accordance with a procedure written by site employees and approved by TVA's Division of Engineering Design. Upon completion of repair, each weld will be examined by magnetic particle test in accordance with TVA Construction Specification, G-29M.
