WATTS BAR NUCLEAR PLANT UNITS 1 AND 2 - REPORTABLE DEFICIENCY -  
UNEXPECTED SOIL CONDITIONS ENCOUNTERED DURING EXCAVATION OF  
INTAKE CHANNEL

WATTS BAR NUCLEAR PLANT UNITS 1 AND 2

REPORTABLE DEFICIENCY

FIRST INTERIM REPORT

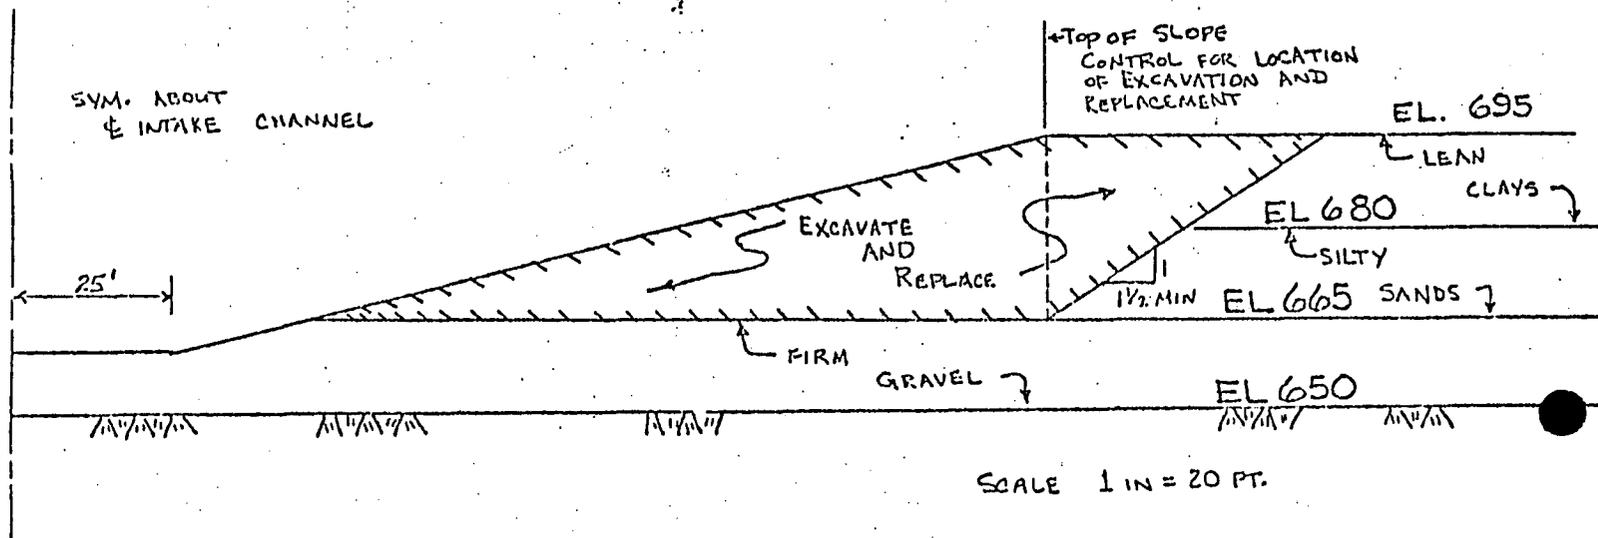
Figure 1 : Intake Channel - Lateral Excavation and Replacement  
Typical Cross Section

The original soils exploration program in the intake channel area defined the general soil profile as a 15 foot layer of lean clay material from elevation 695 to 680, a 15 foot layer of silty sand from elevation 680 to 665, and a 15 foot layer of firm basal gravel from elevation 665 to 650 (top of rock). The layer of silty sand was judged to have a potential for liquefaction during a seismic event, and therefore the design of the intake channel involved removal of this material down to top of firm gravel (elevation 665). A typical cross section of the intake channel is shown in figure 1.
