**CROW BUTTE MINE
DAWES COUNTY, NEBRASKA**

2007 POND INSPECTION REPORT

By: David V. Coe, PE
Nebraska Registration No. E - 4295

October 24, 2007

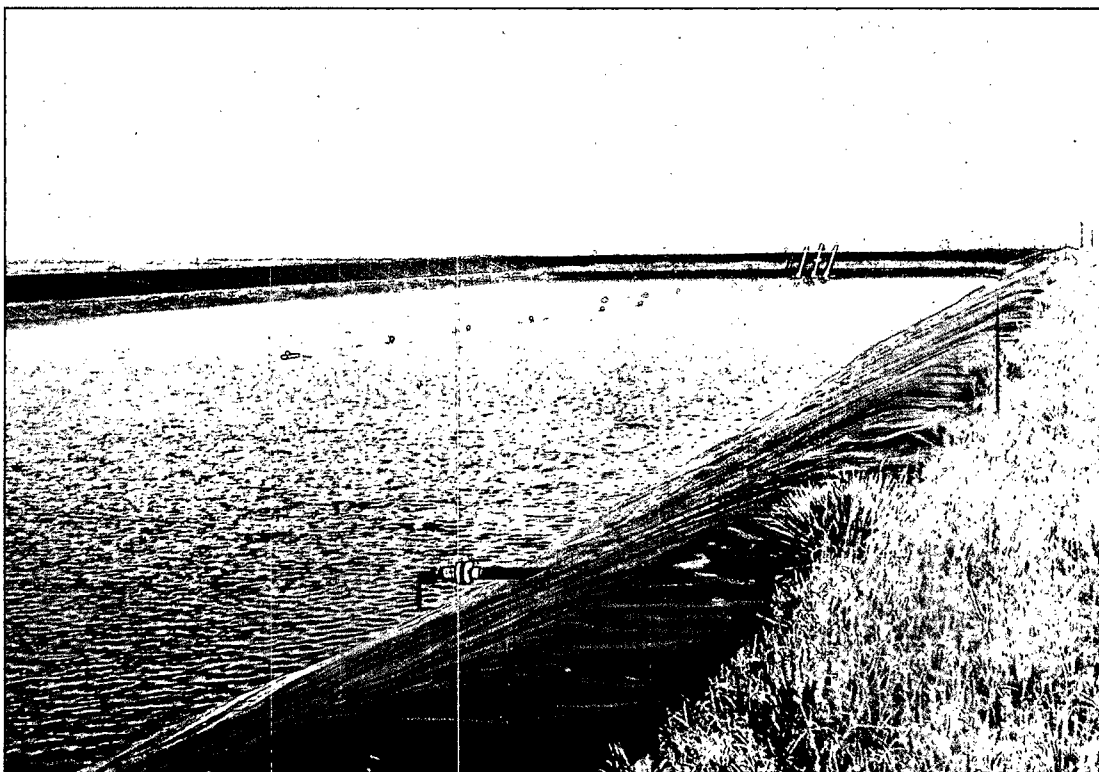
We began our inspection pond #1, the far east pond. This pond seems to be the largest containment structure. We started at the northwest corner of the pond walking in a clockwise direction. I noticed some foaming of the pond water. It was probably the result of strong winds during the night. The vegetation on the north dam face looked good. The vegetation along the east cut slope was rather bare. I have not noticed any significant change in the above vegetation for the last three years. I believe the vegetation does not perform very well because of the lack of topsoil cover. The pond depth was 4.5 feet or measured in free board, not including the required five feet of safety free board would be 7.5 feet. The top of the dam embankment had limestone base course aggregate on the north half. The east half had natural soil cover. The vegetation on the south embankment was fair. I noticed a few gophers borrow on the southwest corner. Walt indicated he has been spot treating recent gopher activity.

Northwest view of evaporation pond #1, date: 10/11/07

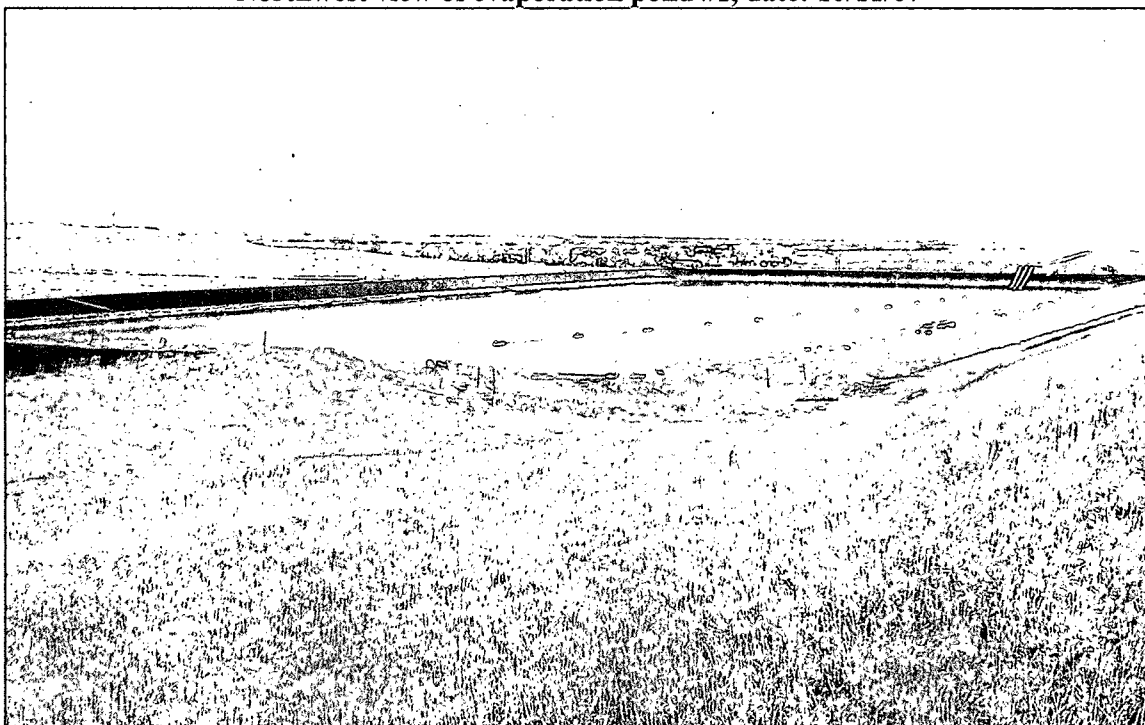
Pond #3 was the next dam inspected. The vegetation around pond #3 is excellent. I did notice that the pond depths were currently being maintained substantially lower than normal. One could see the high water marks along the pond liner. The ponds were approximately 3 to 4 feet lower than normal pond depth. Pond #3 depth marks are on the south side, just opposite of pond #1. The current free board for pond #3 was 5 feet, based on a pond height of 17.5 feet and a safety free board of 5 feet. There was a limestone base course cover on the top of pond #3 embankment along the north, west and south pond tops. I noticed the large aeration guns previously used along the embankment top were removed. Aeration of the ponds is accomplished with individual sprayers aligned in a north/south orientation near the middle of the ponds. A windsock is posted on a hill just east of the commercial pond area used to determine when it is appropriate to run the pond aeration sprays.

Northwest view of pond #3. Date: 10/11/07

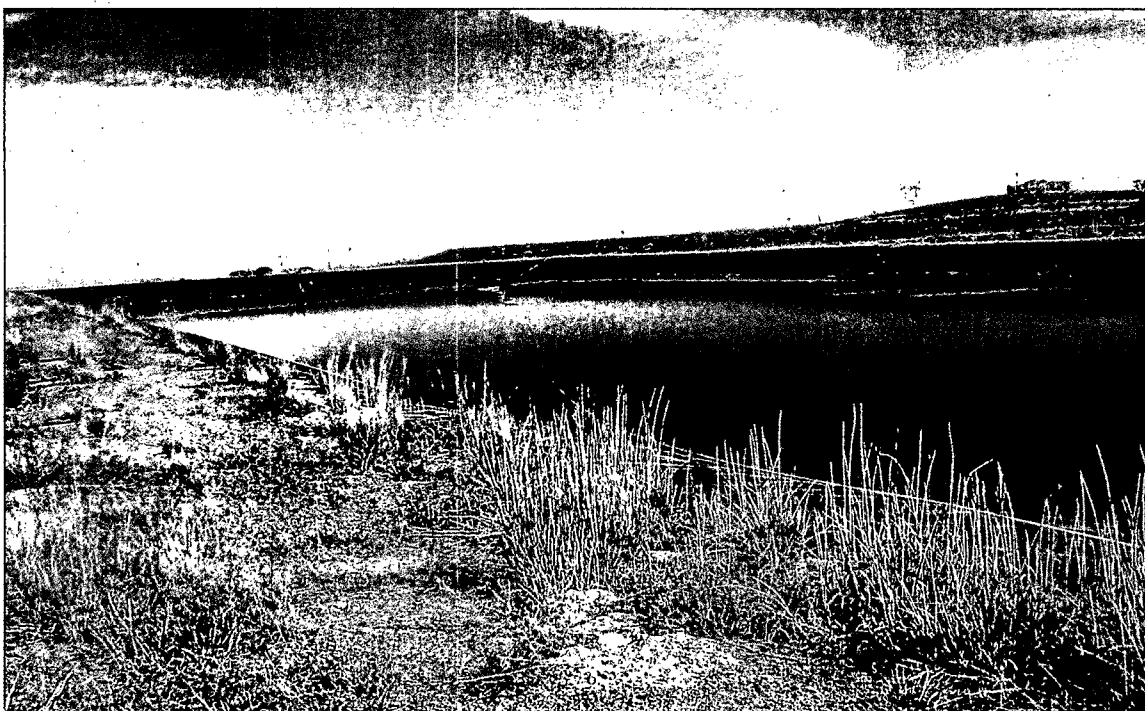
We completed the inspection of the commercial ponds with the visual inspection of pond #4. There were two pumping systems on the north and south embankments of pond #4. They were introducing fresh water near the middle of the two pond liners and drawing out water at the two ends of the pond. The objective is to reduce the concentration of chemicals that increase the conductivity of the water between the two pond liners. Pond #4 has not been used very much during the last year or the level of the pond has been kept substantially lower than the other two ponds. The water depth had a free board of 7.1 feet

The pond liners for the commercial ponds seem to be more brittle than the pond liners for the research and development ponds. I noticed one or two cracks in the liner of pond #4 along the east slope of the pond. The water depth was about five feet below the crack. The repair of the liner performed last year was showing signs of separation. Walt Nelson indicated they have called the company to have the repair corrected. The west embankment slope of pond #4 was fair. Walt plans to install vegetative mats along the embankment to help with the vegetation improvement of the west bank slopes. The west top of the embankment had limestone base course installed. I noticed a small piece of liner floating on the top of the water on the southwest corner of pond #4. The east top of pond #4 did not have a limestone base course cover. The limestone base course stops near the alignment of the east/west fence on the south side of pond #1.

Northeast view of pond #4. Date: 10/11/07

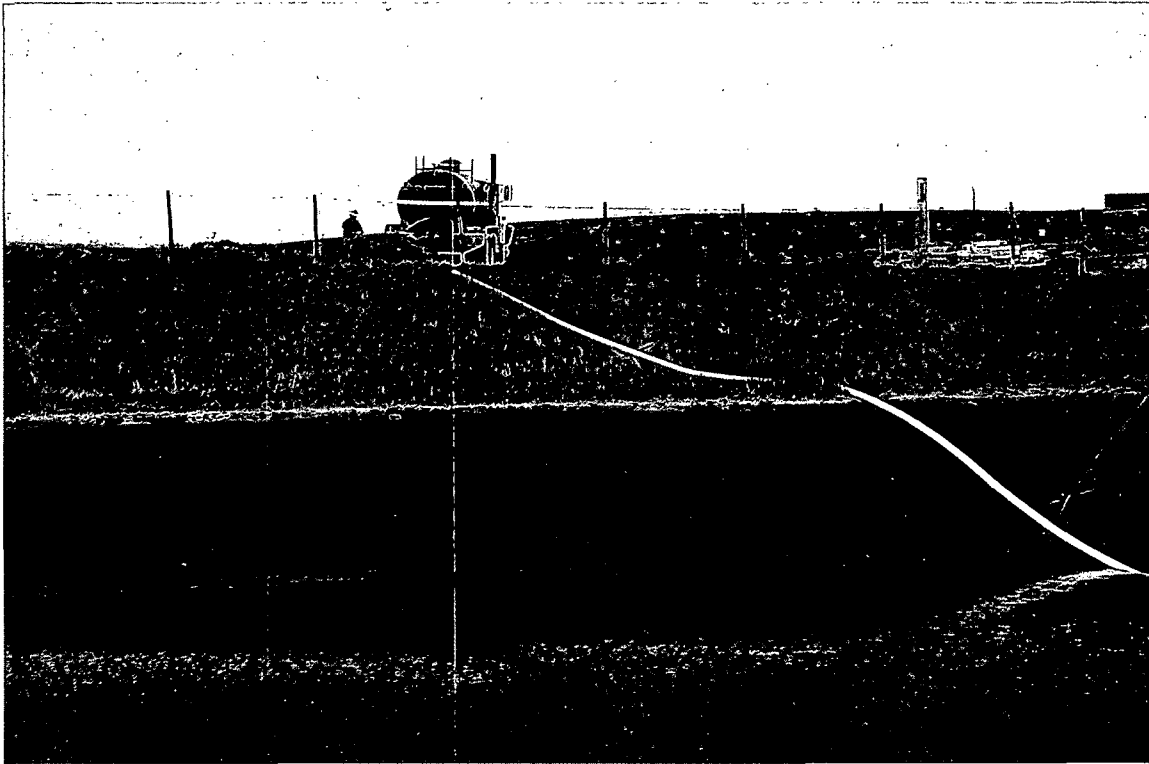
South view of Cell #1 (west) of R & D Ponds. 10/11/07

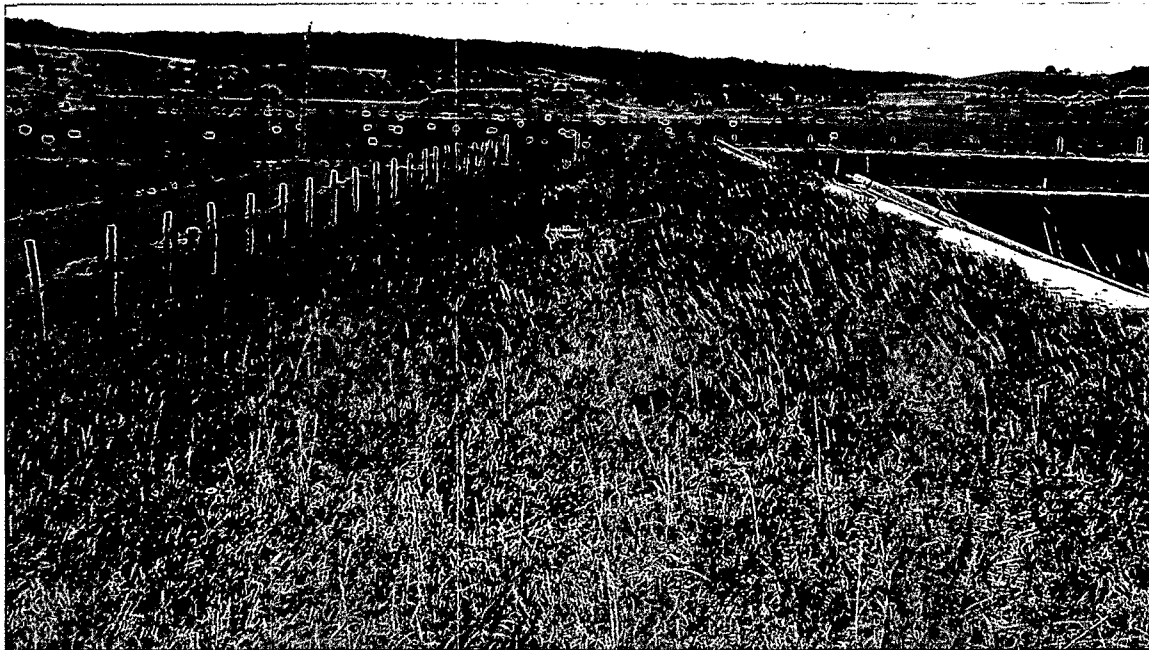
East view of north embankment of R&D ponds. Excellent vegetative cover.
Date: 10/11/07
