Tennessee Valley Authority, Post Office Box 2000, Spring City, Tennessee 37381

WATTS BAR NUCLEAR PLANT (WBN) - UNIT 1 - RESPONSE TO NRC'S SEPTEMBER 15,
1994 ASSESSMENT OF WBN UNIT 1 HOT FUNCTIONAL TESTING

WATTS BAR NUCLEAR PLANT UNIT 1
TVA'S ASSESSMENT OF HOT FUNCTIONAL TESTING ISSUES
RESPONSE TO NRC LETTER OF SEPTEMBER 15, 1994

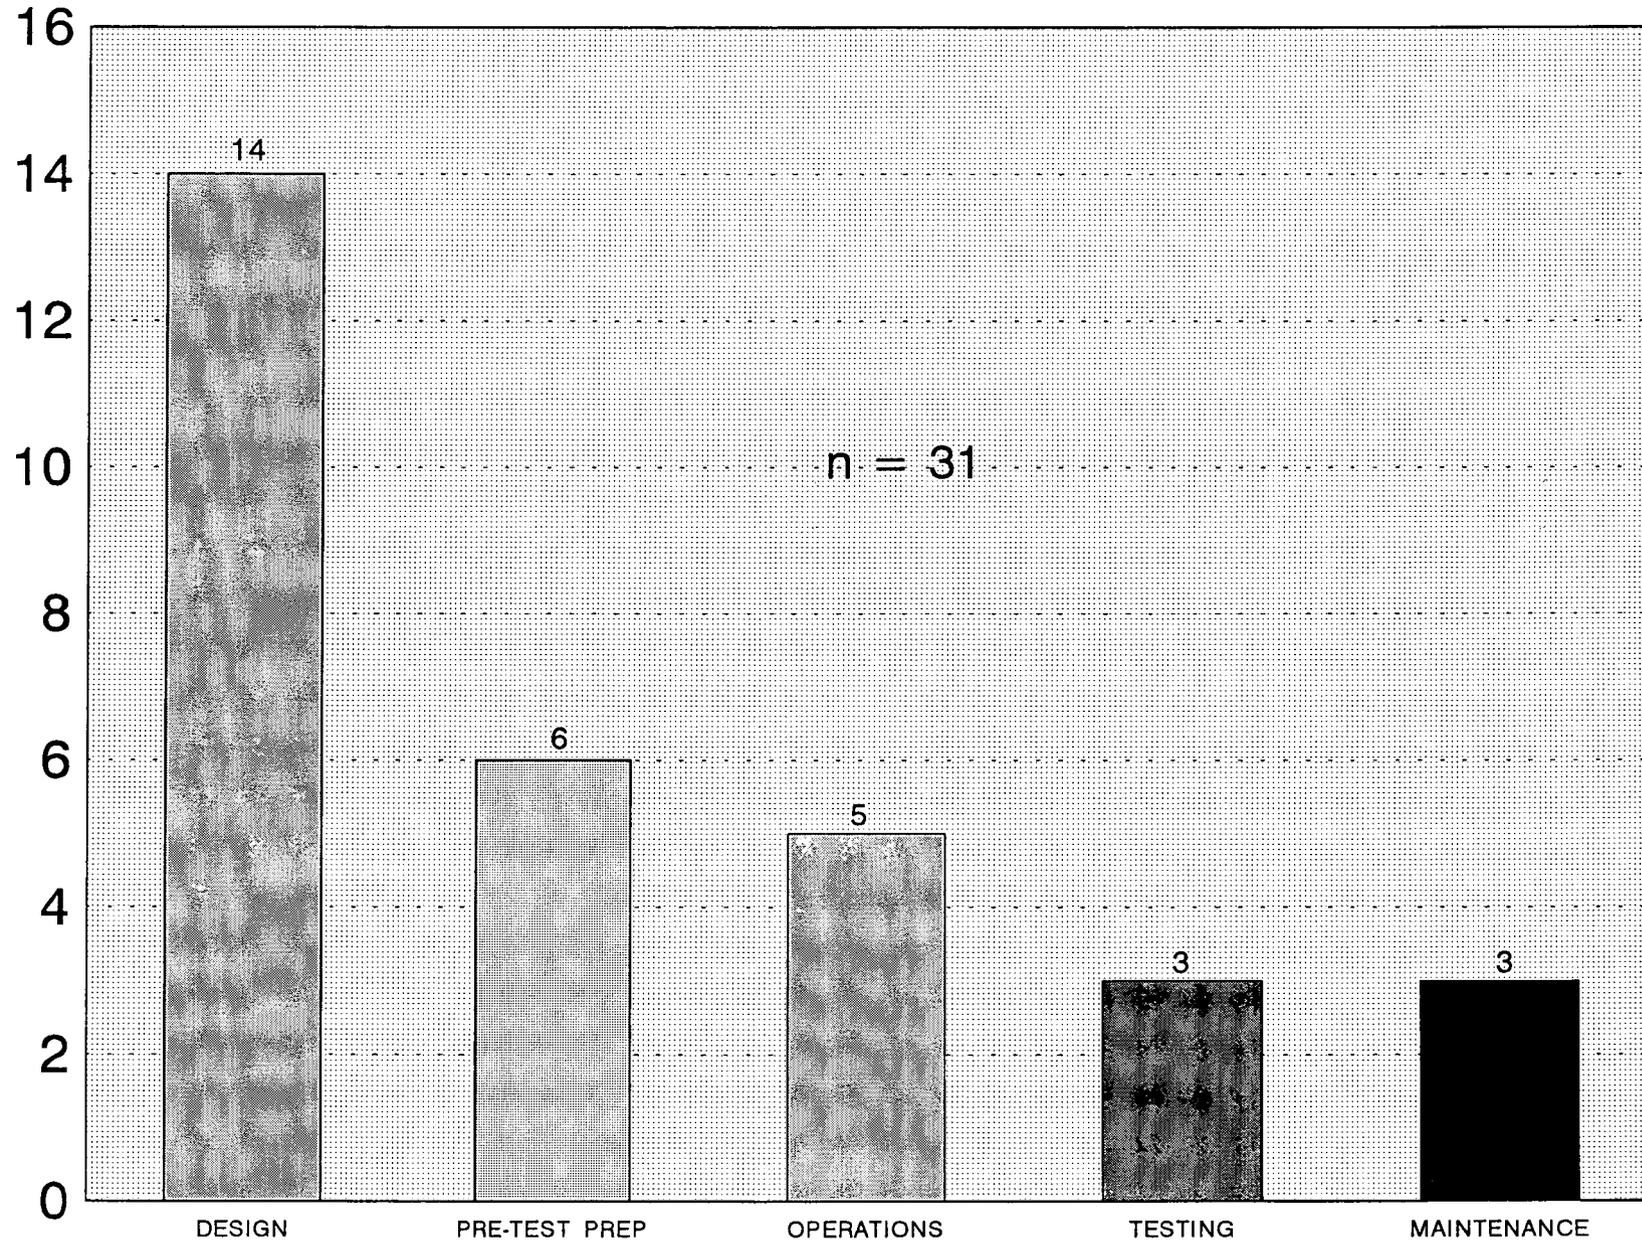
FIGURE 2
EQUIPMENT ISSUES FROM NRC'S SEPTEMBER 15, 1994 LETTER

The following provides an assessment of the equipment issues discussed in the NRC letter. TVA's specific response, including detailed schedules, is provided for each of these issues in the attachment to this enclosure. Referring to Figures 1 and 2 (Pages 9-11), our analysis indicates that 80 percent of the problematic issues are represented by three categories: (1) Design issues, which constitute the majority of items, (2) Pre-test grooming activities, and (3) Operational issues. Isolated examples of insufficient testing and maintenance were observed and are discussed in the attachment. A fourth category, Equipment Tuning, is composed of those items which typically require adjustment/correction during testing.
