Tennessee Valley Authority, Post Office Box 2000, Spring City, Tennessee 37381

WATTS BAR NUCLEAR PLANT (WBN) - VALIDATION OF CAUSES OF EIGHT  
CONSTRUCTION ISSUES

ASSESSMENT OF  
CORRECTIVE ACTION AND OPEN ITEM  
CLOSURE VERIFICATION PROCESS

WATTS BAR NUCLEAR PLANT

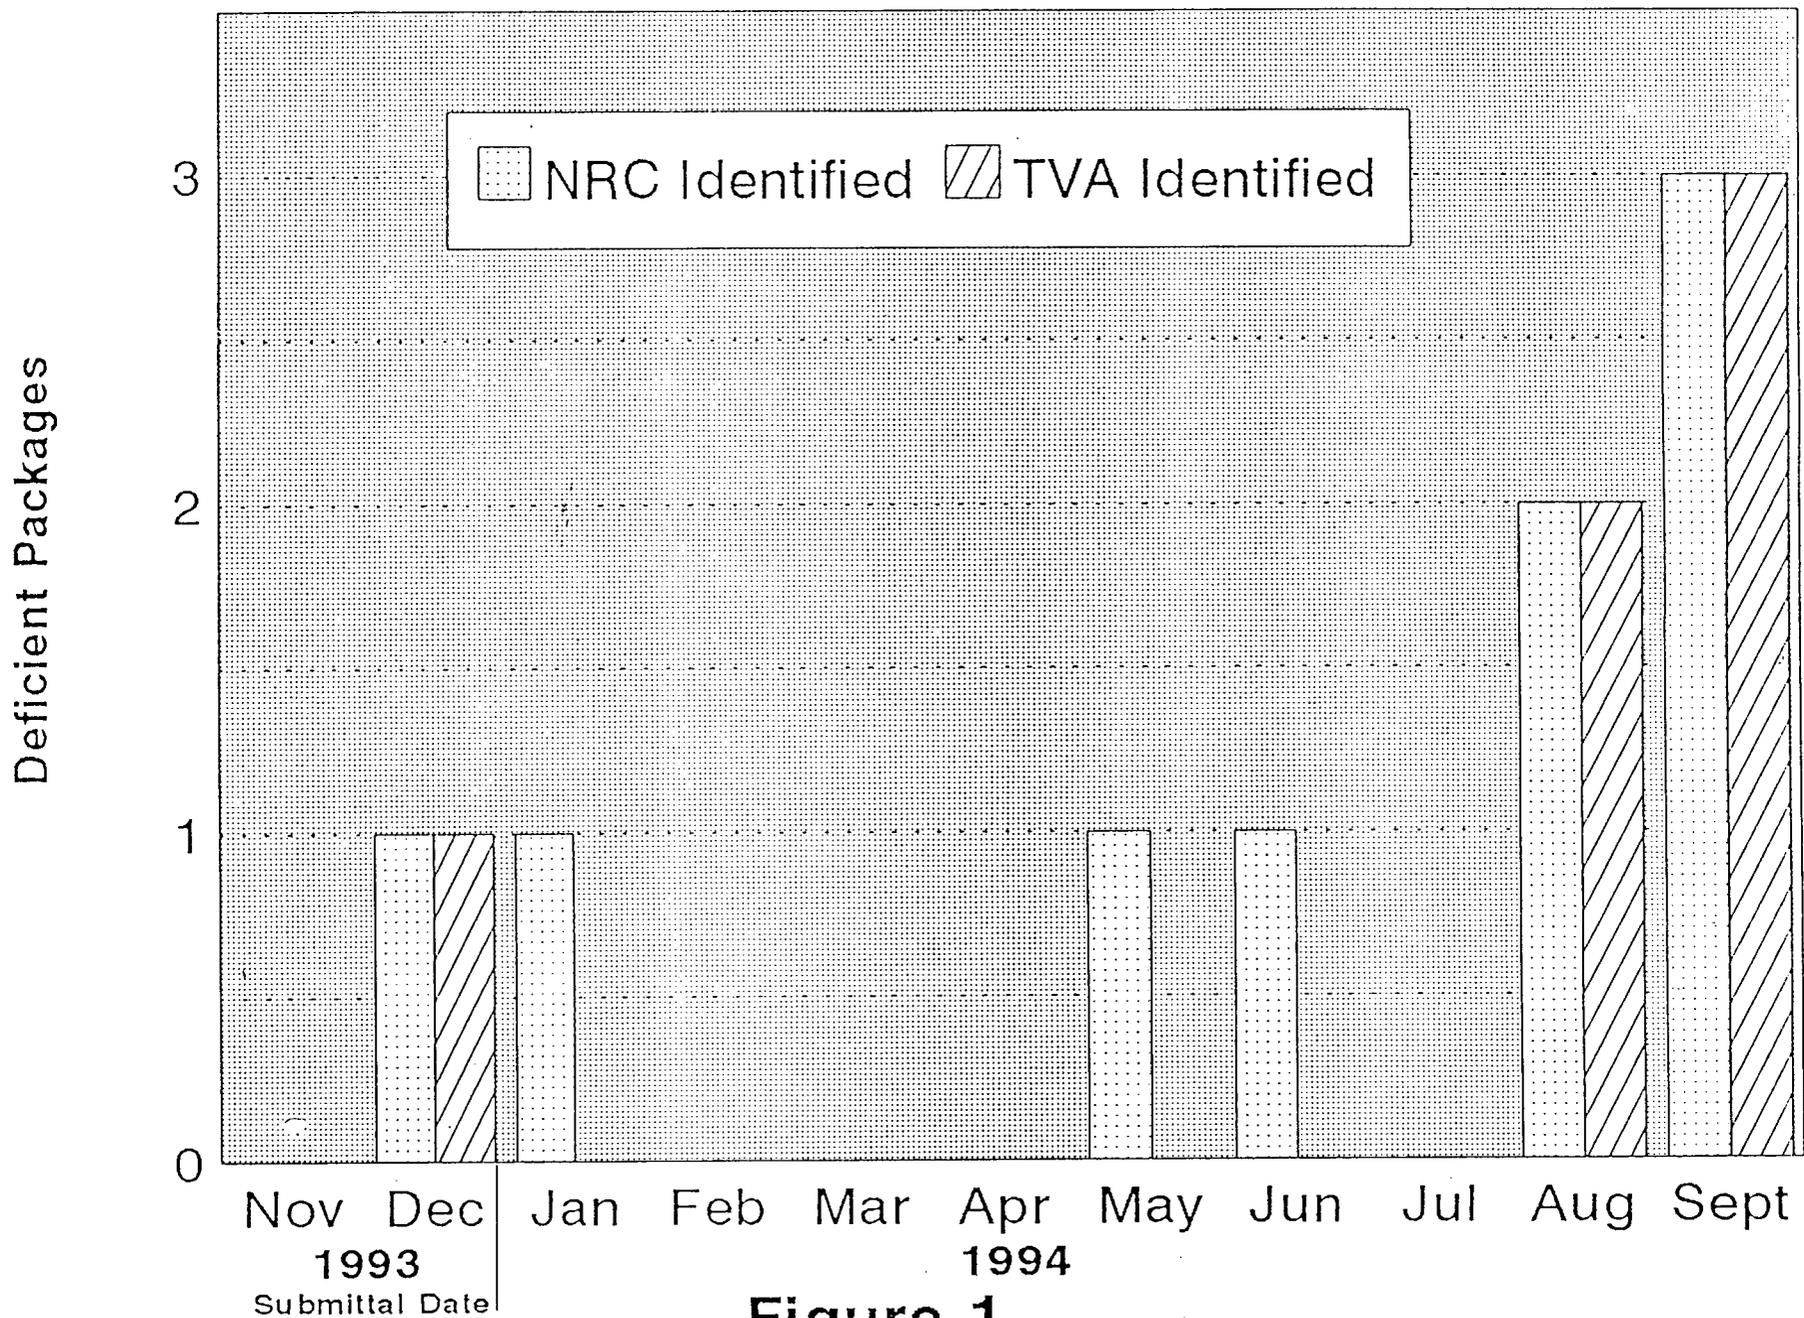
Figure 1

In June, however, the "closure organization" was modified (to a more matrixed organization) and personnel involved were physically relocated. This was done to allow them to focus fully on closures in order to increase the number of package closures. Significantly, ten of fourteen inadequate packages occurred shortly after this change (between June and September, 1994)--NRC reviews identified eight inadequate packages and TVA reviews of 40 packages pulled back from the NRC identified six inadequate packages (see Figure 1).

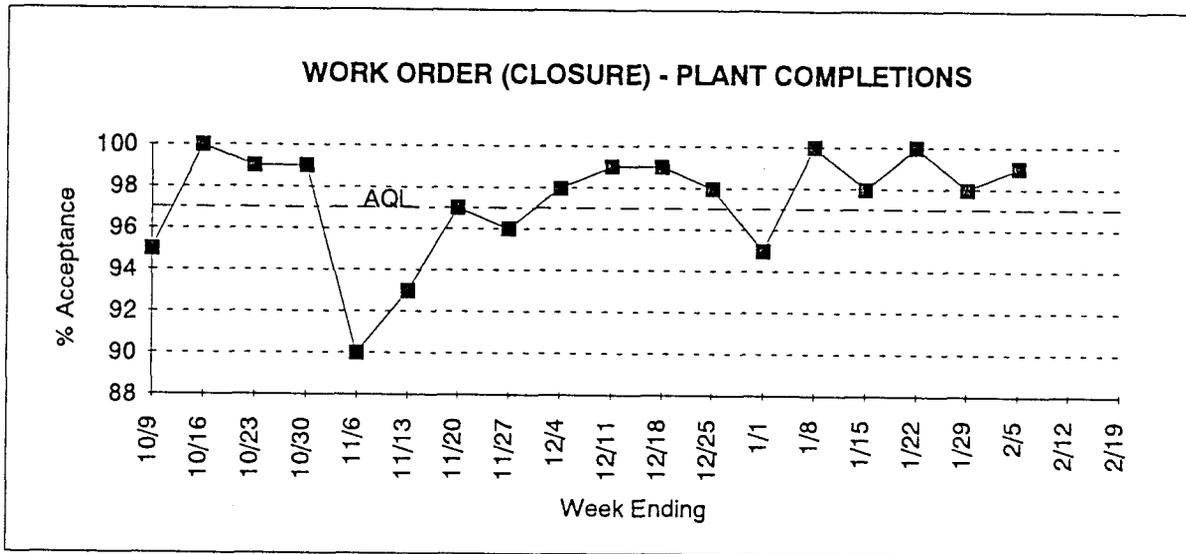
Figure 4

Immediately after QC began including minor deficiencies in inspection acceptance rate data in October, 1994, the acceptance rate declined. However, as attention was applied to these type rejects, the acceptance rate began a steady improvement (see Figure 3). Similarly, Quality Engineering demanded high quality standards in their review of work orders. Initially, there was a decline in the acceptance rate. However, acceptance rates soon began to improve as the line organizations began to understand these expectations (see Figure 4). Similar results were seen in procurement documents (see Figure 5).
