TENNESSEE VALLEY AUTHORITY (TVA)
SEQUOYAH NUCLEAR PLANT (SQN)

Final Report
Metallurgical Examination Results for
Tube Pull During SQN Unit 2 Cycle 14 Refueling Outage

SG-CDME-07-21-NP
Revision 0

Examination of a Steam Generator Tube Removed from Sequoyah Unit 2

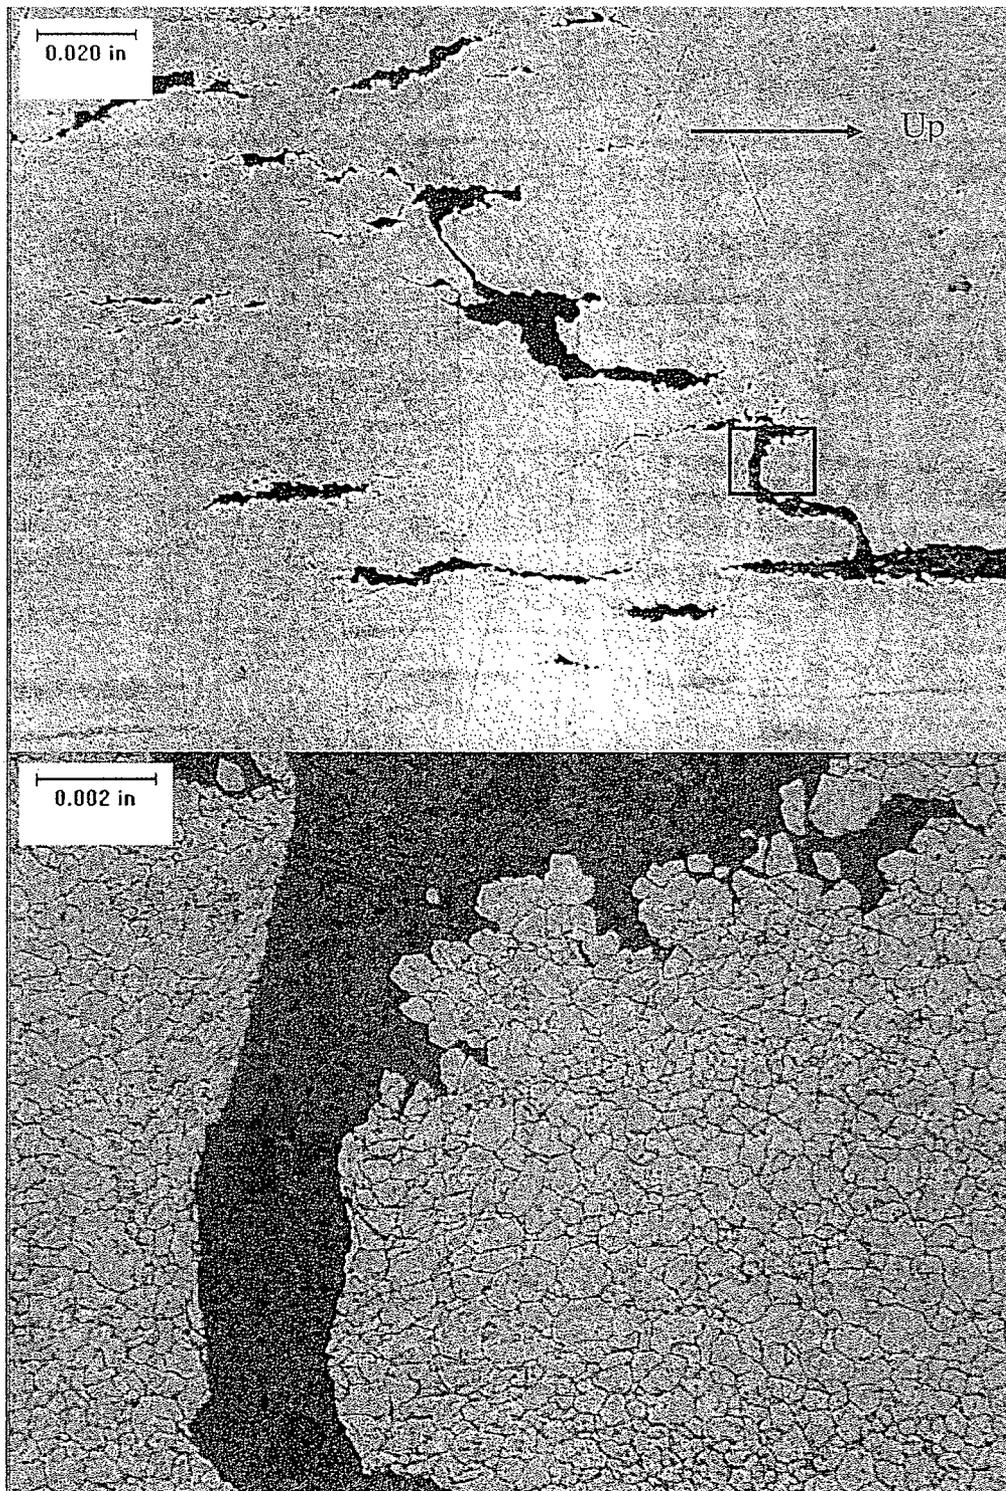
Figure 7-2: Circumferential Feature in Sample 6B2

No significant patches of IGA or cellular corrosion were found. A very small patch was observed near the 180° crack of TSP#1, and this area was selected for examination by radial metallography. A short circumferential opening was observed in a gouge near the 180° crack of TSP#2, and this area was selected for examination by radial metallography as well.
