John A. Scalice
Site Vice President, Watts Bar Nuclear Plant

WATTS BAR NUCLEAR PLANT (WBN) UNIT 1 - REQUEST FOR APPROVAL OF
ALTERNATIVE TO AMERICAN SOCIETY OF MECHANICAL ENGINEERS (ASME)
CODE REQUIREMENTS - REPAIR OF CANOPY SEAL WELDS

WATTS BAR NUCLEAR PLANT UNIT 1
REPAIR AND REPLACEMENT REQUEST FOR RELIEF, 1-RR-1

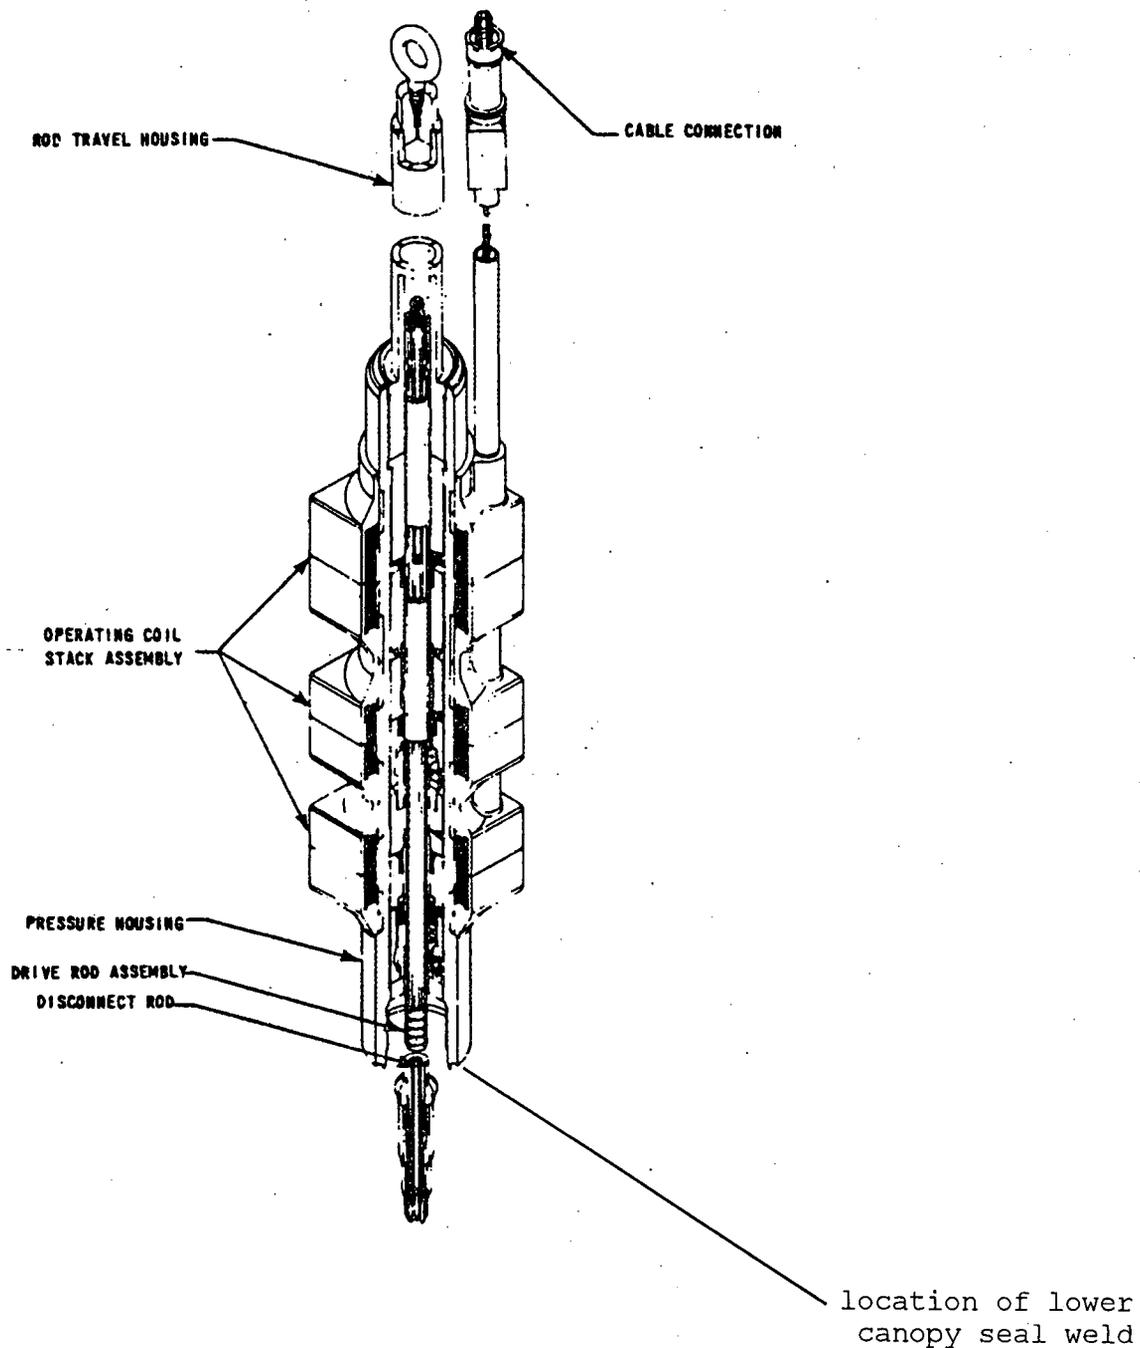
FULL LENGTH CONTROL ROD DRIVE MECHANISM

Summary: During the Watts Bar Nuclear Plant Unit 1 Cycle 1 refueling outage activity of disassembling the reactor vessel, boric acid residue was noticed on the control rod drive mechanisms (CRDMs) (See Attachments 1 and 2). Further inspection shows that two CRDMs have started leaking at the lower canopy seal weld (See Coordinates on Attachment 3). The ASME Code requires the defects be removed and the configuration of the material be reproduced in order to restore the canopy seal to its original design condition. Due to the physical space limitations and in consideration of radiation exposure, Watts Bar proposes as an alternative to perform a weld buildup over the leaking canopy seal welds (See proposed design in Attachment 4) rather than removing the defect and performing a weld repair. Also, an enhanced visual examination is proposed as an alternative to the liquid penetrant examination required by the original construction code for the final weld buildup. TVA's proposed alternative seal weld repair and examination methods have been previously implemented at TVA's Sequoyah Nuclear Plant Unit 1 and other utilities and provides an acceptable level of quality and safety. TVA requests authorization to use these alternatives in accordance with 10CFR50.55a(a)(3)(i).

During the Unit 1 Cycle 1 Refueling Outage (U1C1 RFO) activity of disassembling the reactor vessel, boric acid residue was noticed on a control rod drive mechanism (CRDM). Further inspection shows that two CRDMs have started leaking at the lower canopy seal weld. See Attachments 1, 2 and 3 for configuration and location of the CRDMs and canopy seal welds.

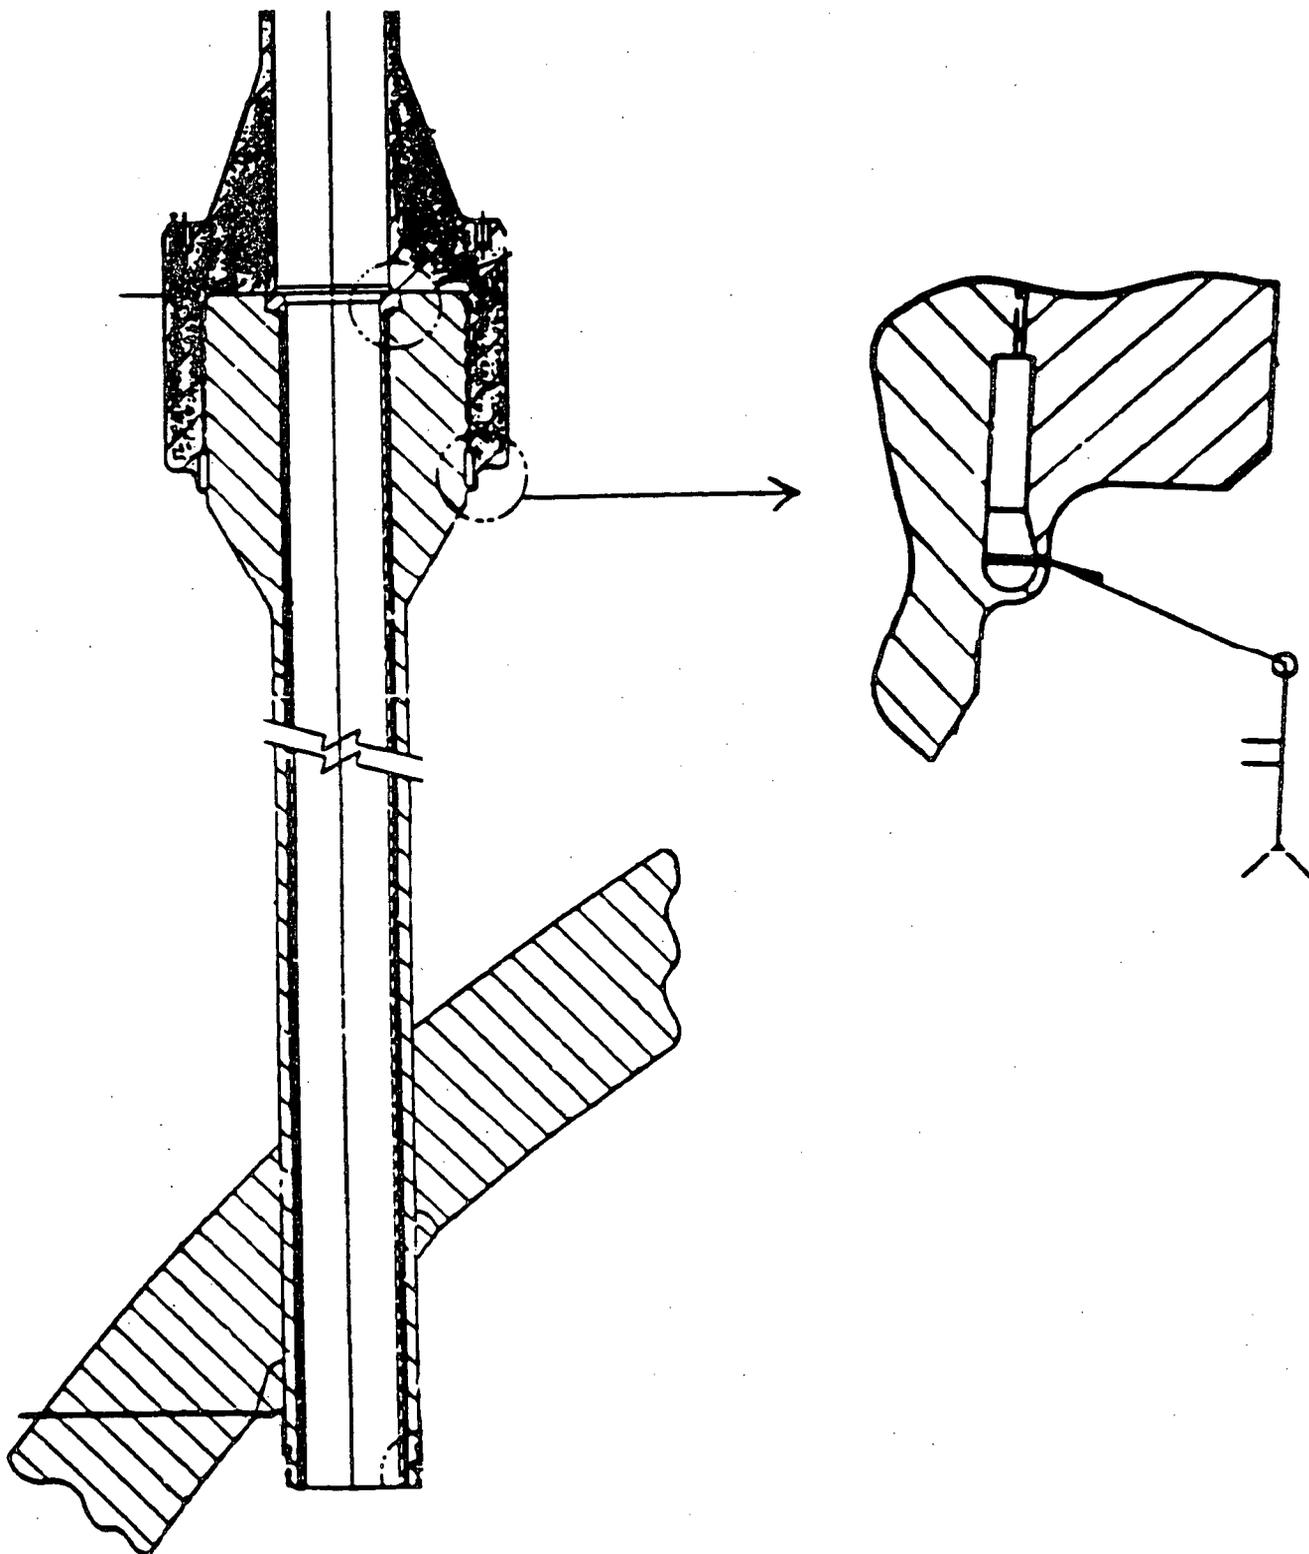
TYPICAL LOWER CANOPY SEAL WELD DETAIL

The CRDMs are fabricated in sections with threaded joints providing the pressure-retaining capabilities. Since the threaded joint provides pressure retention, the canopy seal weld is not pressure retaining and is for leakage

- a. A weld overlay repair designed under the requirements of ASME Section XI, 1989 Edition, Paragraph IWB-3640, "Evaluation Procedures and Acceptance Criteria for Austenitic Piping," and Appendix C, "Evaluation of Flaws in Austenitic Piping," will be used as an alternative repair method. Guidance will also be taken from ASME Section XI Code Case N-504, "Alternative Rules for Repair of Class 1, 2, and 3 Austenitic Stainless Steel Piping," and NUREG-0313, "Technical Report on Material Selection and Processing Guidelines for BWR Coolant Pressure Boundary Piping, Final Report," Revision 2.

- b. An enhanced visual examination using a remote video camera with a magnification of approximately 8X will be used to monitor the repair and to perform a visual examination of the final weld at the enhanced magnification.

The material used for the repair is Inconel 625 weld material which has a tensile strength of approximately 110 kips per square inch (ksi). The Inconel weld material is stronger than the underlying base material (304 stainless steel) with a tensile strength of 75 ksi, more resistant to degradation mechanisms such as stress corrosion cracking, and is highly ductile. The load carrying capability of the repaired location will be greater than the original component.

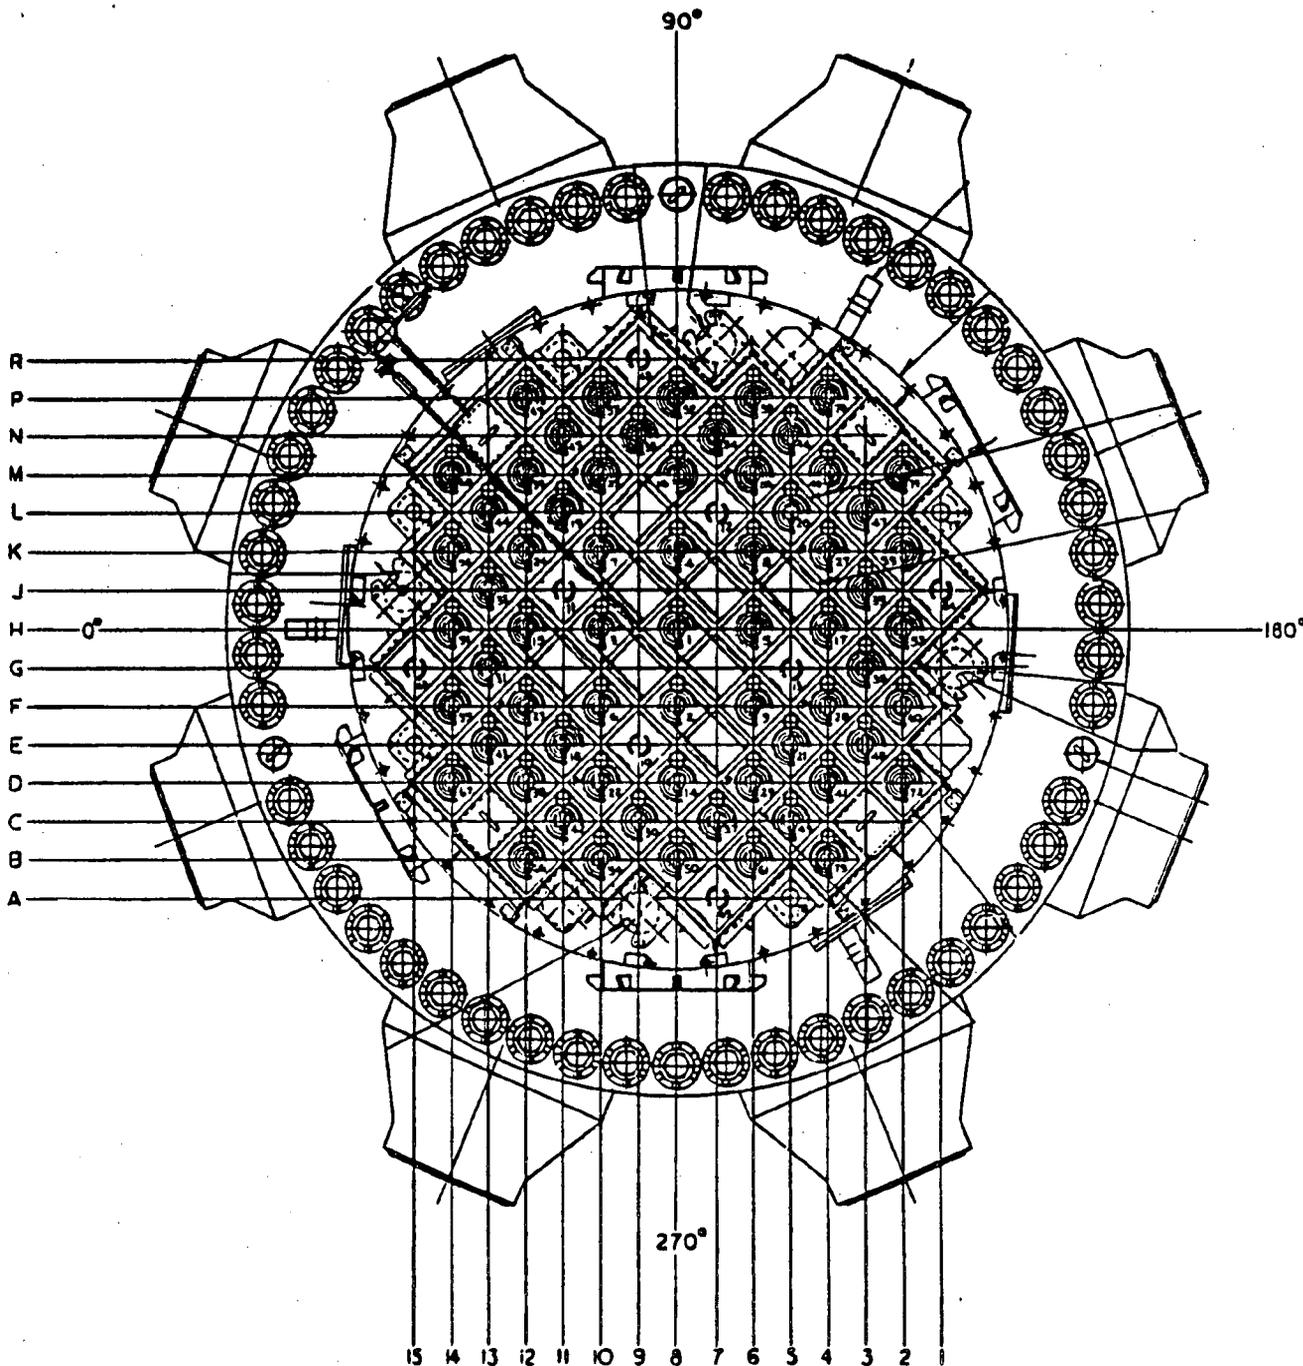
LOCATION OF CRDMs TO BE REPAIRED

Pursuant to 10 CFR 50.55a(a)(3)(i) TVA is requesting the use of alternatives to the ASME code for repair and examination of two lower canopy seal welds as described in Enclosure 1 of this letter. During the reactor vessel disassembly in the Unit 1 Cycle 1 refueling outage, boric acid residue was noticed on a control rod drive mechanism (CRDM) and further review was conducted. That review determined that the lower canopy seal weld on two CRDMs (Coordinates F-2 and G-15 in Attachment 3 of Enclosure 1) had indications of minor leakage (boric acid residue).

CRDMs with Lower Canopy Seal Weld Overlay Repairs	
CRDM #	Location
60	F-2
62	G-15
