LICENSEE EVENT REPORT (LER)

Watts Bar Nuclear Plant - Unit 1

DIESEL GENERATOR FUEL OIL TRANSFER HANDSWITCHES

EVENT DATE (5)			LER NUMBER (6)			REPORT DATE (7)			OTHER FACILITIES INVOLVED (8)	
MONTH	DAY	YEAR	YEAR	SEQUENTIAL NUMBER	REVISION NUMBER	MONTH	DAY	YEAR	FACILITY NAME	DOCKET NUMBER
12	05	97	97	016	00	12	24	97		05000
									FACILITY NAME	DOCKET NUMBER
										05000

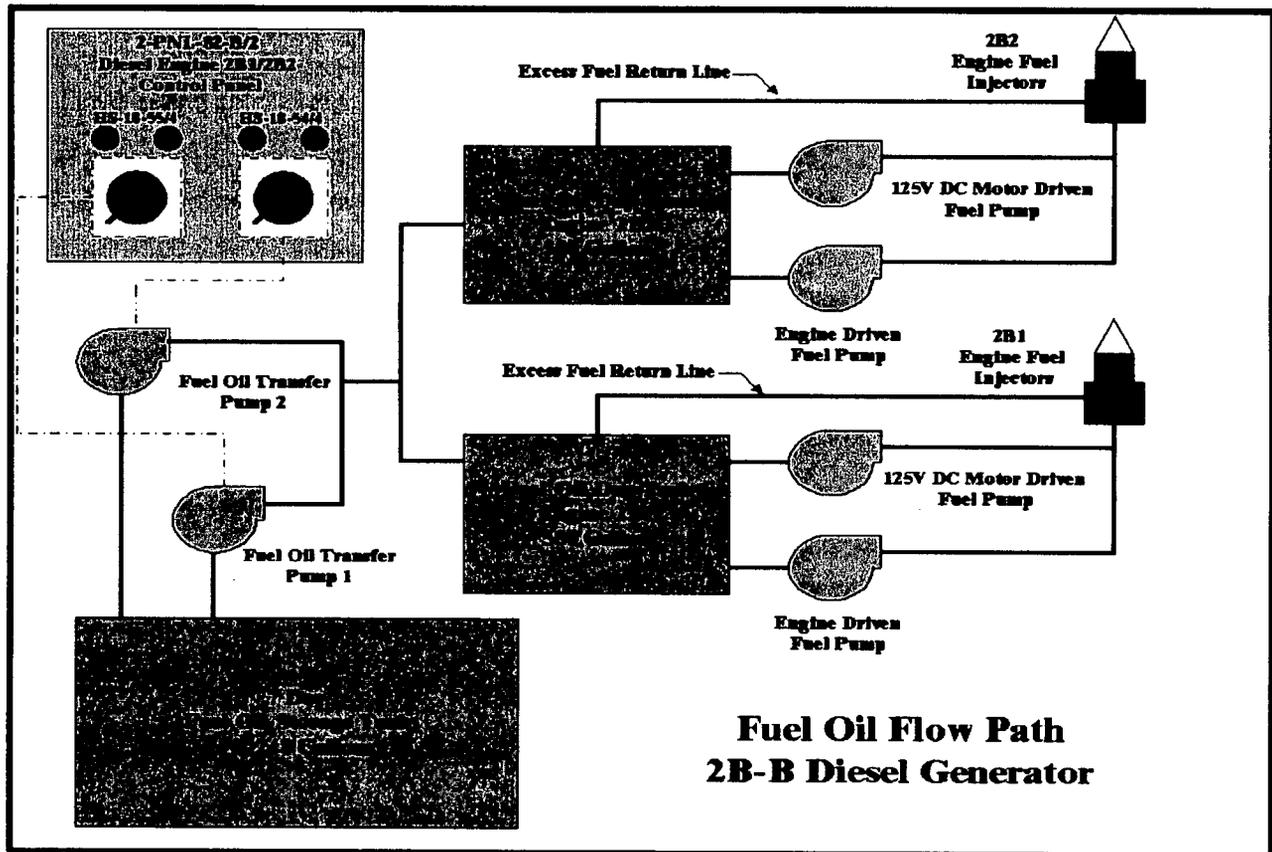
A sketch of the system layout is provided below:

The fuel oil transfer system incorporates redundant design features to ensure that one pump will automatically start and supply both day tanks in the event the other pump experiences a failure. In the event that a complete failure of the fuel oil transfer system occurs (such as in the subject condition with both switches in OFF), a low level alarm provides main control room (MCR) annunciation with sufficient fuel oil remaining in the day tanks to operate at full load for one hour or more based on EDG loading.

As directed by the MCR annunciator response instructions, and as discussed in the Tech Spec Bases, an operator would be dispatched to the EDG room and have sufficient time to take corrective action to prevent the loss of the EDG.

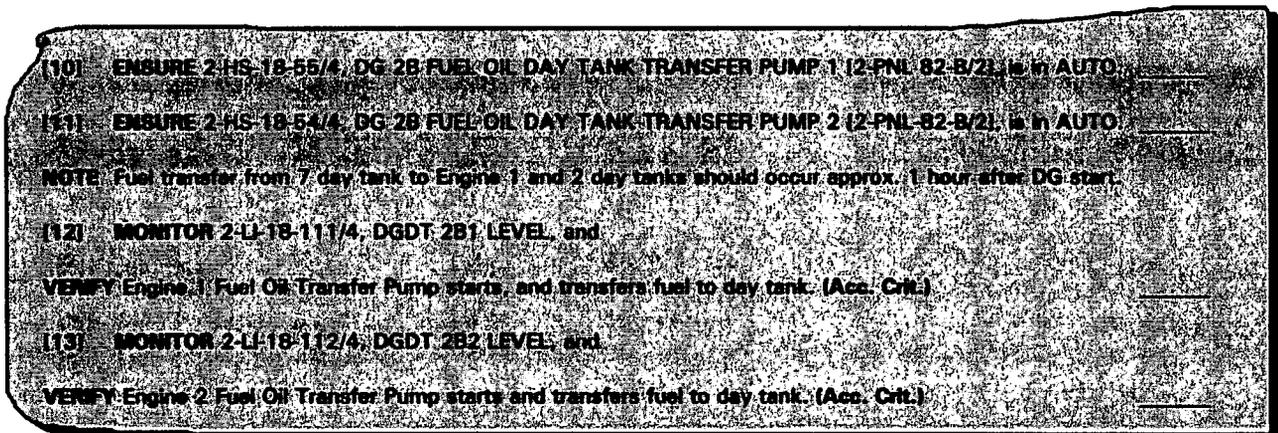
The actual text of the pump performance portion of the SI is as follows:

Depending on initial day tank levels (one is usually lower than the other), operation in AUTO results in the following typical sequence during performance of the SI:

In this manner, the required verification of automatic operation of the fuel oil transfer system is performed by monitoring tank levels. Once the first pump starts, the test requires verification of a level increase on its associated day tank and then the test requires the other tank to be monitored for the same criteria. Depending on initial day tank levels, performance of the SI in the manner described above may require extended operation of the diesel generator, well beyond the required 1-hour performance run. This is due to the draining, filling, and re-draining sequence necessary to demonstrate automatic operation of both transfer pumps.
