Docket Nos. 50-390, 50-391  
License Nos. CPPR-91, CPPR-92

SUBJECT: MEETING SUMMARY - WATTS BAR UNITS 1 AND 2

This letter refers to the NRC/TVA management meeting held at the NRC Region II office in Atlanta, Georgia on September 1, 1994. The meeting was held to discuss lessons learned in preoperational testing and hot functional testing, CAPs and SPs, plant status and licensing issues. Enclosure 1 is a list of the individuals who attended the meeting and Enclosure 2 is the handout information material supplied by TVA.

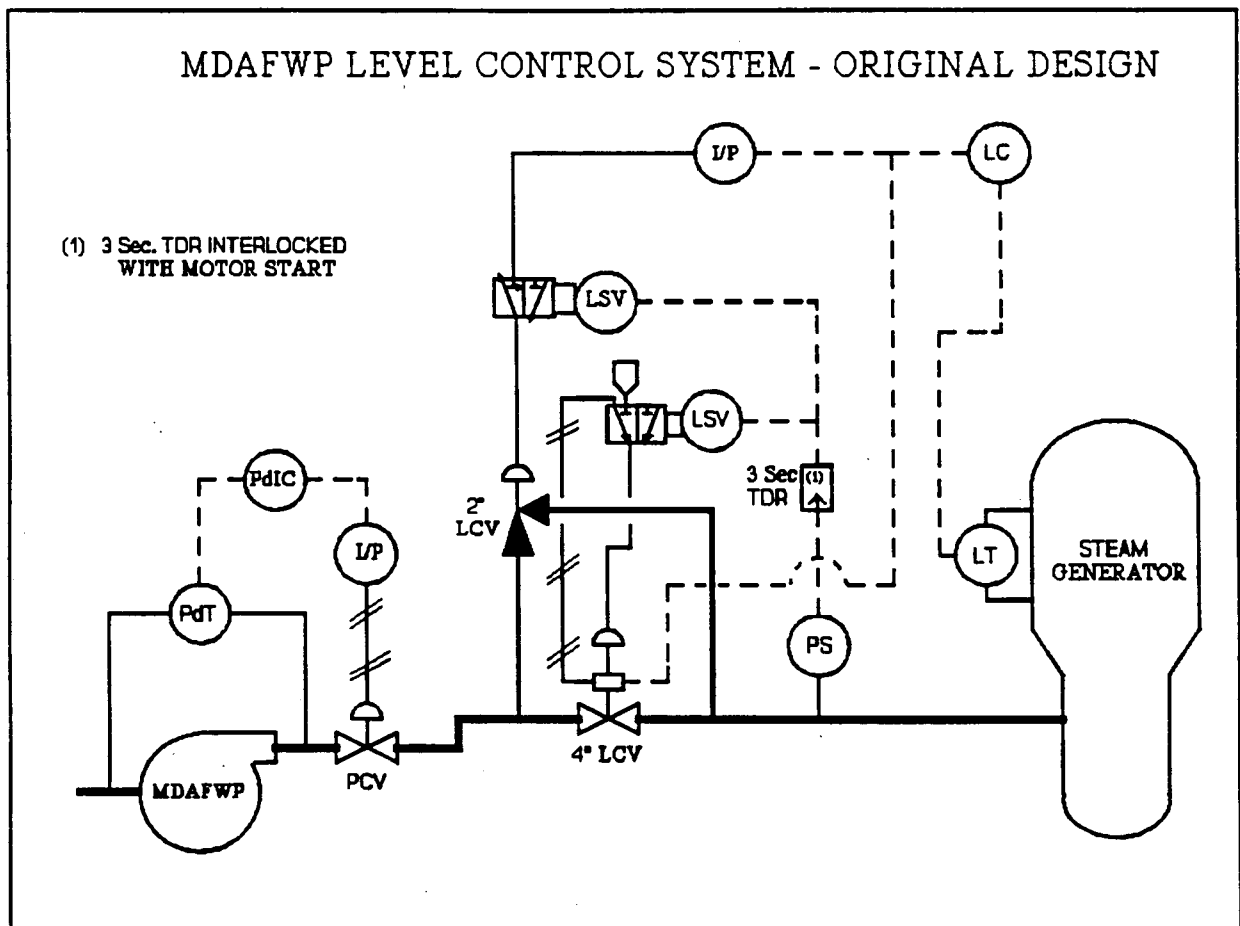
Figure 1

The control system for the Motor Driven Auxiliary Feedwater Pumps (MDAFWPs) consists of two basic subsystems; a backpressure control system to prevent pump run out and a steam generator level control system. During HFT, the controls exhibited unsatisfactory and occasionally unstable response. This was particularly evident during testing at low to moderate steam generator pressures. The level control system consists of a 4" Level Control Valve (LCV) for use when high flow rates are required and a 2" bypass LCV for use when low flow rates are required. The sequencing of these valves is controlled by a downstream pressure switch and a time delay relay. The discharge pressure control valve (PCV) and associated controls are to prevent pump run out.

The trouble shooting of the control system by the licensee identified the following problems:

2. The 4" LCV would not close when high differential pressure (approximately 1500 lbs) existed across the valve. The resolution of this issue is still pending.
3. The interaction of the pressure switch, TDR and the LCV's resulted in slow response time for the MDAFWPs. This longer time for the MDAFWPs to deliver design flow rates exceeded maximum times specified in the design output documents.

The licensee is implementing a design change that splits the range of the 2" and 4" LCVs. The design modification will change the sequencing logic, reduce the pressure switch set point to sense a faulted steam

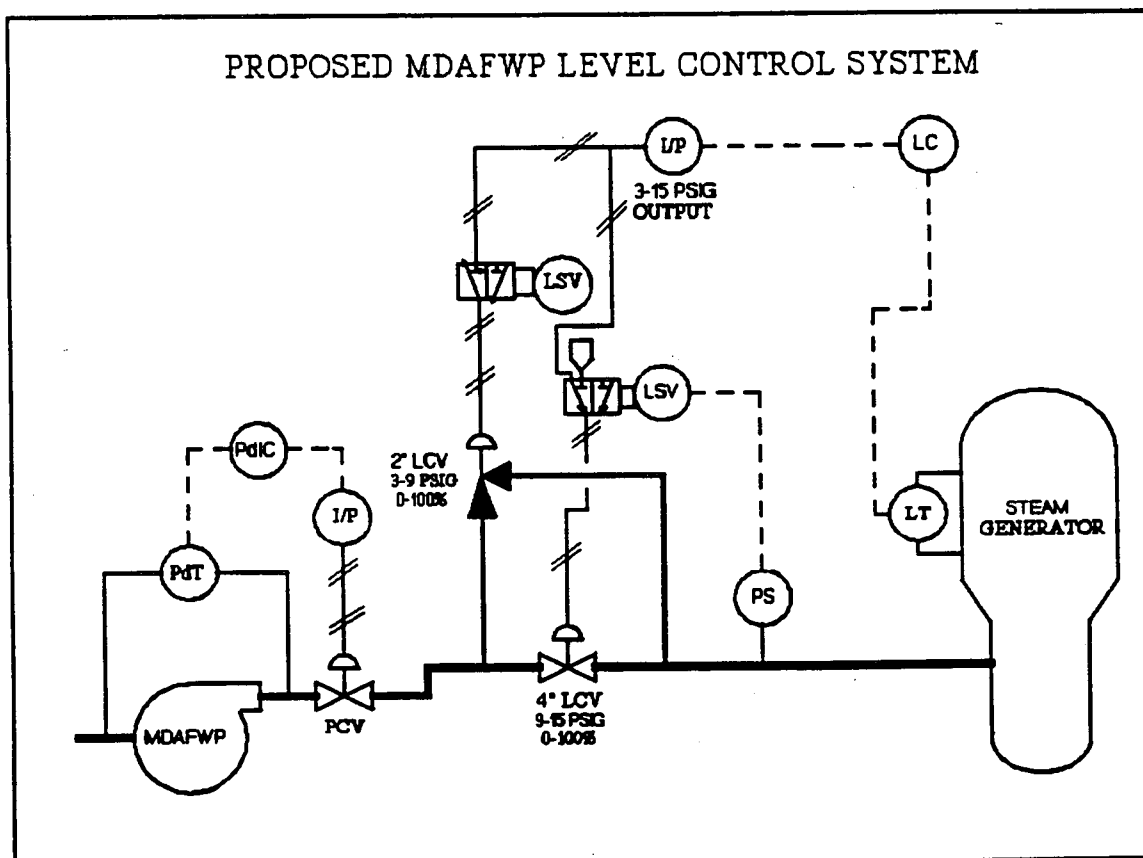
Figure 2

Since The 2" and 4" valves alternate opening in response to the downstream sensed pressure switch, and the action of the valves along with PCV interaction causes sensed pressure to change, this may be indicative of a inadequate review of the design for this system.

generator and provide an isolation signal to the LCV. The new modification will only opens the 2" valve at low SG pressures, and as pressure increases the 4" valve opens.
