**From:** "Dotson, Barbara E." <bdotson@entergy.com>  
**To:** "Mahesh Chawla" <MLC@nrc.gov>  
**Date:** 09/21/2007 12:33:33 PM  
**Subject:** FW: Steam Generator Tube Inspection Discussion During Upcoming Palisades Outage

The Palisades' responses to the NRR request for Steam Generator Tube Inspection Discussion During Upcoming Palisades Outage are attached.

## **STEAM GENERATOR TUBE INSPECTION DISCUSSION DURING UPCOMING PALISADES OUTAGE**

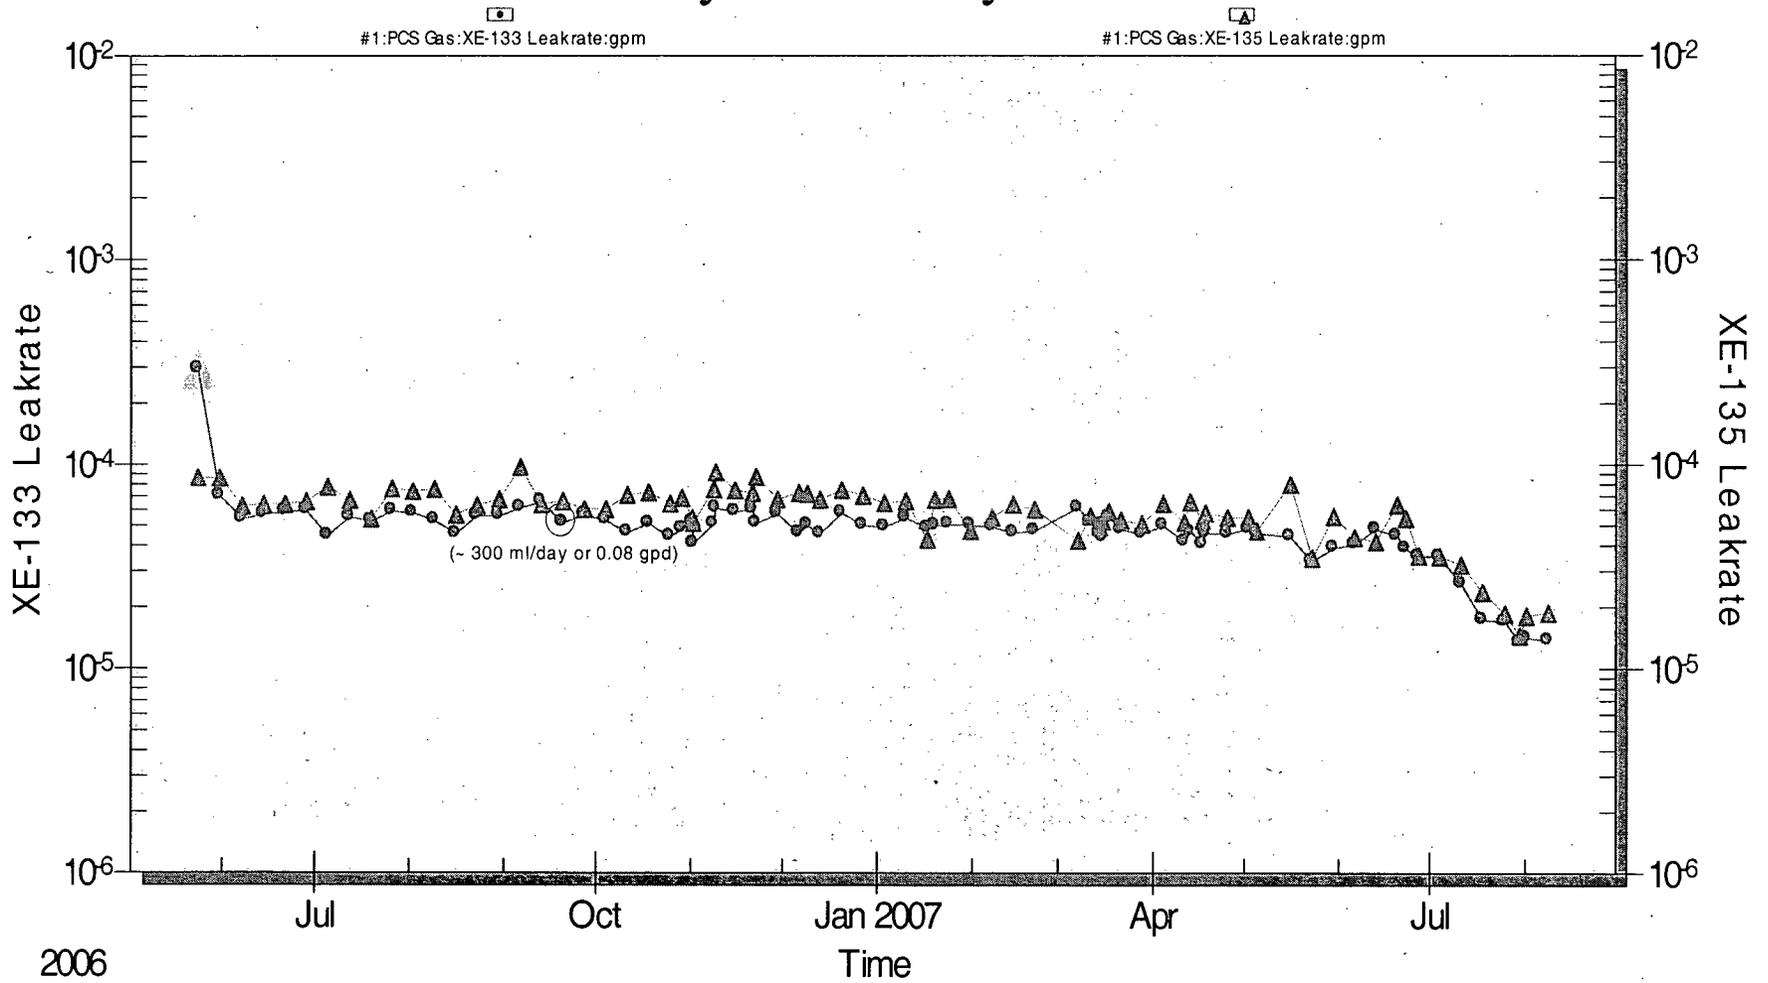
# Primary to Secondary Leakrate

1. Discuss any trends in the amount of primary-to-secondary leakage observed during the recently completed cycle.

Refer to attached Primary to Secondary Leak Rate for Operational Cycle 19 Primary to Secondary Leak Rate graph.
