Subject 2007 Annual Site Inspection and Monitoring Compliance Report for UMTRCA Title II  
Disposal Sites

# **2007 Annual Site Inspection and Monitoring Report for Uranium Mill Tailings Radiation Control Act Title II Disposal Sites**

**November 2007**

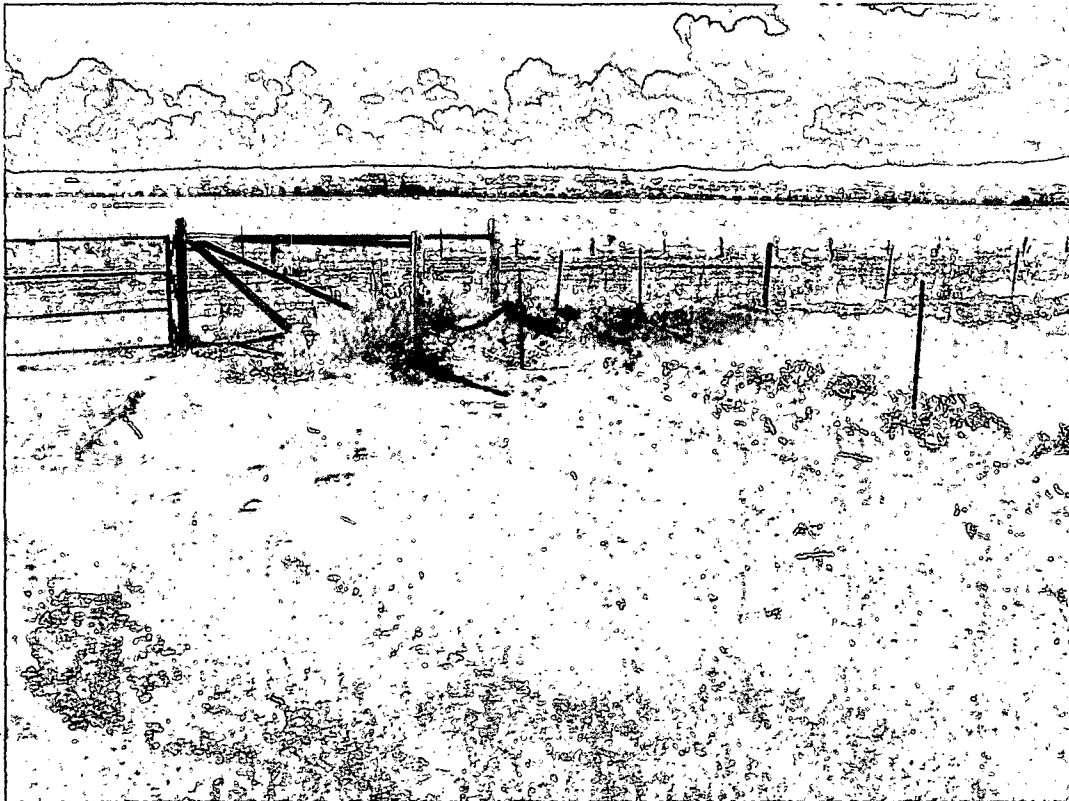
BLU 8/2007. PL-1. Windblown sand removed from the west fence near boundary monument BM-21 to the site entrance.

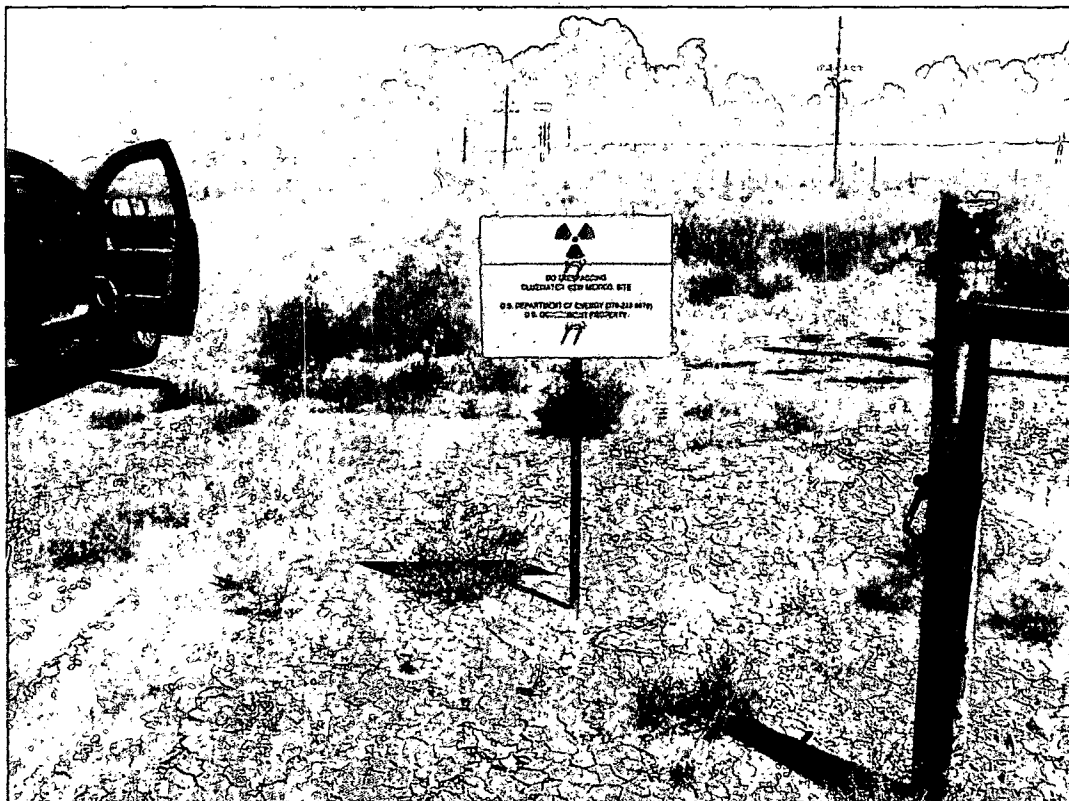
BLU 8/2007. PL-2. New perimeter sign P1 located inside the entrance gate.

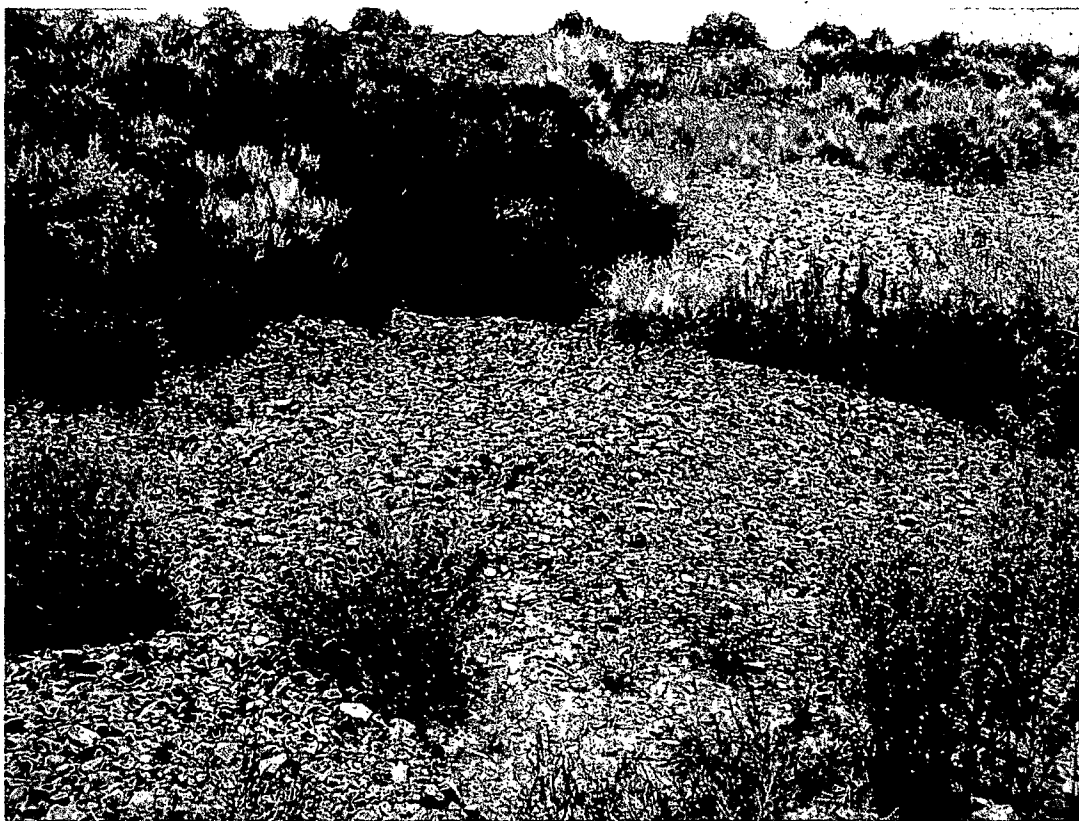
*BLU 8/2007. PL-7. Repaired depression in the asbestos disposal cell cover.*

1C inspection but had not been a concern because it does not encroach on asbestos-containing materials. However, to mitigate the potential for encroachment into these materials, the depression was filled with crushed basalt rock during spring 2007. No additional settling had occurred since the repair was completed (PL-7). The asbestos disposal area is in excellent condition.

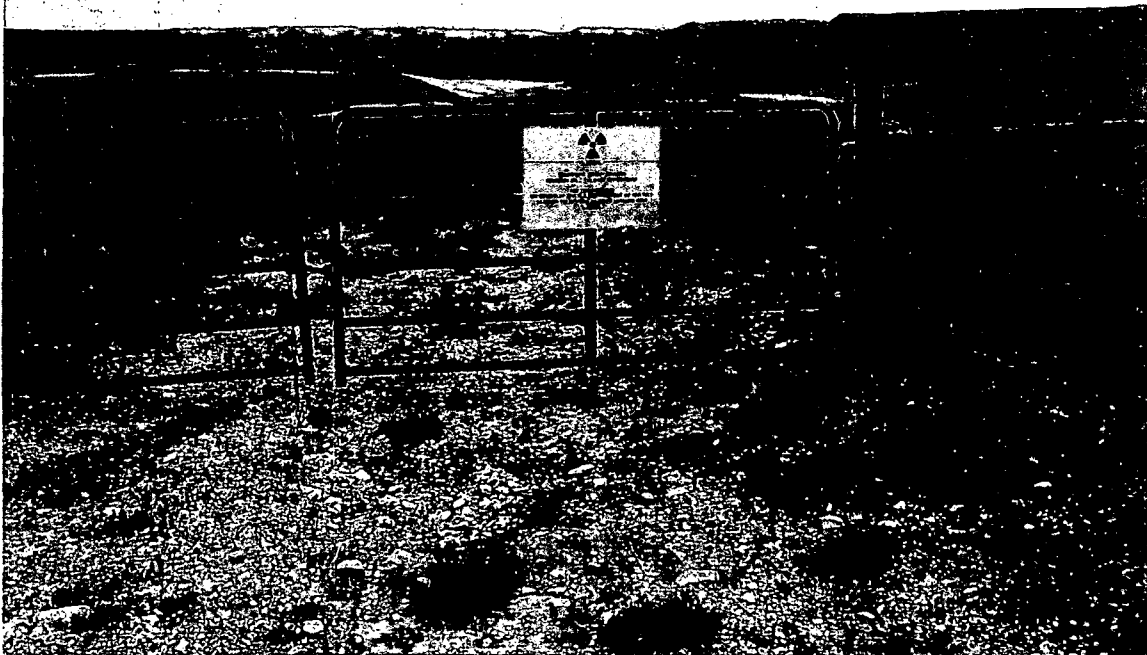
*EDG 6/2007. PL-1. Entrance sign relocated to the entrance gate.*

2A The entrance sign was the only warning/no trespassing sign installed at the site. At the time of the inspection, the signpost was broken and laying on the ground; the damage likely was caused by cattle. The sign was relocated to the entrance gate (PL-1), and will be moved to a new post inside the gate in 2008.

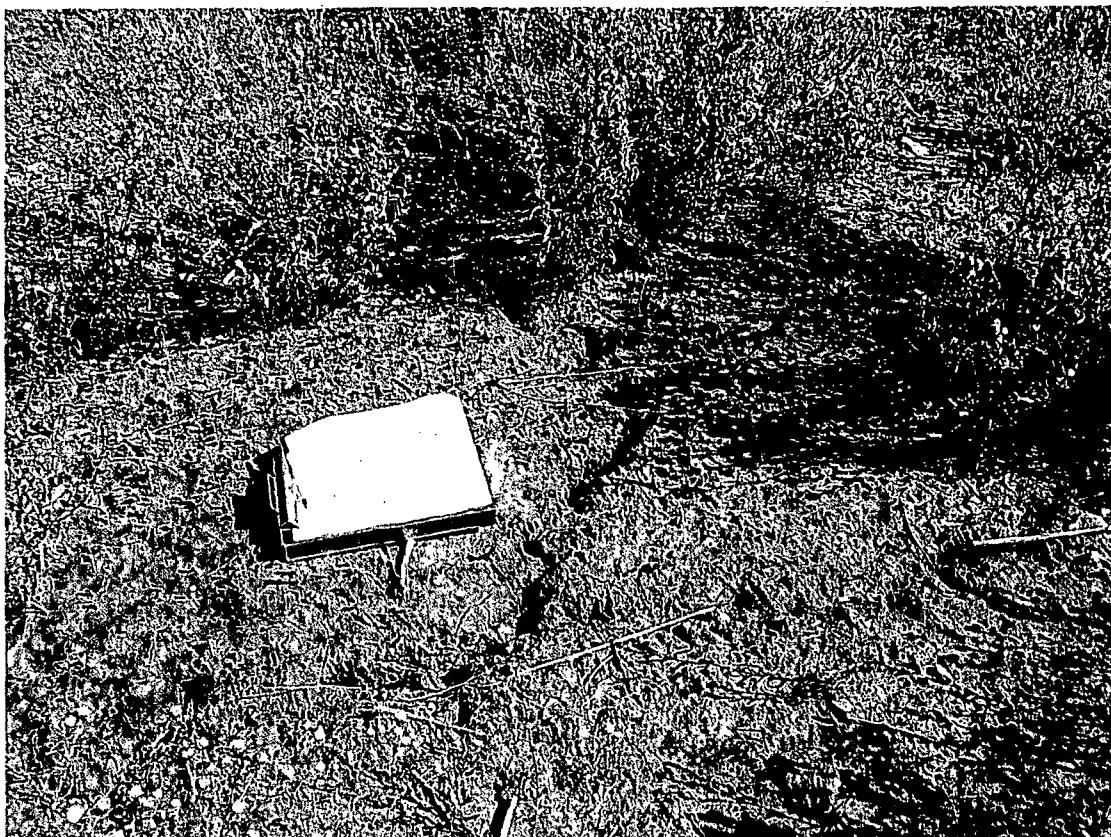
*BAR 8/2007. PL-5. Cracks in the tailings impoundment cover soil near erosion monitoring point C2.*

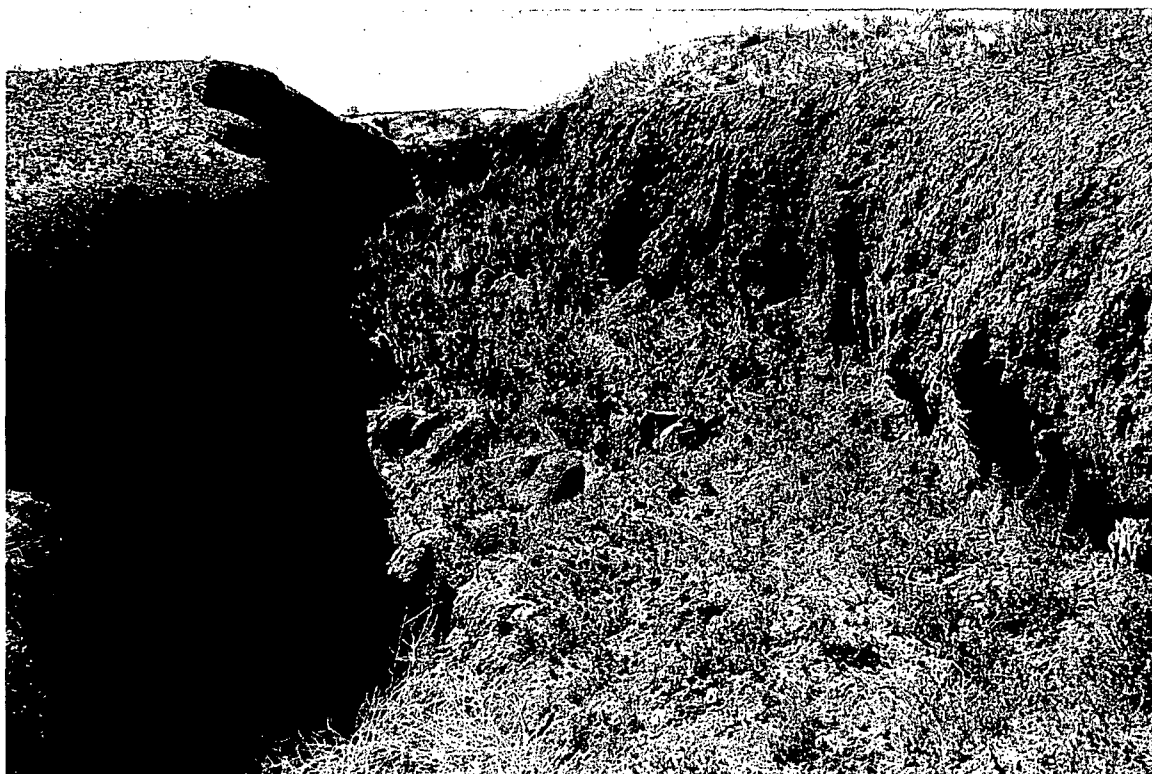
*BAR 8/2007. PL-6. Gully upgradient of the sediment trap.*

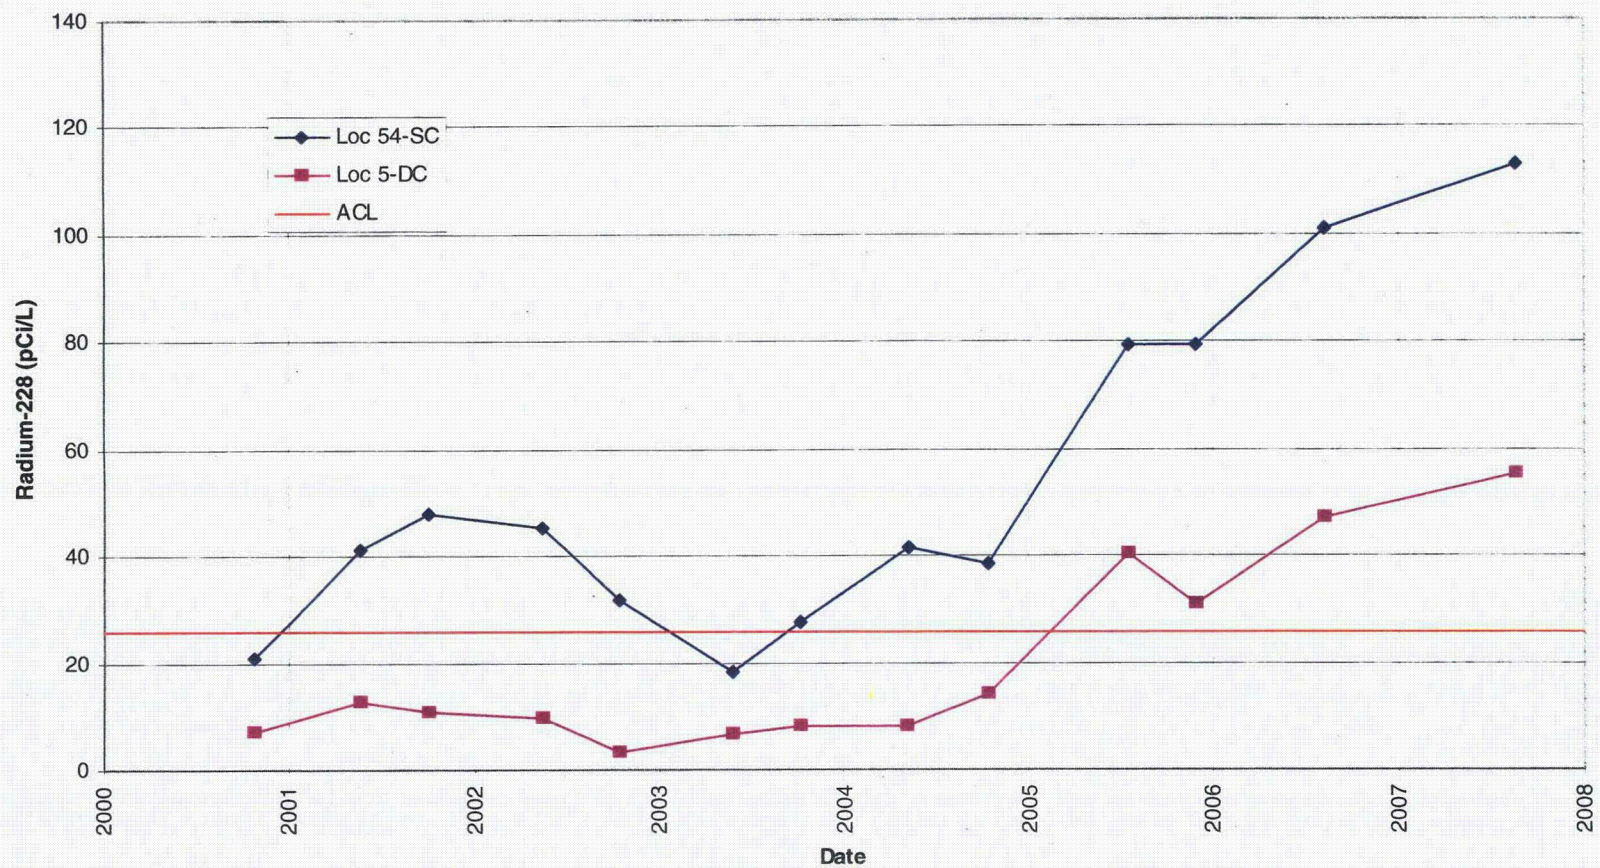
Figure 5-3. Radium-228 Concentrations in Wells MW-5-DC and MW-54-SC Since Completion of the Disposal Cell

The cause for the upward trend for radium-228 has not been determined. An upward trend has occurred for nickel in MW-54-SC since 1996, and TDS has increased in both MW-5-DC and MW-54-SC since measurements were initiated in 2004. However, the concentrations for the other constituents in these wells are remaining steady or are decreasing.

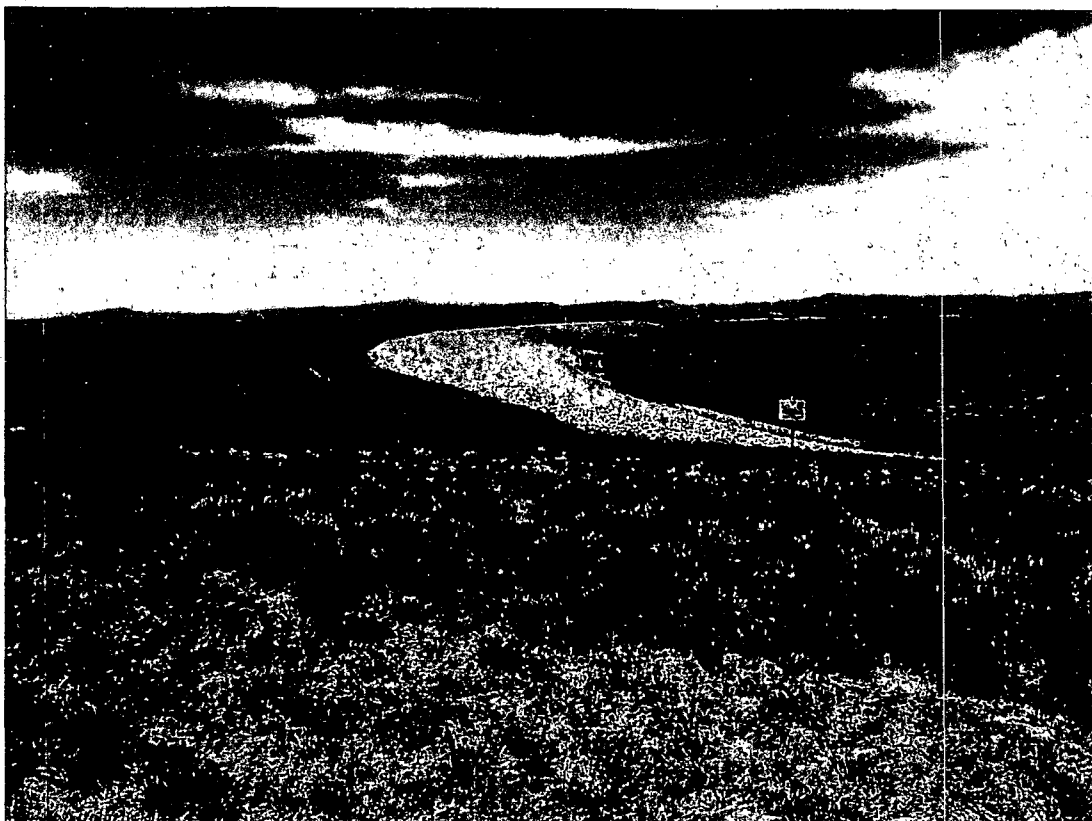
**Cover of the Tailings Impoundment**—The tailings impoundment, completed in 2000, is approximately 142 acres and has a grass cover. The cell surface is constructed at two elevations separated by a riprap-armored slope. The slope is in excellent condition (PL-5). The eastern

*SBS 6/2007. PL-5. The rock-armored slope separating the upper and lower surfaces of the disposal cell.*
