CNETRAL FILES 50-391

WATTS BAR NUCLEAR PLANT UNIT 2 - REPORTABLE DEFICIENCY - BROADLINE CORPORATION POLAR CRANE ASSEMBLY - REJECTABLE WELDS (NCR 938R)

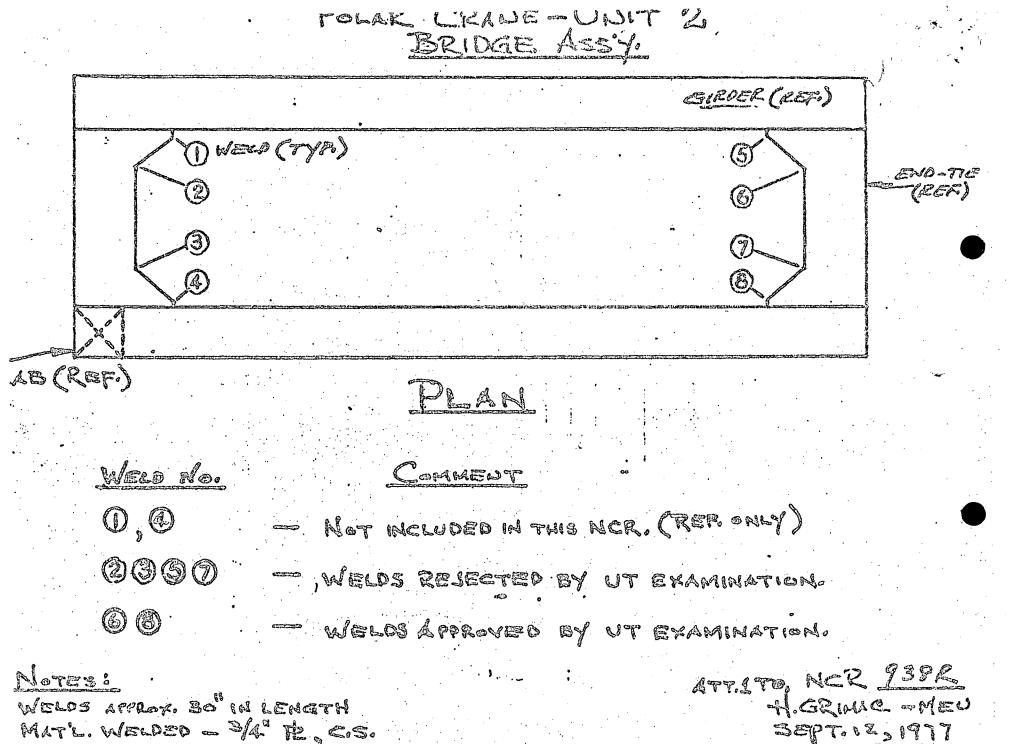
During the assembly of unit 2 polar crane bridge, the bolt holes for one of the two end ties would not line up. Site employees contacted the Division of Engineering Design (EN DES) and it was decided to cut out welds Nos. 1 and 4 (see enclosed sketch), align the members with bolt holes, and reweld.

When these welds were cut out, slag inclusions and lack of fusion were discovered. EN DES was again contacted, and the remaining welds were examined using UT. Four of the six were rejectable, and NCR 938R was issued. Documentation of repair for welds Nos. 1 and 4 was made on NCR 947R. The crane bridge was assembled, and the two welds which had been cut out were rewelded, MT examined, and found acceptable. The bridge with the 600-ton construction hoist was tested successfully and used to install unit 2 major components.
