WATTS BAR NUCLEAR PLANT UNITS 1 AND (2) - REPORTABLE DEFICIENCY -
UNEXPECTED SOIL CONDITIONS ENCOUNTERED DURING EXCAVATION OF
INTAKE CHANNEL

WATTS BAR NUCLEAR PLANT UNITS 1 AND 2

REPORTABLE DEFICIENCY UNEXPECTED CONDITIONS ENCOUNTERED DURING EXCAVATION OF THE INTAKE CHANNEL FINAL REPORT

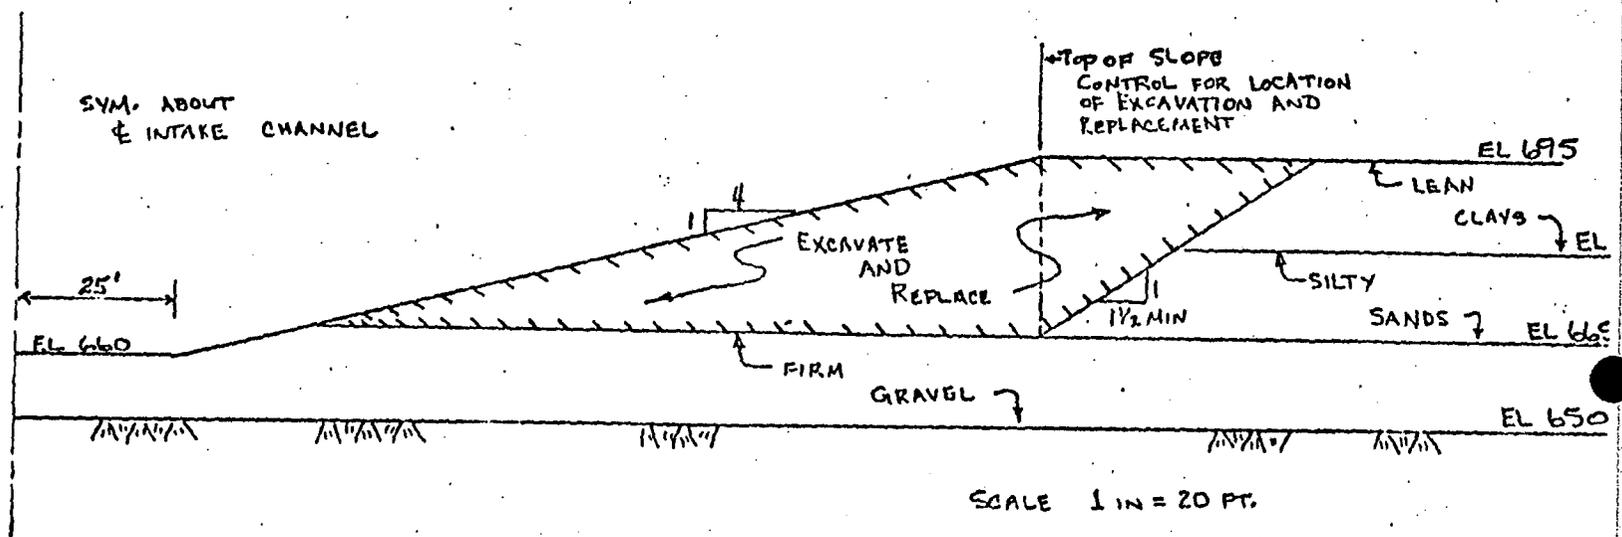
FIGURE 1 Intake Channel - Lateral Excavation and Replacement
 Typical cross-section based on original soils exploration

The original soils exploration program in the intake channel area defined the general soil profile as a 15-foot layer of lean clay material from elevation 695 to 680, a 15-foot layer of silty sand from elevation 680 to 665, and a 15-foot layer of firm basal gravel from elevation 665 to 650 (top of rock). The layer of silty sand was judged to have a potential for liquefaction during a seismic event, and therefore the design of the intake channel involved removal of this material down to top of firm gravel (elevation 665). A typical cross section of the intake channel with the profile discussed above is shown in figure 1.

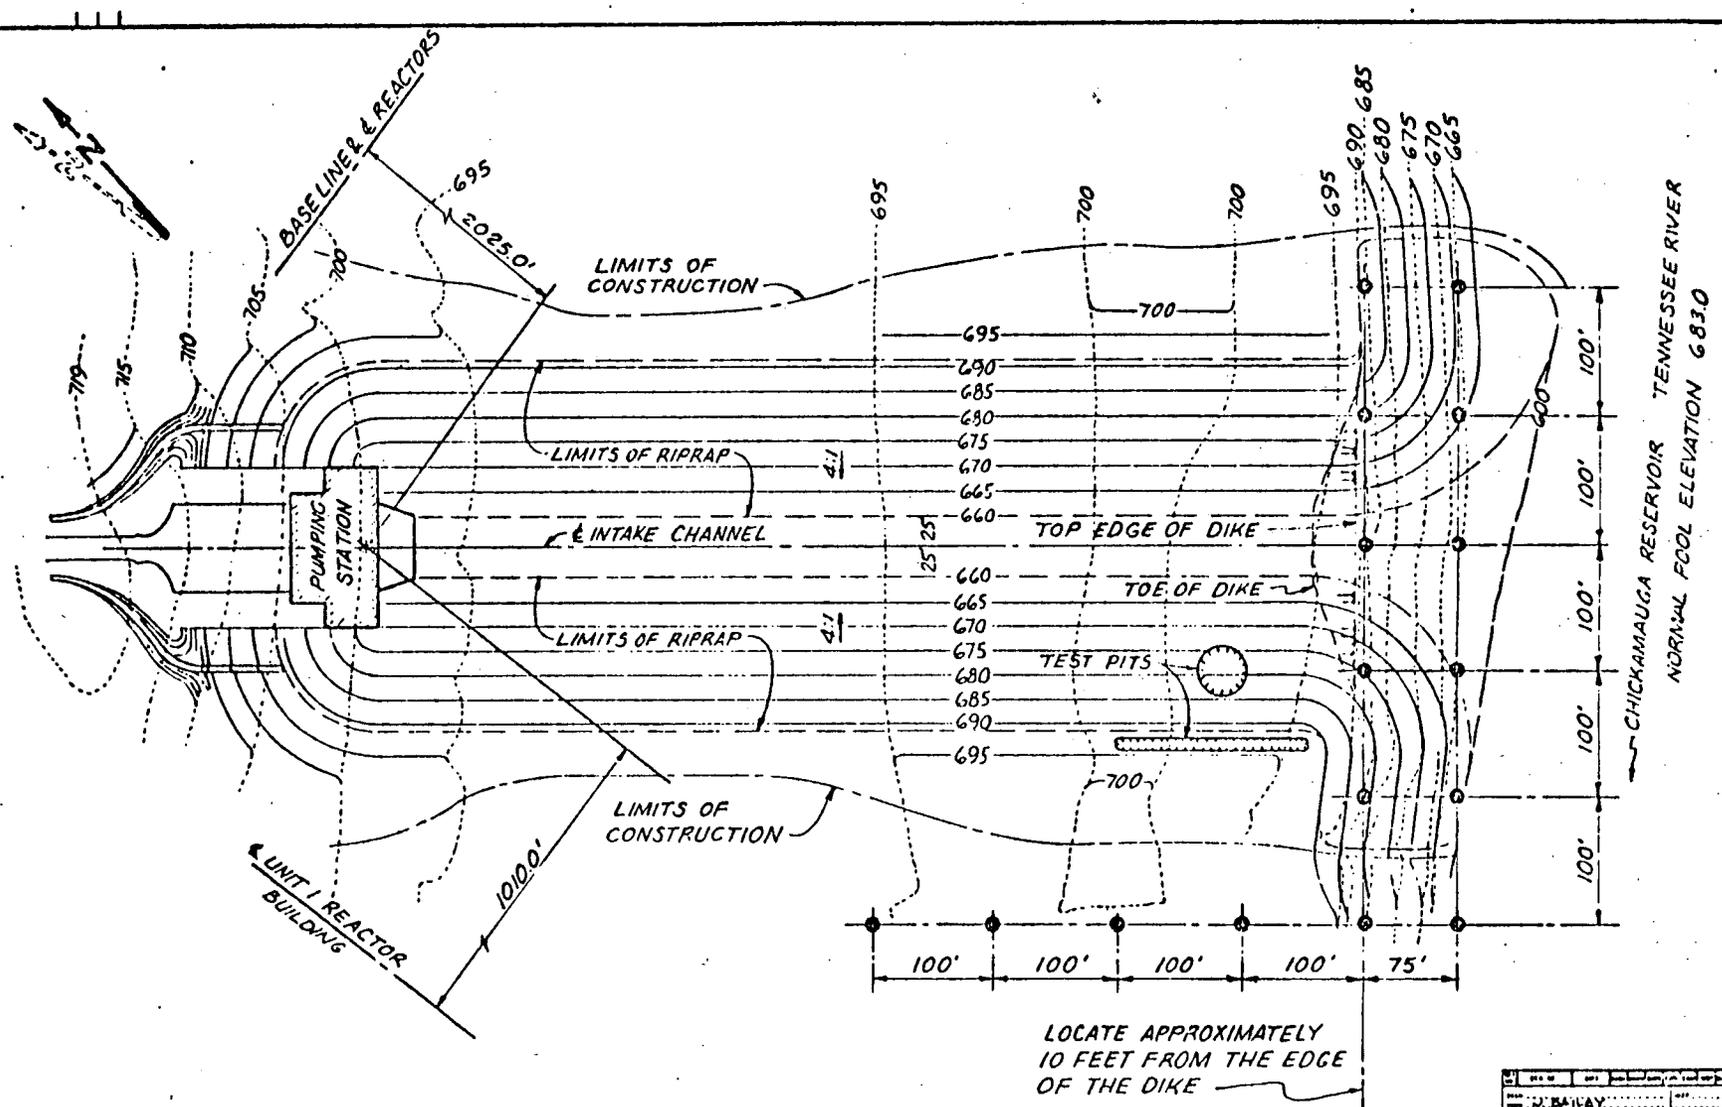
FIGURE 2
Additional Soils Exploration Program

Accordingly, a program of additional soils borings was formulated to determine the lateral and vertical extent of the sand and clay layers and to better define top of rock. Figure 2 is a plan view of the channel which shows the locations of the additional soils borings. The exploration program determined that the lowest bedrock elevation occurred near the mouth of the channel at elevation 650. In addition, a program of cyclic testing of the sandy material and static testing of the clay material, under R conditions in both cases, was instituted. The results of the exploration and testing program were evaluated to determine the need for additional analysis. These results indicated a probable liquefaction of the sand layer during a seismic event. In addition, the strength properties of the clay layer were too low to stabilize overlying slopes. Additional analyses have been made to determine new limits of excavation to top of rock for the downstream side of the channel extending from the reservoir to approximately halfway to the pumping station.
