WATTS BAR NUCLEAR PLANT UNITS 1 AND (2) - REPORTABLE DEFICIENCY -
UNEXPECTED SOIL CONDITIONS ENCOUNTERED DURING EXCAVATION OF
INTAKE CHANNEL

WATTS BAR NUCLEAR PLANT UNITS 1 AND 2

REPORTABLE DEFICIENCY

FINAL REPORT

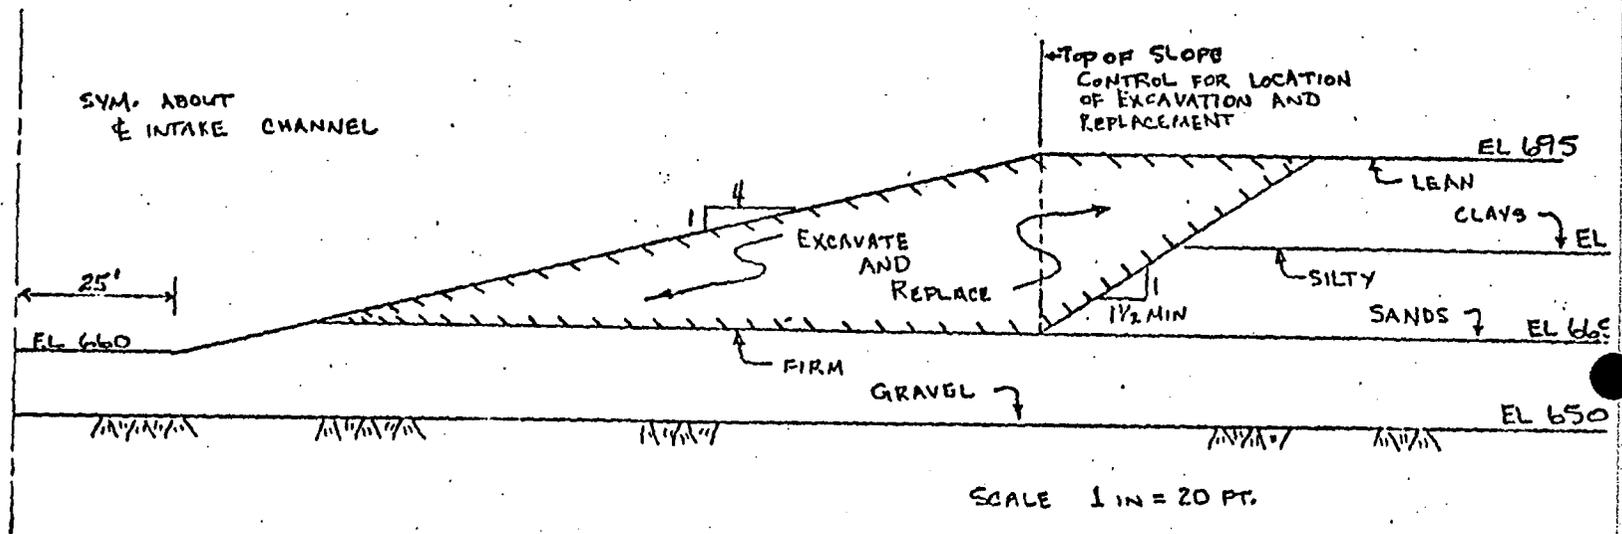
The original soils exploration program in the intake channel area defined the general soil profile as a 15-foot layer of lean clay material from elevation 695 to 680, a 15-foot layer of silty sand from elevation 680 to 665, and a 15-foot layer of firm basal gravel from elevation 665 to 650 (top of rock). The layer of silty sand was judged to have a potential for liquefaction during a seismic event, and therefore the design of the intake channel involved removal of this material down to top of firm gravel (elevation 665). A typical cross section of the intake channel with the profile discussed above is shown in figure 1.

FIGURE 1 Intake Channel - Lateral Excavation and Replacement
 Typical cross-section based on original soils exploration

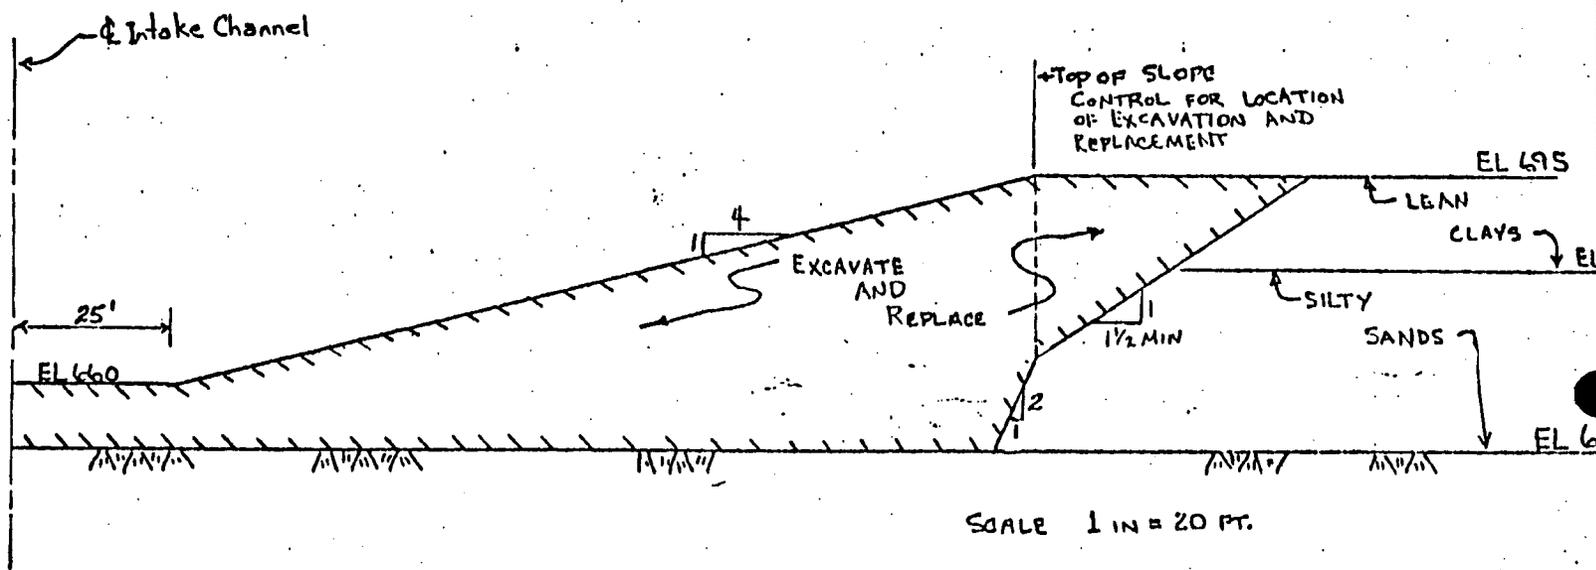
FIGURE 3

Intake Channel - Lateral Excavation and Replacement
 Downstream side of intake channel with bedrock at 656

For bedrock elevation from 660 to 656 the limits of excavation will be as shown in figure 3. The factor of safety for a wedge failure along a plane at 656 is 1.12. The slope is therefore stable against failure by sliding.

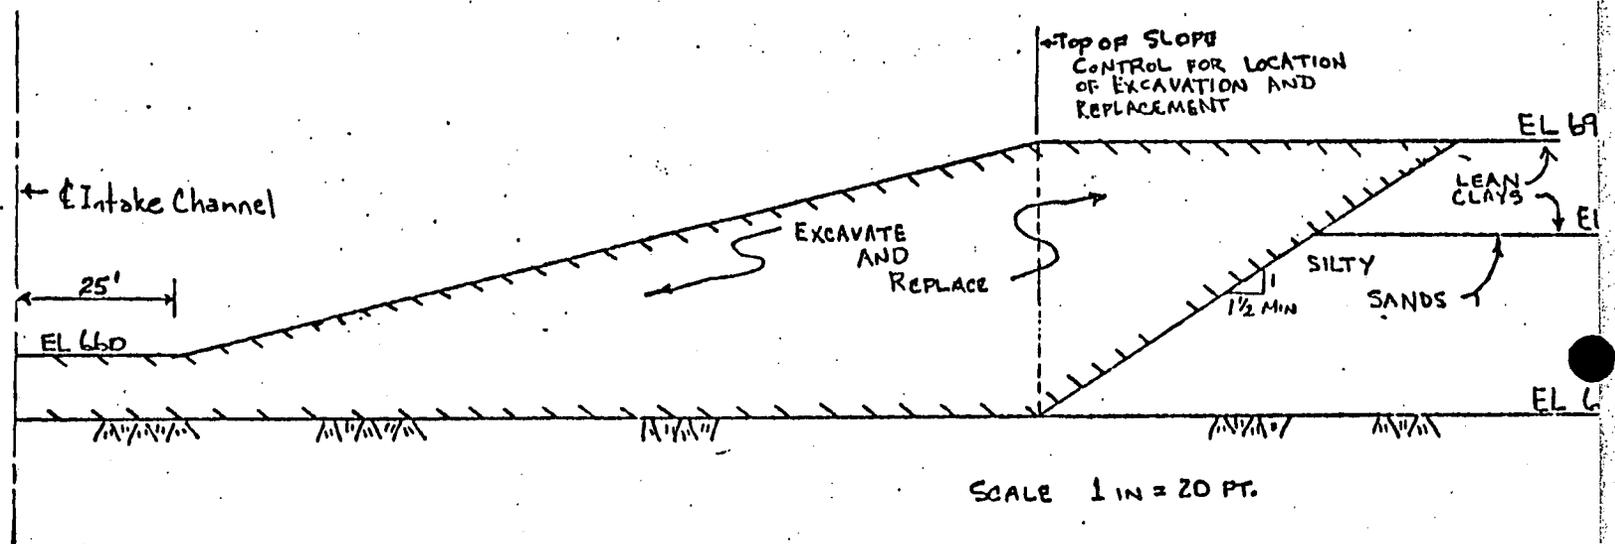
FIGURE 4 Intake Channel - Lateral Excavation and Replacement
Downstream side of intake channel with bedrock at 650

Figure 4 shows the limits of excavation for a section with a bedrock elevation of 650. The factor of safety for a wedge failure along a plane at elevation 650 is 1.0. This factor of safety is considered adequate since it was computed with the use of extremely conservative assumptions. As shown on figure 4, the factor of safety was computed assuming that the entire zone of sandy material extending from elevation 680 to 650 liquefies completely during a seismic event. This is a very conservative assumption. Furthermore, the assumption has been made that no shear strength exists along the failure plane where it passes through the sandy zone; again, this is a very conservative assumption. Even a small amount of shear strength in the liquefiable zone along the failure plane would make the safety factor greater than 1.0.

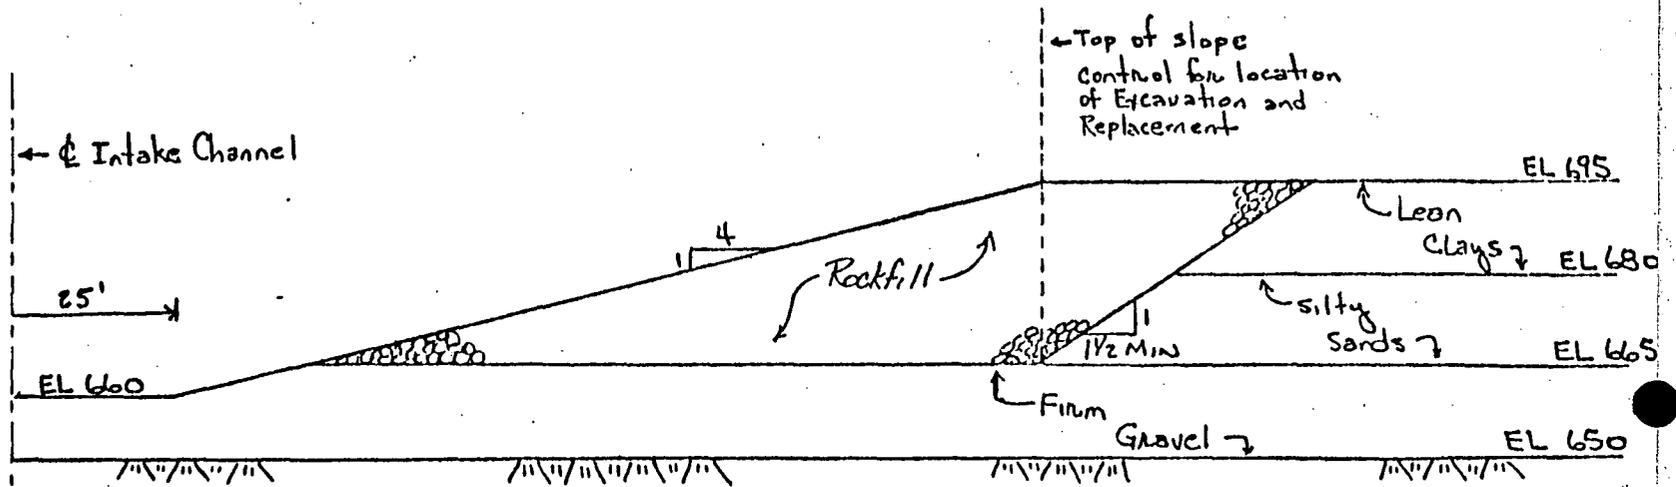
FIGURE 5 Intake Channel - Lateral Excavation and Replacement
 Upstream reservoir end with rockfill placed at 665

Figure 5 shows a typical cross section of the rockfill slopes on the upstream side of the channel. The factor of safety against sliding along a plane at elevation 665 is 1.5.

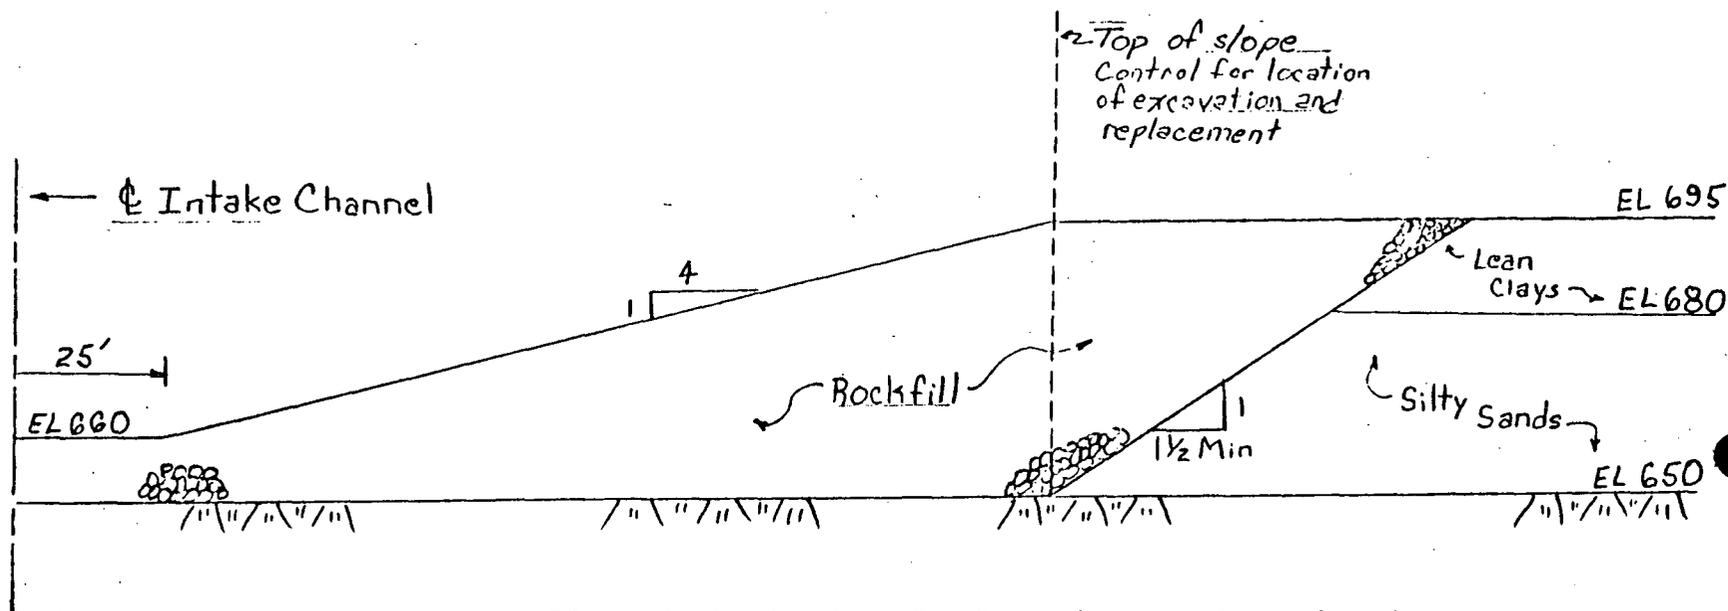
FIGURE 6 Intake Channel - Lateral excavation and replacement
 downstream reservoir end with rockfill placed at EL 650

The downstream side of the channel with rockfill placed on a bedrock elevation of 650 is shown in figure 6. The factor of safety for a wedge failure at 650 is 1.30, and the slope is therefore stable.
