David Hills - Fwd: Additional Document for Davis-Besse Call

Please find attached one additional section from the Exponent report regarding the wastage of nozzle 3 of the Davis-Besse head that may be helpful to review in advance of tomorrow's call.

10. The Unique Nature of the Davis-Besse Nozzle 3 Crack and the RPV Head Wastage Cavity

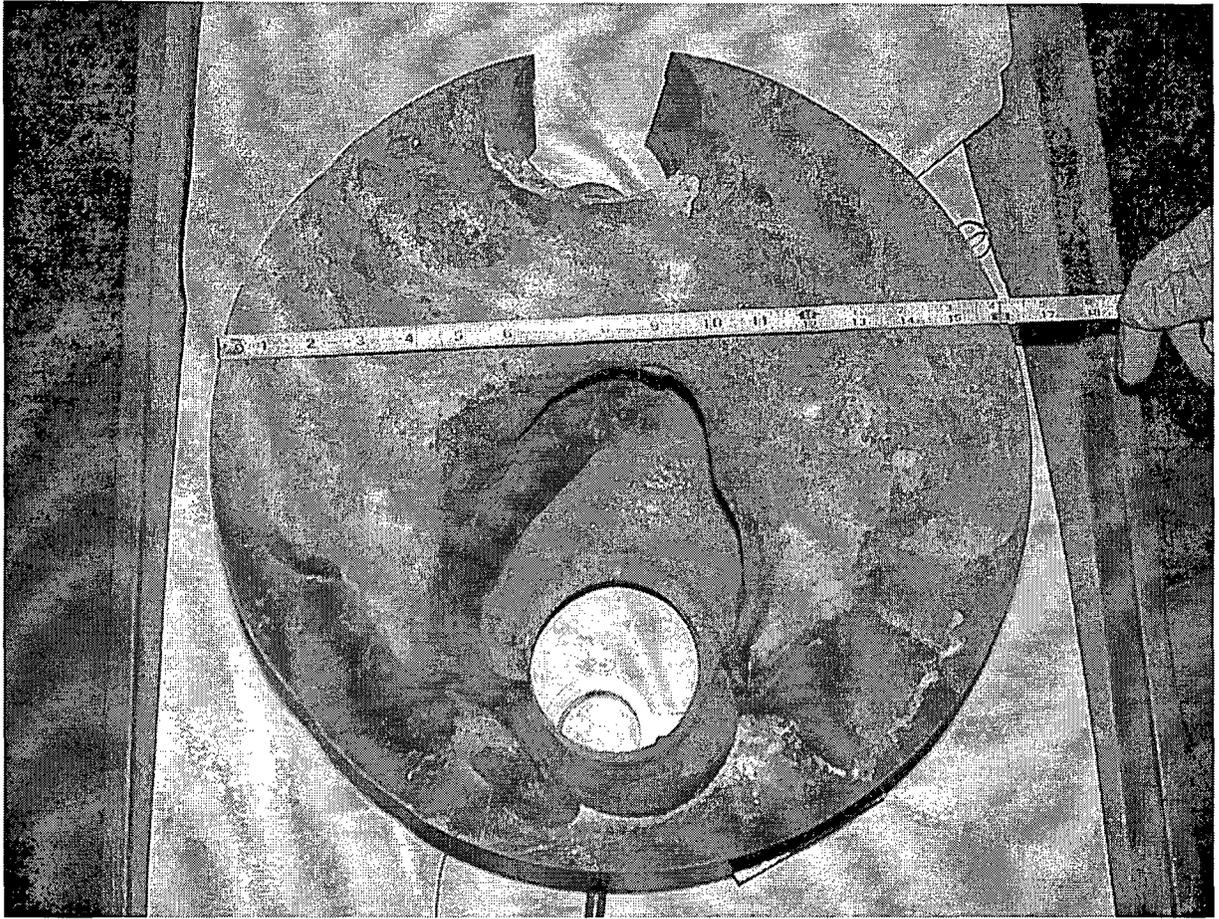
- The cavity extends down to the upper surface of the stainless steel cladding, exposing both the cladding and the J-groove weld.
- The cavity extends approximately 8 inches towards nozzle 11, is a maximum of approximately 4 inches in lateral dimension, and extends back to approximately the 90° and 270° points on the nozzle bore.
- The total volume of alloy steel removed was approximately 195 cubic inches.

Figure 10.1 Top view of wastage cavity.

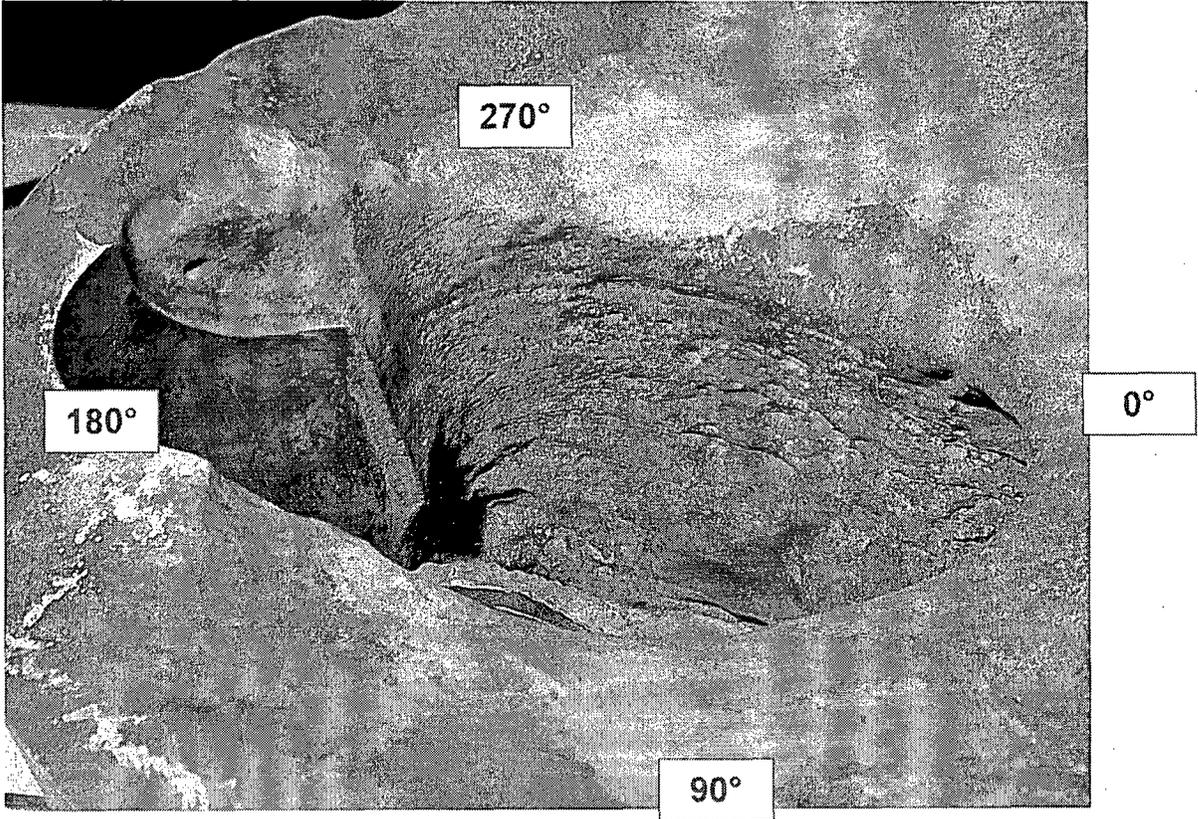
Figure 10.2 View of cavity looking toward 270°

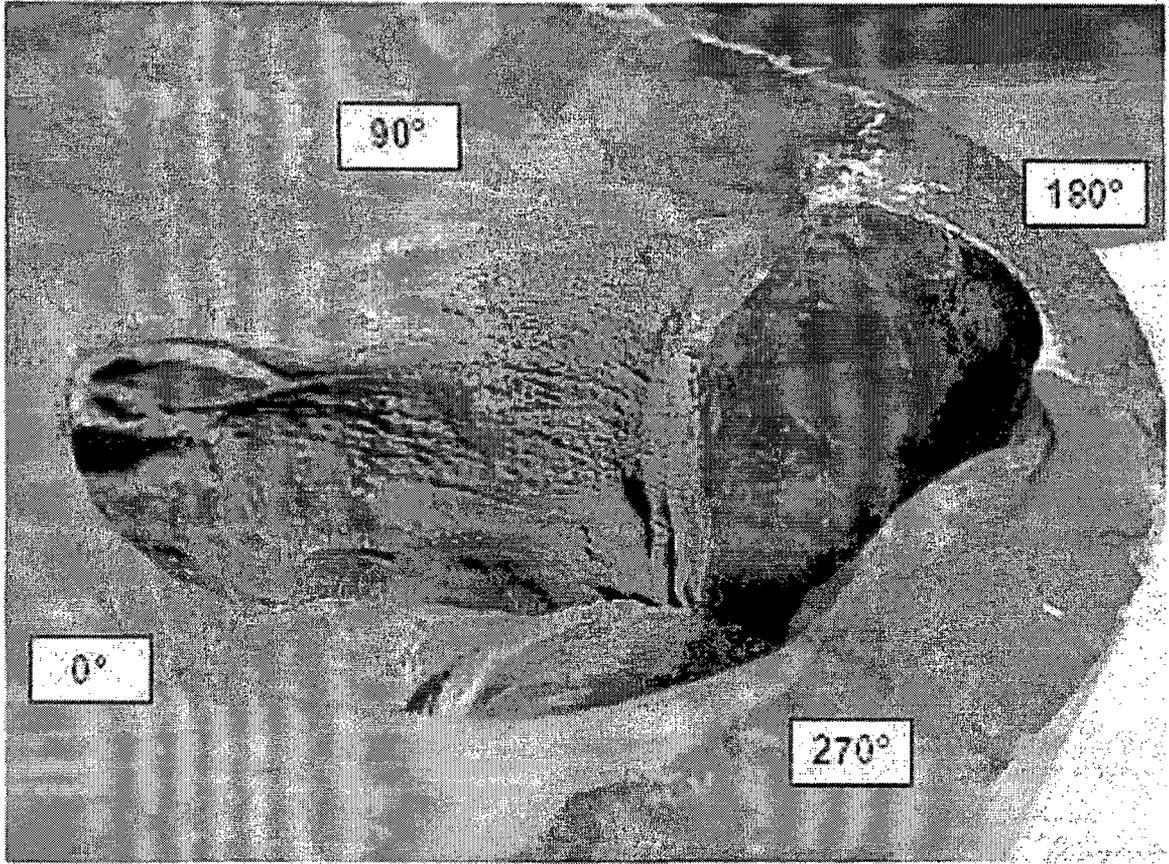
Figure 10.3 View of cavity looking toward 90°

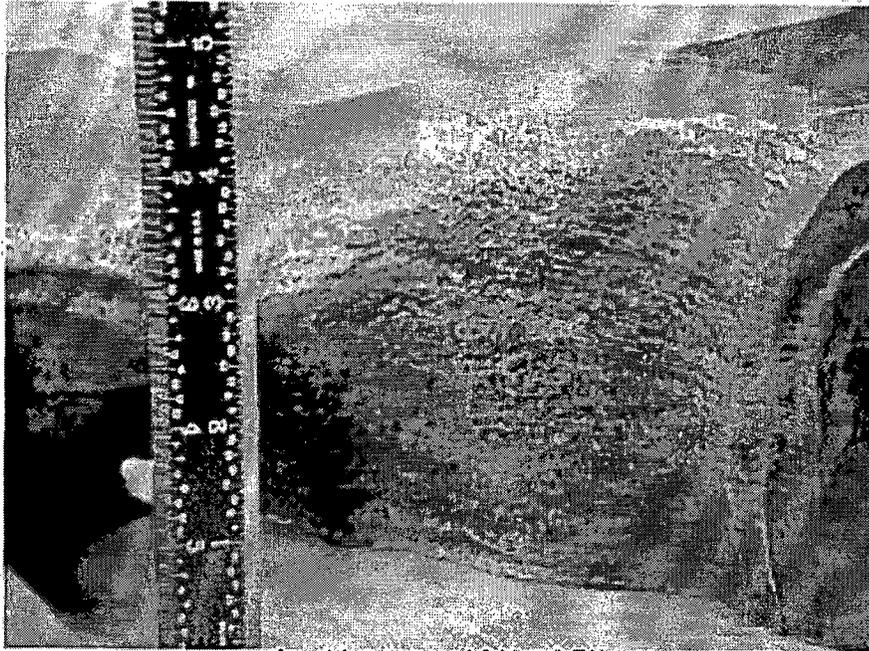
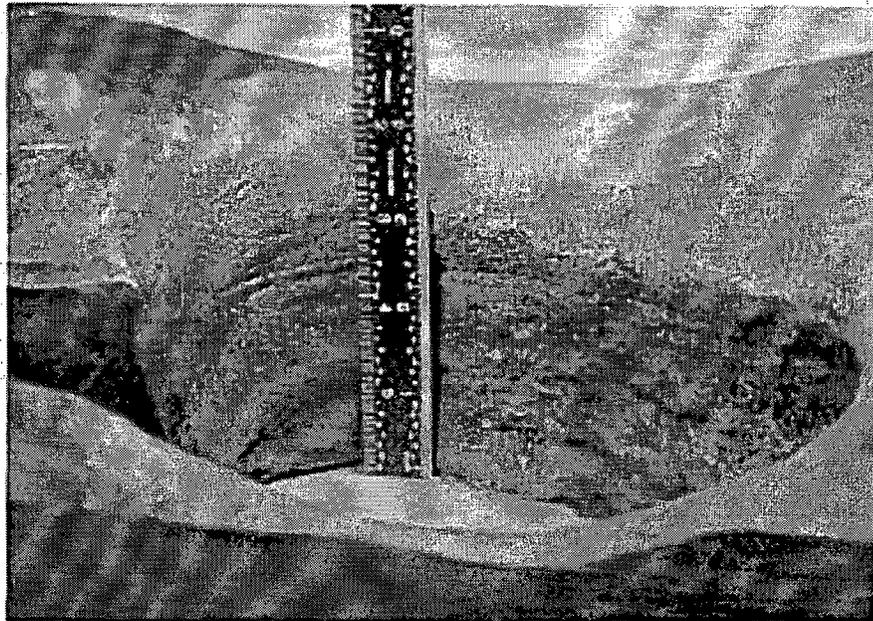
- General corrosion of the upper RPV head surface around the cavity is evident to a depth of 1 to 1.5 inches. This can be seen in the view of the top section of the cavity (Figure 10.4) and more clearly shown in the dental mold impressions (Figure 10.5).

Looking toward 90° ~0.7X

Looking toward 270° ~0.5X

Figure 10.4 Low magnification photographs of cavity sidewalls

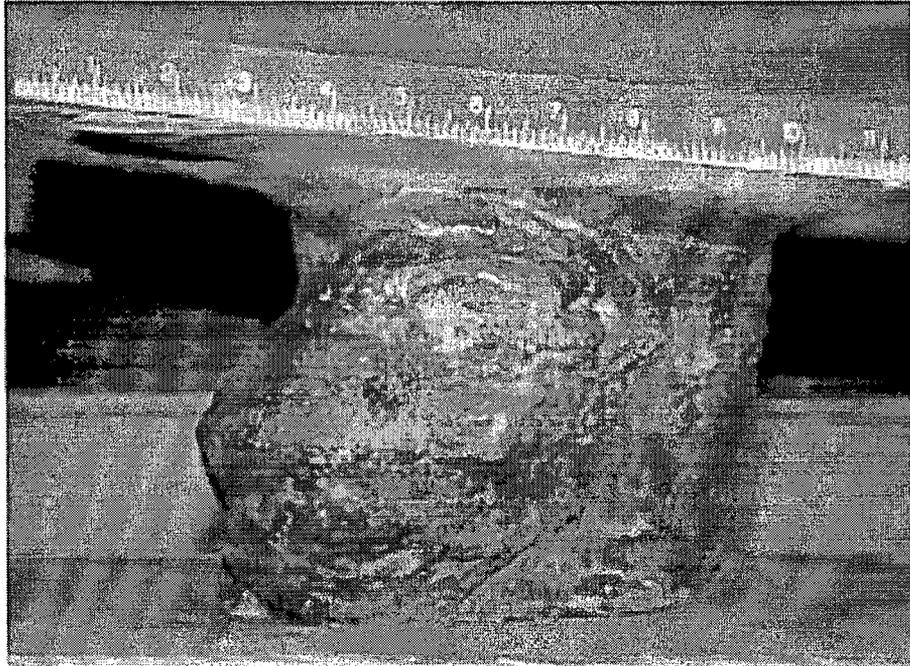
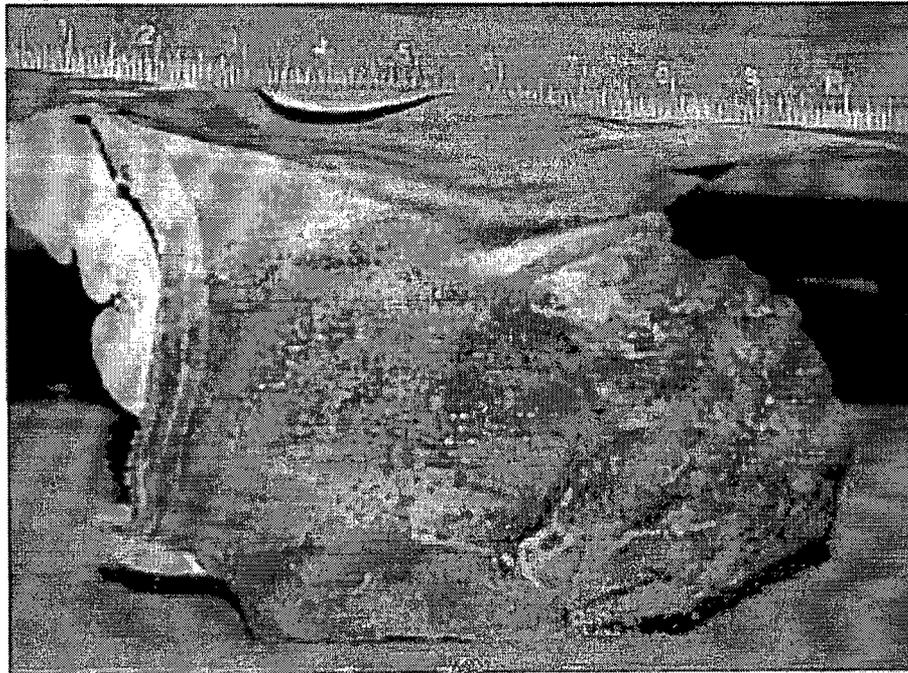
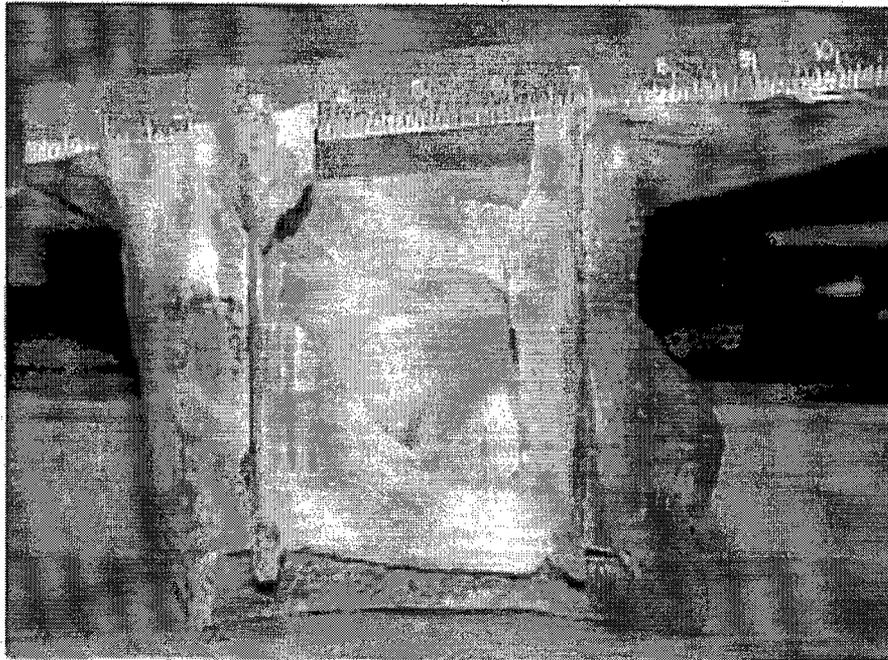
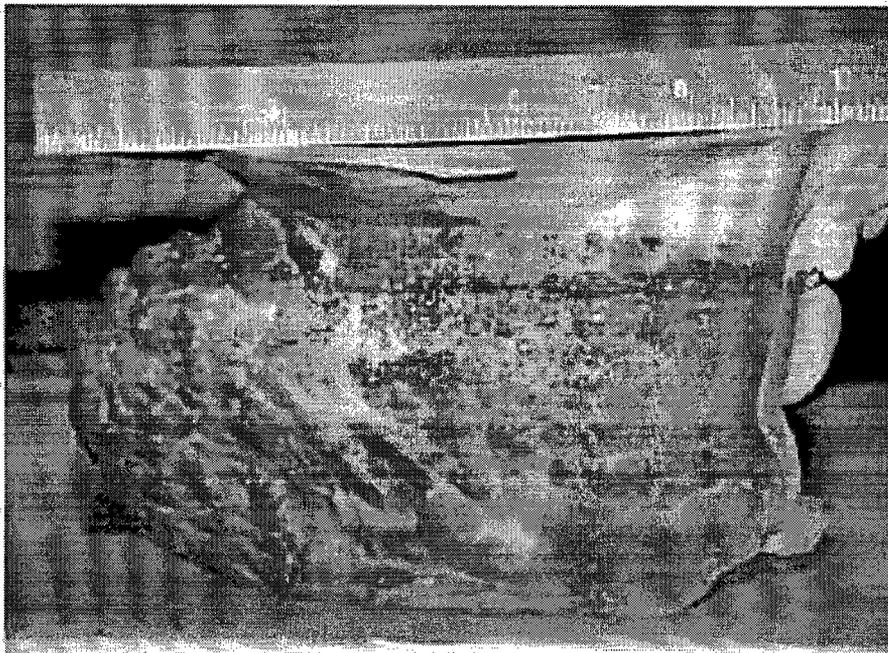
Figure 10.5(a) Photographs of cavity dental mold

Figure 10.5(b) Photographs of cavity dental mold

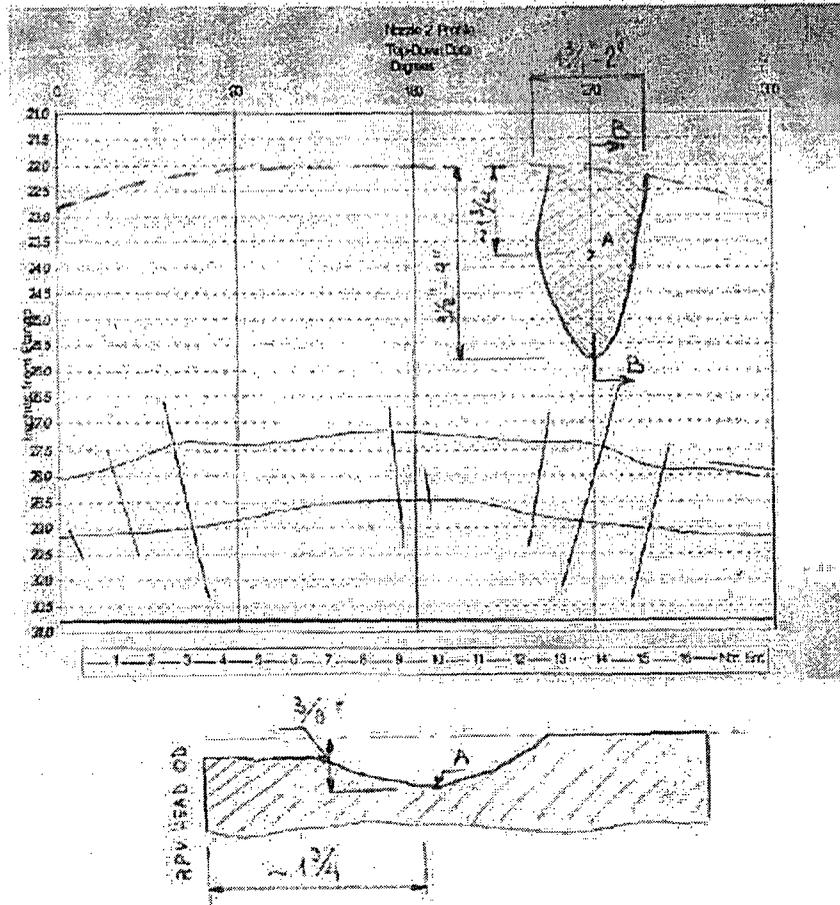
- The wastage cavity was located above three of the through wall axial cracks in Nozzle 2, in the upper half of the nozzle bore, centered on the 270° location.
- The wastage area was located 180° away from the two longest axial cracks in Nozzle 2, which were either side of the 90° location.

- Enlargement of the annulus clearance at the upper surface of the RPV head was observed at approximately the 90° location.
- None of the axial cracks extended up into the wastage cavity.
- The wastage area extended approximately 3 ½ to 4 inches down from the upper surface of the RPV head and was 50° (1 ¾ inches) in circumferential extent.
- The maximum penetration of the cavity into the RPV head was approximately 3/8 inch in the radial direction away from the nozzle OD, and this maximum point was approximately 1 ¾ inches below the upper surface of the RPV head. This indicates that whatever processes of mechanical removal, corrosion, or flow-assisted corrosion were active; the cavity was growing at its maximum rate sub-surface.

Figure 10-6 Wastage Cavity at CRDM Nozzle 2

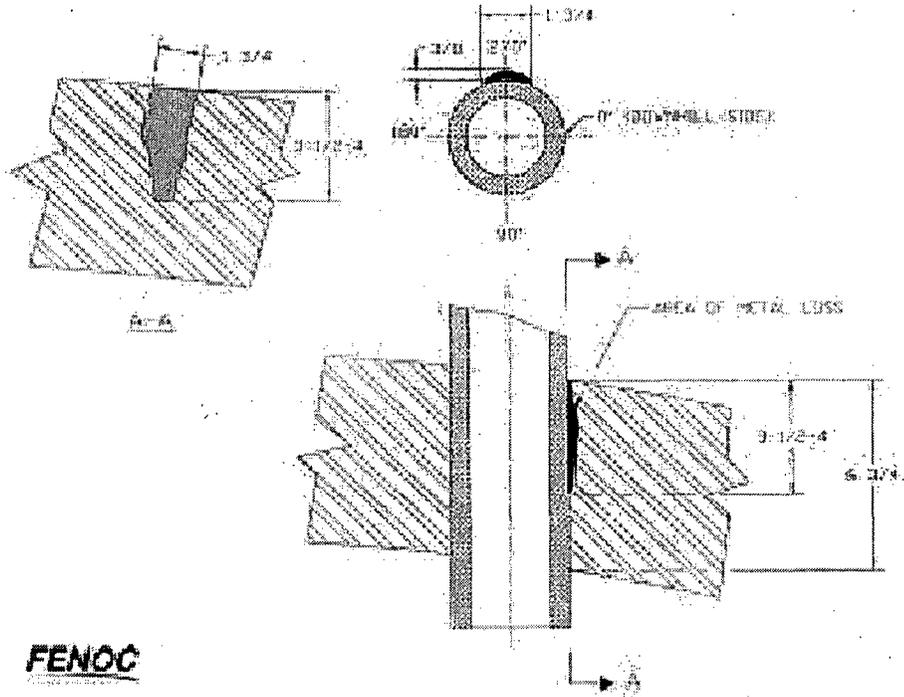
Figure 10-7 Wastage Cavity at CRDM Nozzle 2

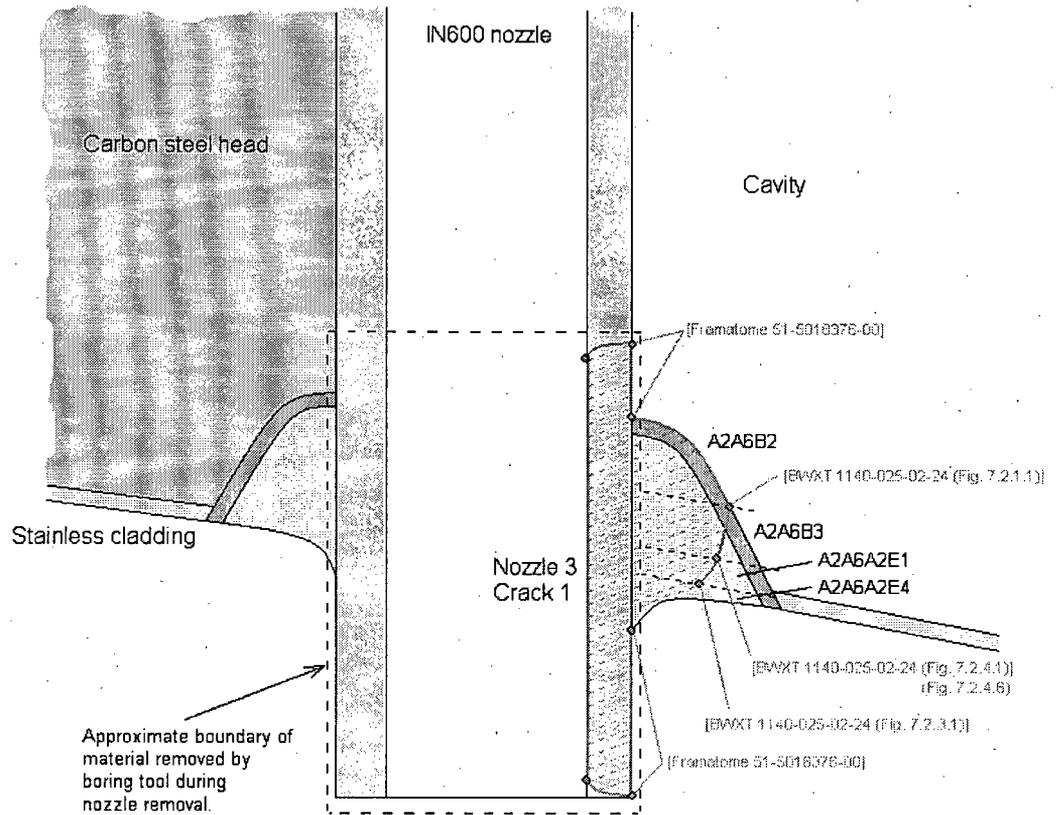
However, careful metallurgical examination of the portion of the J-groove weld that remained after the RPV head section containing the cavity was removed from the RPV head, together with the UT data, allowed us to build up a composite picture of the large nozzle and weld crack at CRDM Nozzle 3 that is shown in Figure 10.8 (See Section 8.4.2).

Figure 10.8 Schematic of final size and shape of Crack 1 in Davis-Besse CRDM Nozzle 3 (from Section 8, Figure 8-10).

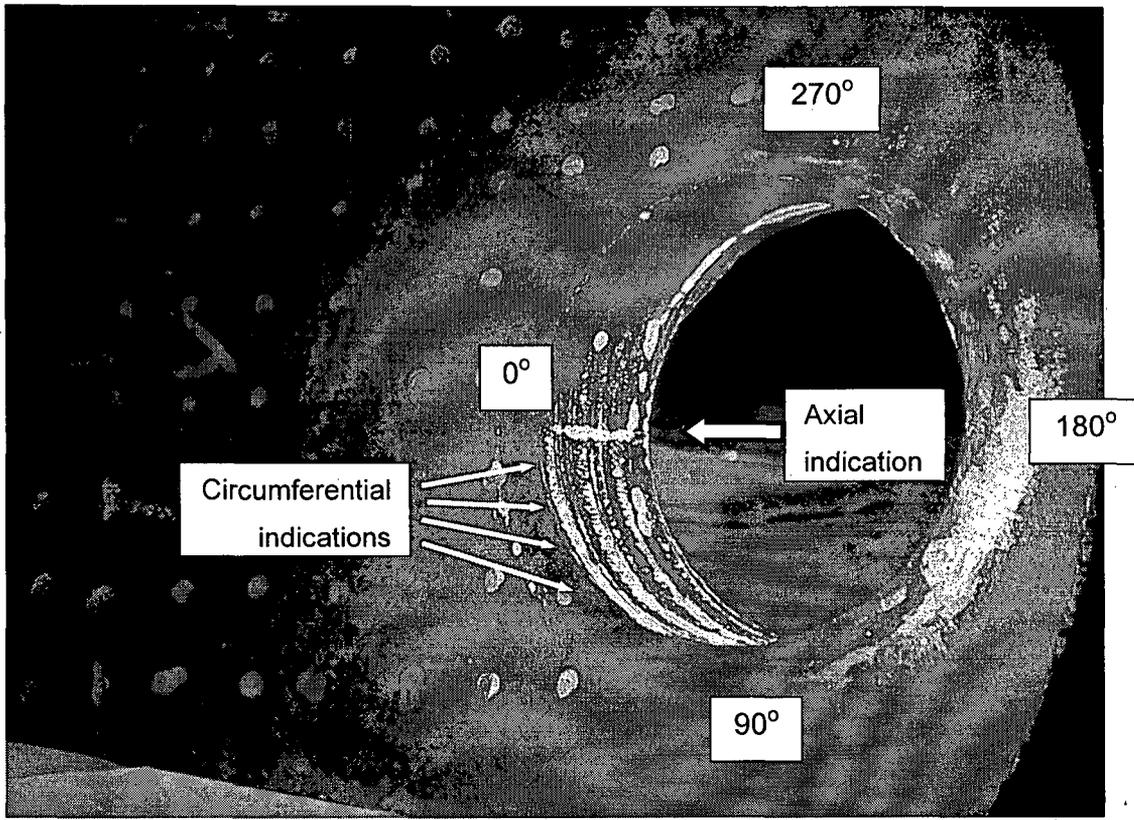
Figure 10.9 PT results for nozzle 3 J-groove weld bore and cladding underside. The J-groove weld contained an axial indication near 10° on the bore ID and circumferential indications on the RCS side from ~20° to ~45°.

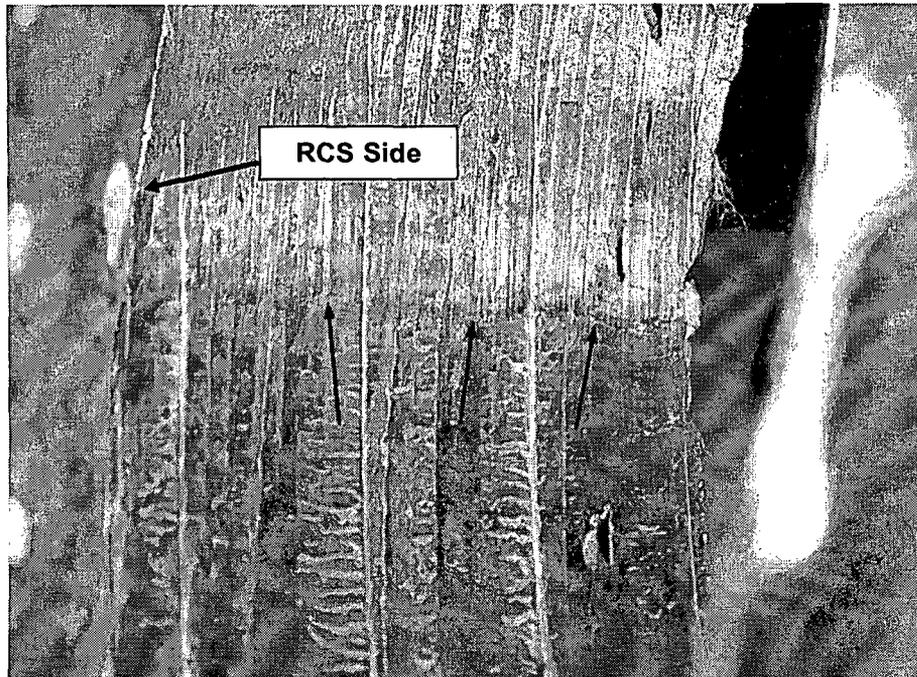
Looking at J-groove weld bore near 10°. ~1.2X

Figure 10.10 Photograph showing the remaining portion of the axial crack near 10° in the CRDM Nozzle 3 J-groove weld. This is the portion remaining after the machining was completed for nozzle repair.

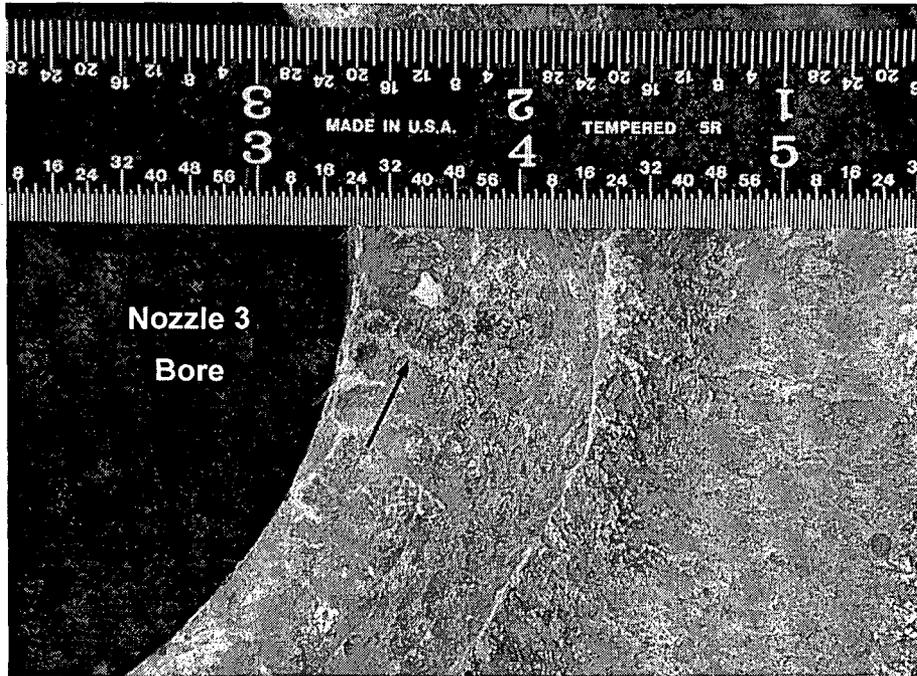
Top view of J-groove weld crack near 10°. ~1.4X

Figure 10.11. Photograph showing axial crack in CRDM nozzle 3 J-groove weld near 10°.

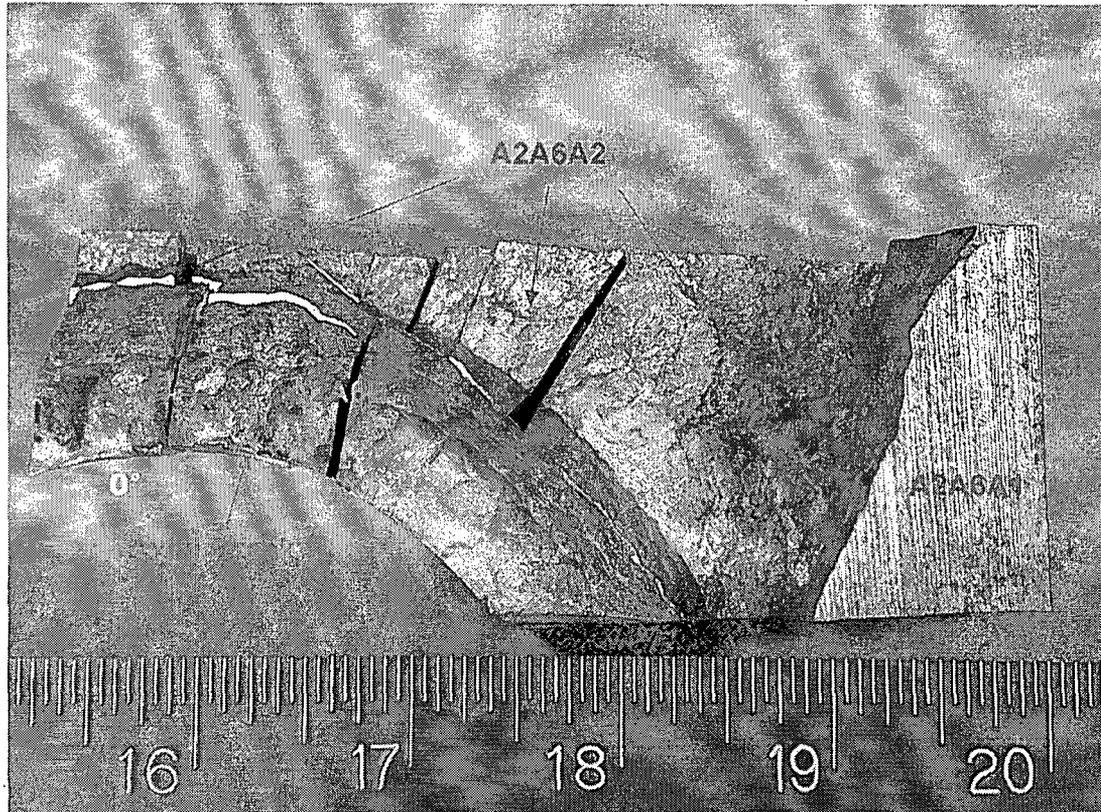
Figure 10.12 Piece A2A6 was first sectioned into Pieces A2A6A and A2A6B. Piece A2A6A was further sectioned into Pieces A2A6A1 and A2A6A2. Both cuts were made on the same plane, parallel to the paper. The first cut line is partially visible; Piece A2A6B is the upper portion of the weld. The second cut line between Pieces A2A6A1 and A2A6A2 is obscured by Piece A2A6A1

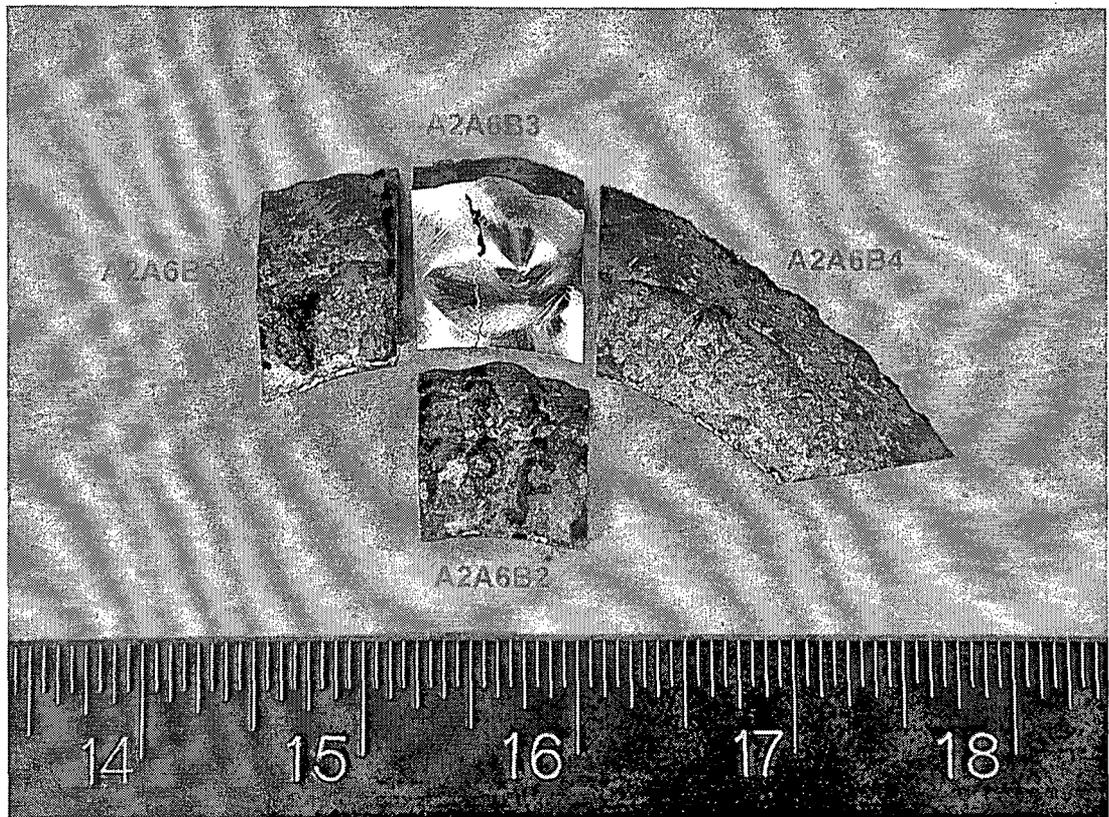
Figure 10.13 Piece A2A6B after sectioning. The bottom surface of A2A6B2 was mounted. The axial crack in A2A6B3 was opened up for SEM.

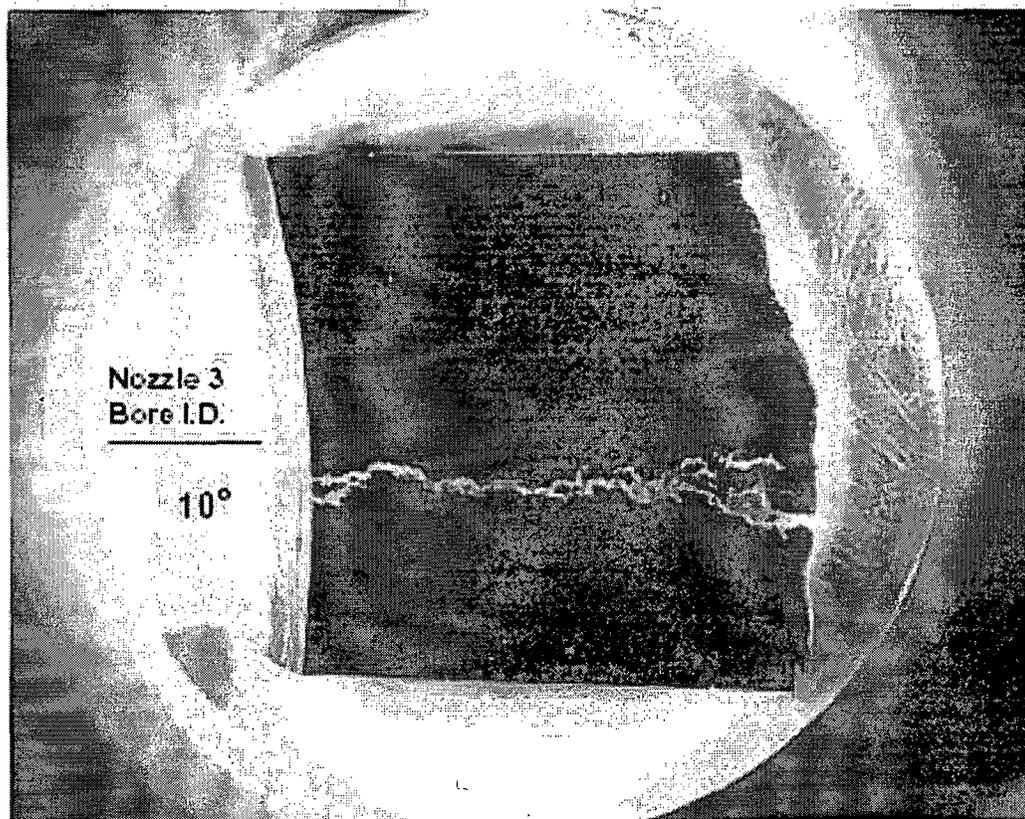
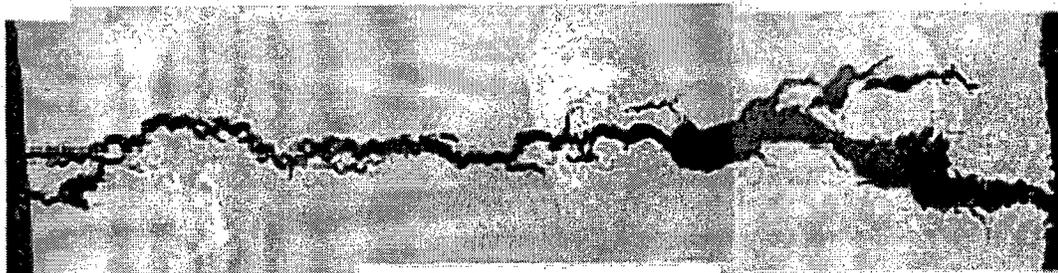
Figure 10.14 Macro photograph of metallographic mount sample A2A6B2 (see Figures 5.4 and 5.5 for the sample orientation). The axial cracking at $\sim 10^\circ$ is through the J-groove weld, in contrast to the cracking near 180° , which was partially through the weld. A slightly higher magnification micrograph is also provided
