WATTS BAR NUCLEAR PLANT UNITS 1 AND 2
RUSKIN FIRE DAMPERS
NCR WBN MEB 8008
10 CFR 50.55(e)
FINAL REPORT

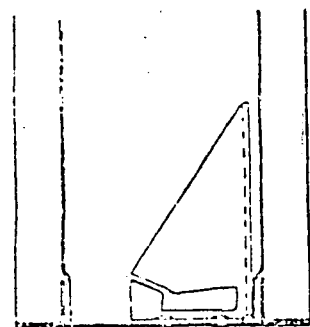
In our response to NRC on NCR WBN MEB 8007 (formally MEB 80-04), we addressed a problem relating to Ruskin's vertical, spring closure, NIBD23 Fire Dampers and a fix or correction was suggested which consisted of fastening a #6 screw in the narrow portion of the slot in the spring brackets.

ORIGINAL INSTALLATION
(VERTICAL FIRE DAMPERS
WITH SPRING CLOSURE)

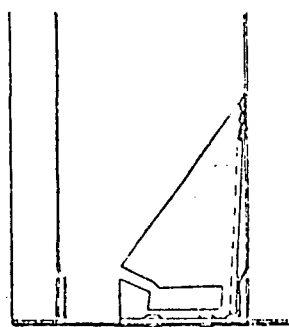
TOP EDGE OF BRACKET
TACKWELDED TO PROVIDE
EXTRA SUPPORT FOR
BRACKET & RESULTING
ALTERATION OF SPRING
SLOT

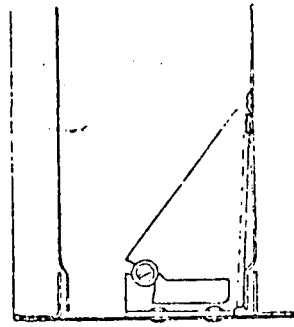
Although it appears that this method should have eliminated the problem, an engineering firm has indicated to us that some of the screws worked loose during shipment. This raises the possibility that the use of screws as a fix is questionable.

ORIGINAL FIX USING
#6 SCREW, WASHER, STAR
LOCKWASHER & HEX NUT

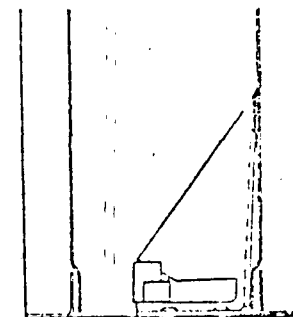
BRACKET WITH CLAMP
INSTALLED

Ruskin has now developed an alternate fix consisting of a small metal clamp which attaches to the spring bracket and provides a positive stop for the spring (see drawing 5564).

INSTALLATION OF
PROPOSED BRACKET
CLAMP (SEE DETAIL
ABOVE ALSO)

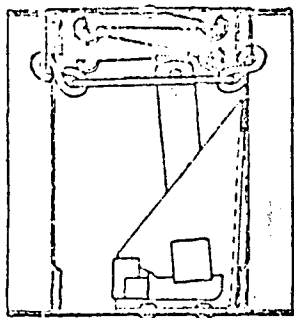
VERTICAL NIBBERS
AS SHOWN, THE DAMPER
WILL CLOSE COMPLETELY
AND CONSISTANTLY WHEN
THE FUSE LINK MELTS

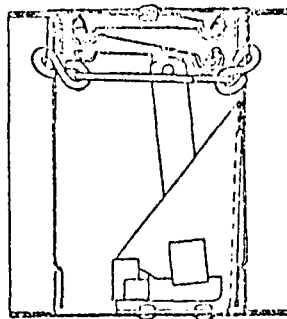
A second problem has also been brought to our attention. If the blade package in vertical units less than 9" high is shifted such that the leading edge of the bottom blade rests higher than the trailing edge, the blades may jam when released.

ABOVE, THE BLADE PACKAGE
HAS BEEN SHIFTED ALLOWING
THE LEADING EDGE OF
THE BOTTOM BLADE TO BE
ABOVE THE TRAILING
EDGE - IF THE FUSE
LINK MELTS WITH THE
BLADES IN THIS POSITION,
THEY WILL JAM AS IN
THE NEXT DETAIL

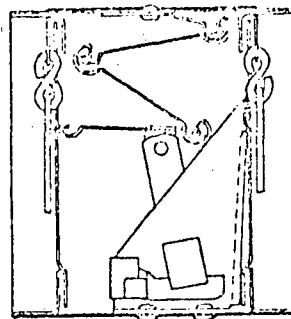
BLADE PACKAGE JAMMED

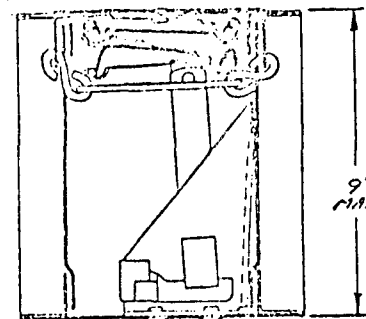
DAMPER WITH SNAP-IN
STRIP (SHOWN AT RIGHT)
INSTALLED. SINCE LEADING
EDGE IS HELD BELOW
TRAILING EDGE ON BOTTOM
BLADE, UNIT CLOSSES
COMPLETELY & CONSISTANTLY

Ruskin has developed a snap-in strip which when installed will hold the bottom blade in the proper orientation and ensure complete and consistent closure (see drawing 5565).
