WATTS BAR NUCLEAR PLANT UNITS 1 AND 2
ORIFICE FLANGES NOT
MEETING SPECIFICATIONS
NCR WB-M-79-06, DEFICIENCY 4
10 CFR 50.55(e) FIRST INTERIM REPORT

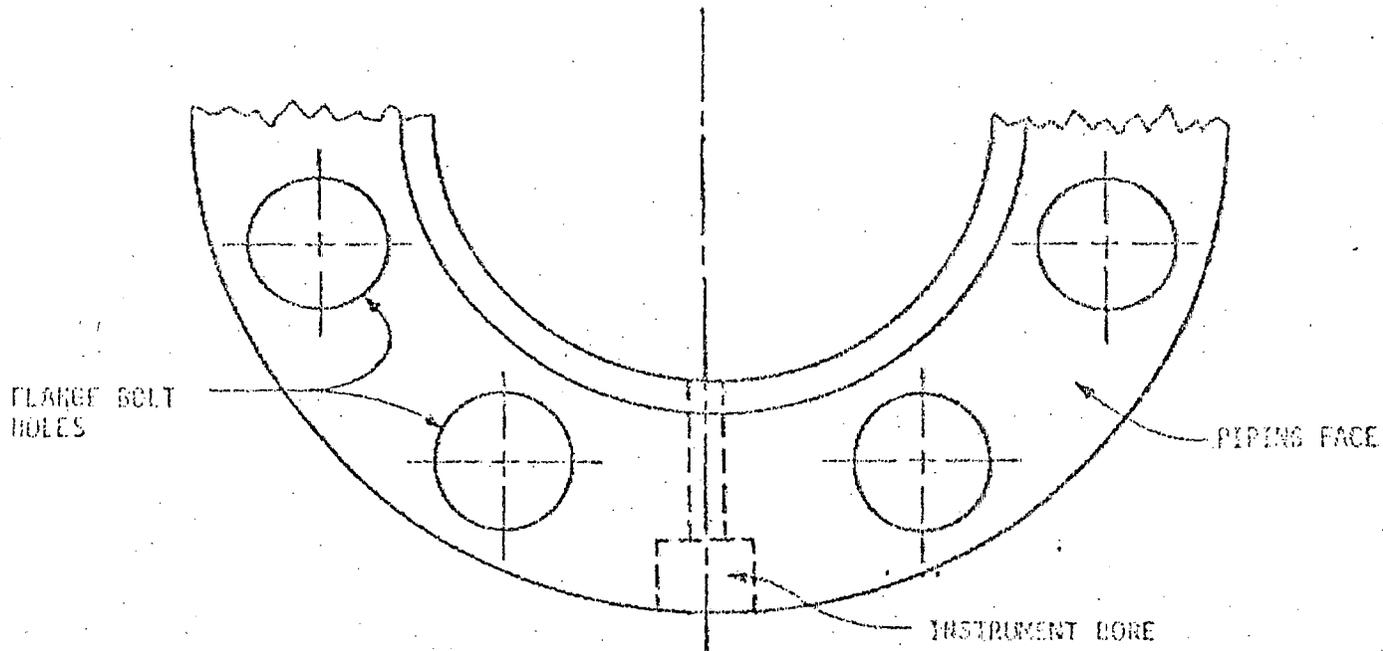
TOP VIEW

Two orifice flanges with 1.05 inch bore (for instrumentation purposes) were found to leak in the area of the bore during hydrostatic testing of the residual heat removal system. These orifice flanges were manufactured by Afco Company of Long Island City, New York and were supplied by Taylor Forge. In addition, several other flanges have been found in which the metal thickness between the piping face of the flange and the bore does not meet TVA requirements to allow for minimum fillet weld dimension of 0.125 inch on the attaching instrument line socket weld. The attached figure is to provide a clearer explanation of the dimension in question (shown as dimension "D" on the figure). Approximately ten other stored or installed flanges have been examined and found to have the weld dimension condition.
