WATTS BAR NUCLEAR PLANT

EVALUATION OF BLACK AND VEATCH INDEPENDENT REVIEW

MARCH 16, 1984

WATTS BAR NUCLEAR PLANT
INDEPENDENT REVIEW
FINAL SUMMARY REPORT

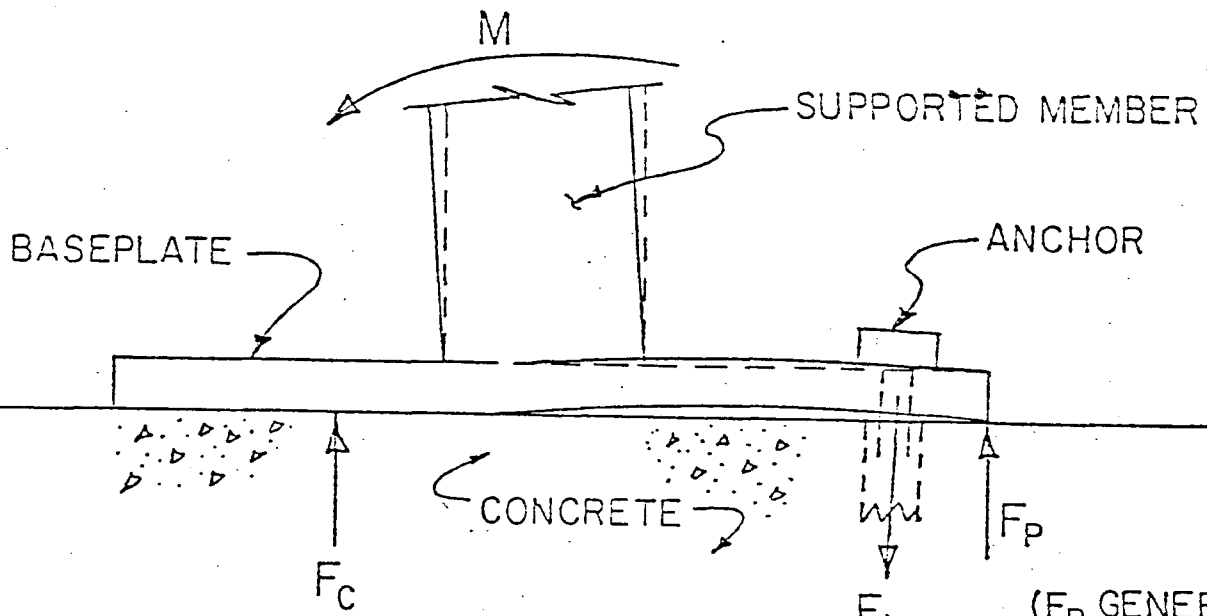
FIGURE B1

The second concern involves prying action. Baseplates for pipe supports and similar attachments which are loaded with tensile loads or bending moments may develop prying forces. The mechanism which results in prying for a typical pipe support is illustrated in Figure B1. The magnitude of the prying force depends primarily on the following variables; the stiffness of the plate, the stiffness of the anchor, and the preload in the anchor. If prying action exists, the prying force will place additional tensile load in the anchor.

In summary, TVA evaluated prying action for the 79-02 Bulletin work but this evaluation showed that prying forces do not develop for baseplates with self-drilling expansion anchors. This determination has been validated by testing.

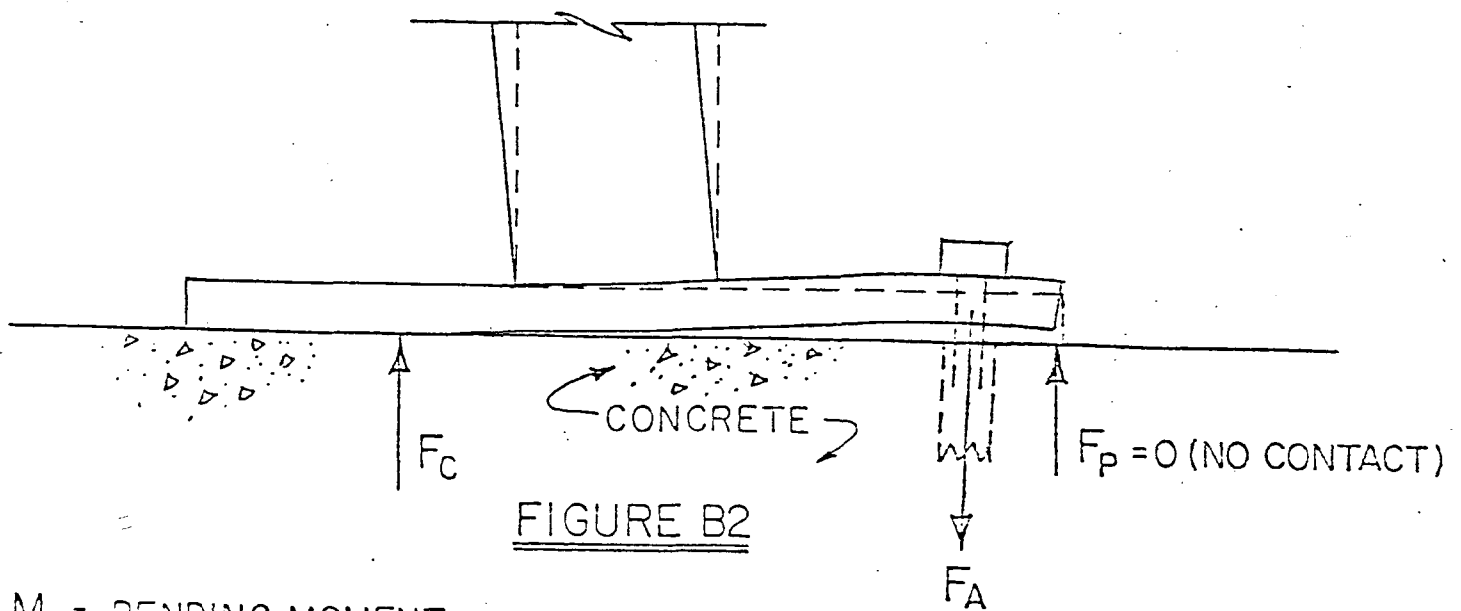
FIGURE B2

- M = BENDING MOMENT
- F_C = RESULTANT BEARING FORCE ON CONCRETE
- F_A = ANCHOR TENSILE LOAD
- F_P = PRYING FORCE
