TENNESSEE VALLEY AUTHORITY

WATTS BAR NUCLEAR PLANT
NRC QUESTIONS OF AUGUST 14, 1984

ENCLOSURE 2
WATTS BAR NUCLEAR PLANT
10 CFR 50 APPENDIX R DEVIATION REQUESTS

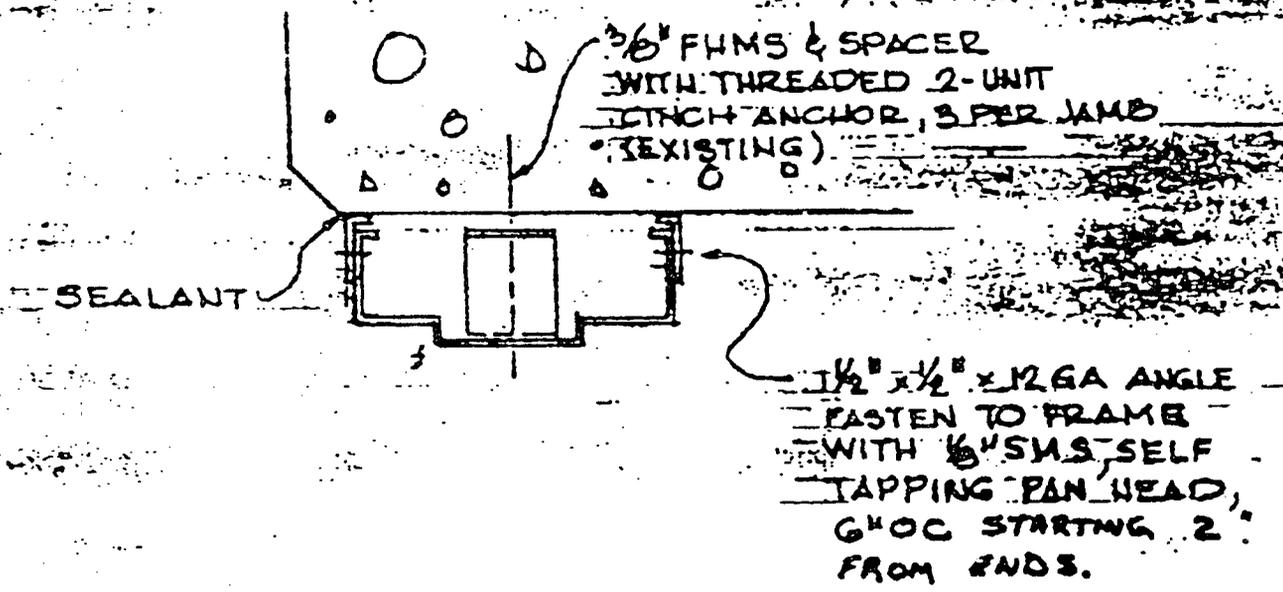
FILE
NC777-1
ILL 1

12. With regard to the installation of the existing opening fire door frames, NFPA 80, PAR. 2-3 requires that "Frames shall be securely anchored to the wall construction." The installation of the frames with approximately a 1/4 in. gap around the perimeter of the frame between the frame and the masonry wall may not meet this intent. Two adverse conditions may develop under fire situations.

REPAIR DETAIL FOR EXISTING
 LABEL FRAMES TO STABILIZE
 FRAME TO WALL

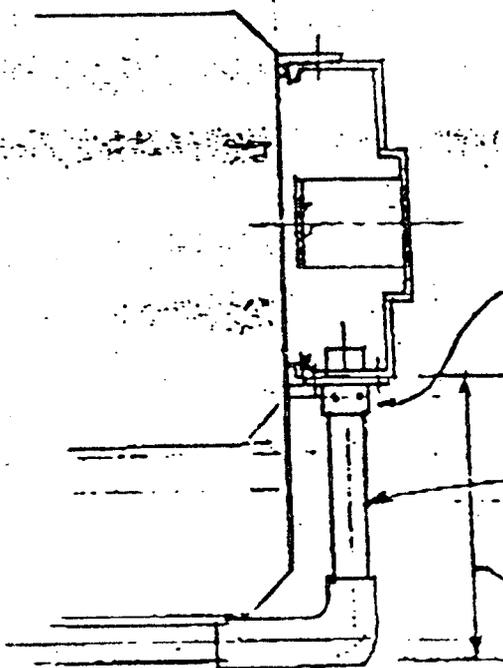
FILE
SK777-1
ILL 2

The installation of conduit to one side of a door frame with the proper fitting and conduit penetration protection, as shown by ILL. 2, is judged not to adversely affect the performance of the frame assembly under fire conditions.

- b. All existing gasketing material will be removed and replaced with material which is UL listed for use on fire rated door assemblies.
 - c. All conduit penetrations into the door frame will be anchored either in accordance with sketch No. SK ACH-G2 (ILL.2 of UL letter) or by a continuously welded fitting (item 4 of UL letter).

WHERE CONDUIT IS NOT SECURED TO FRAME MOUNT A SPLIT SLEEVE WITH 3/8\"
