RES & EPRI Team Response to FAQ 07-0035
NUREG/CR-6850, EPRI TR-1011989
“Bus Duct Counting Guidance for High Energy Arcing Faults”

Final, Revision 2.1 – 12/18/2007

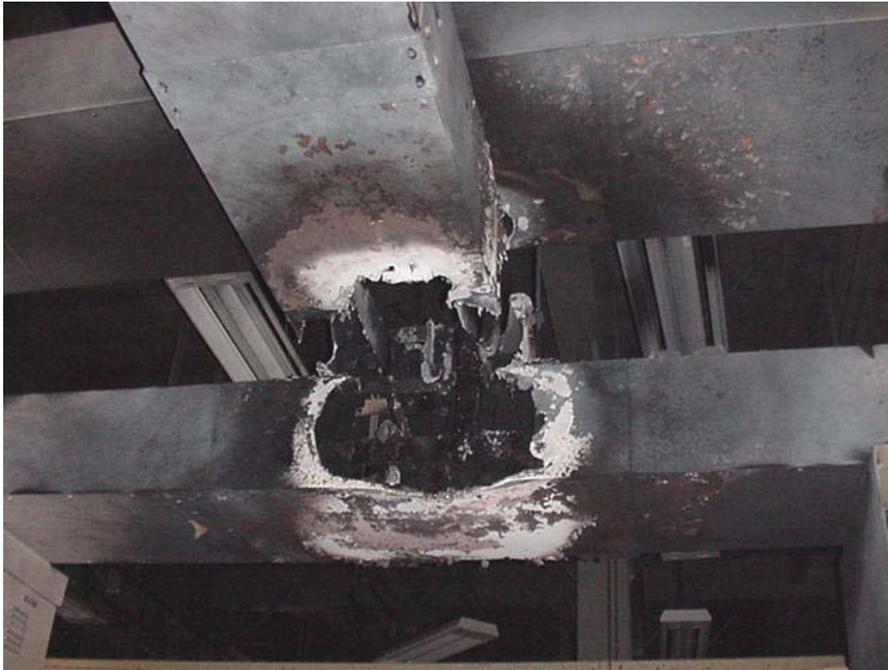
For reference, one well documented event considered prototypical of a bus duct fire occurred at Diablo Canyon on May 15, 2000². Figures 1 and 2 provide photographs taken after this event (as provided in the cited inspection report - see footnote). Note the breach of the bus duct at the fault point, and apparent surface damage of the neighboring duct. Damage is visible to the face panels on cabinets located below and to the side of the fault point. The photos show clear evidence (soot traces) that the surface-mounted components (e.g., the dial indicators, labels, switches, etc.) ignited and burned. Individual points of charring on the panel face are taken as indicative of impinging molten metal droplets. The exterior surfaces of cabinets on both sides of the access walkway directly below the primary faulting point were damaged. The fire did not extend to the interior of these cabinets. Surface damage also occurred on cabinets on both sides of the aisle-way directly below the fault point, and extended to three adjacent panels on each side of the aisle.

Figure 1: Photograph of the point on the bus duct where the arcing fault at Diablo Canyon was manifested (the fault point). Note that the tops of the cabinets to the left and right (the cabinets to the left are shown in figure 2) are visible in the lower corners of this photograph.

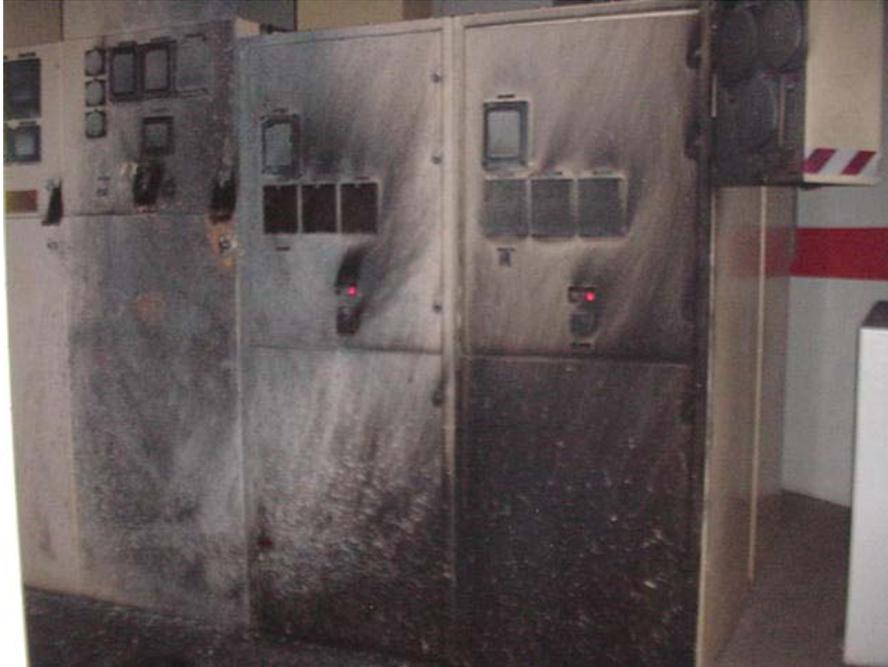
Figure 2: Photograph of the surface damage and burning observed for the more heavily impacted cabinets on one side of the aisle-way below the fault point (the cabinets to the left as seen in Figure 1).
