TENNESSEE VALLEY AUTHORITY

SUBJECT: WATTS BAR NUCLEAR PLANT - NUCLEAR SAFETY REVIEW STAFF INVESTIGATION REPORT IN-85-442-X13 - SEISMIC TRENCHES - RELATED EMPLOYEE CONCERNS IN-85-066-001, IN-85-472-007, IN-85-496-001, AND WI-85-040-004

SUBJECT: NUCLEAR SAFETY REVIEW STAFF INVESTIGATION REPORT IN-85-442-X13 - SEISMIC TRENCHES

EMPLOYEE CONCERN IN-85-442-X13

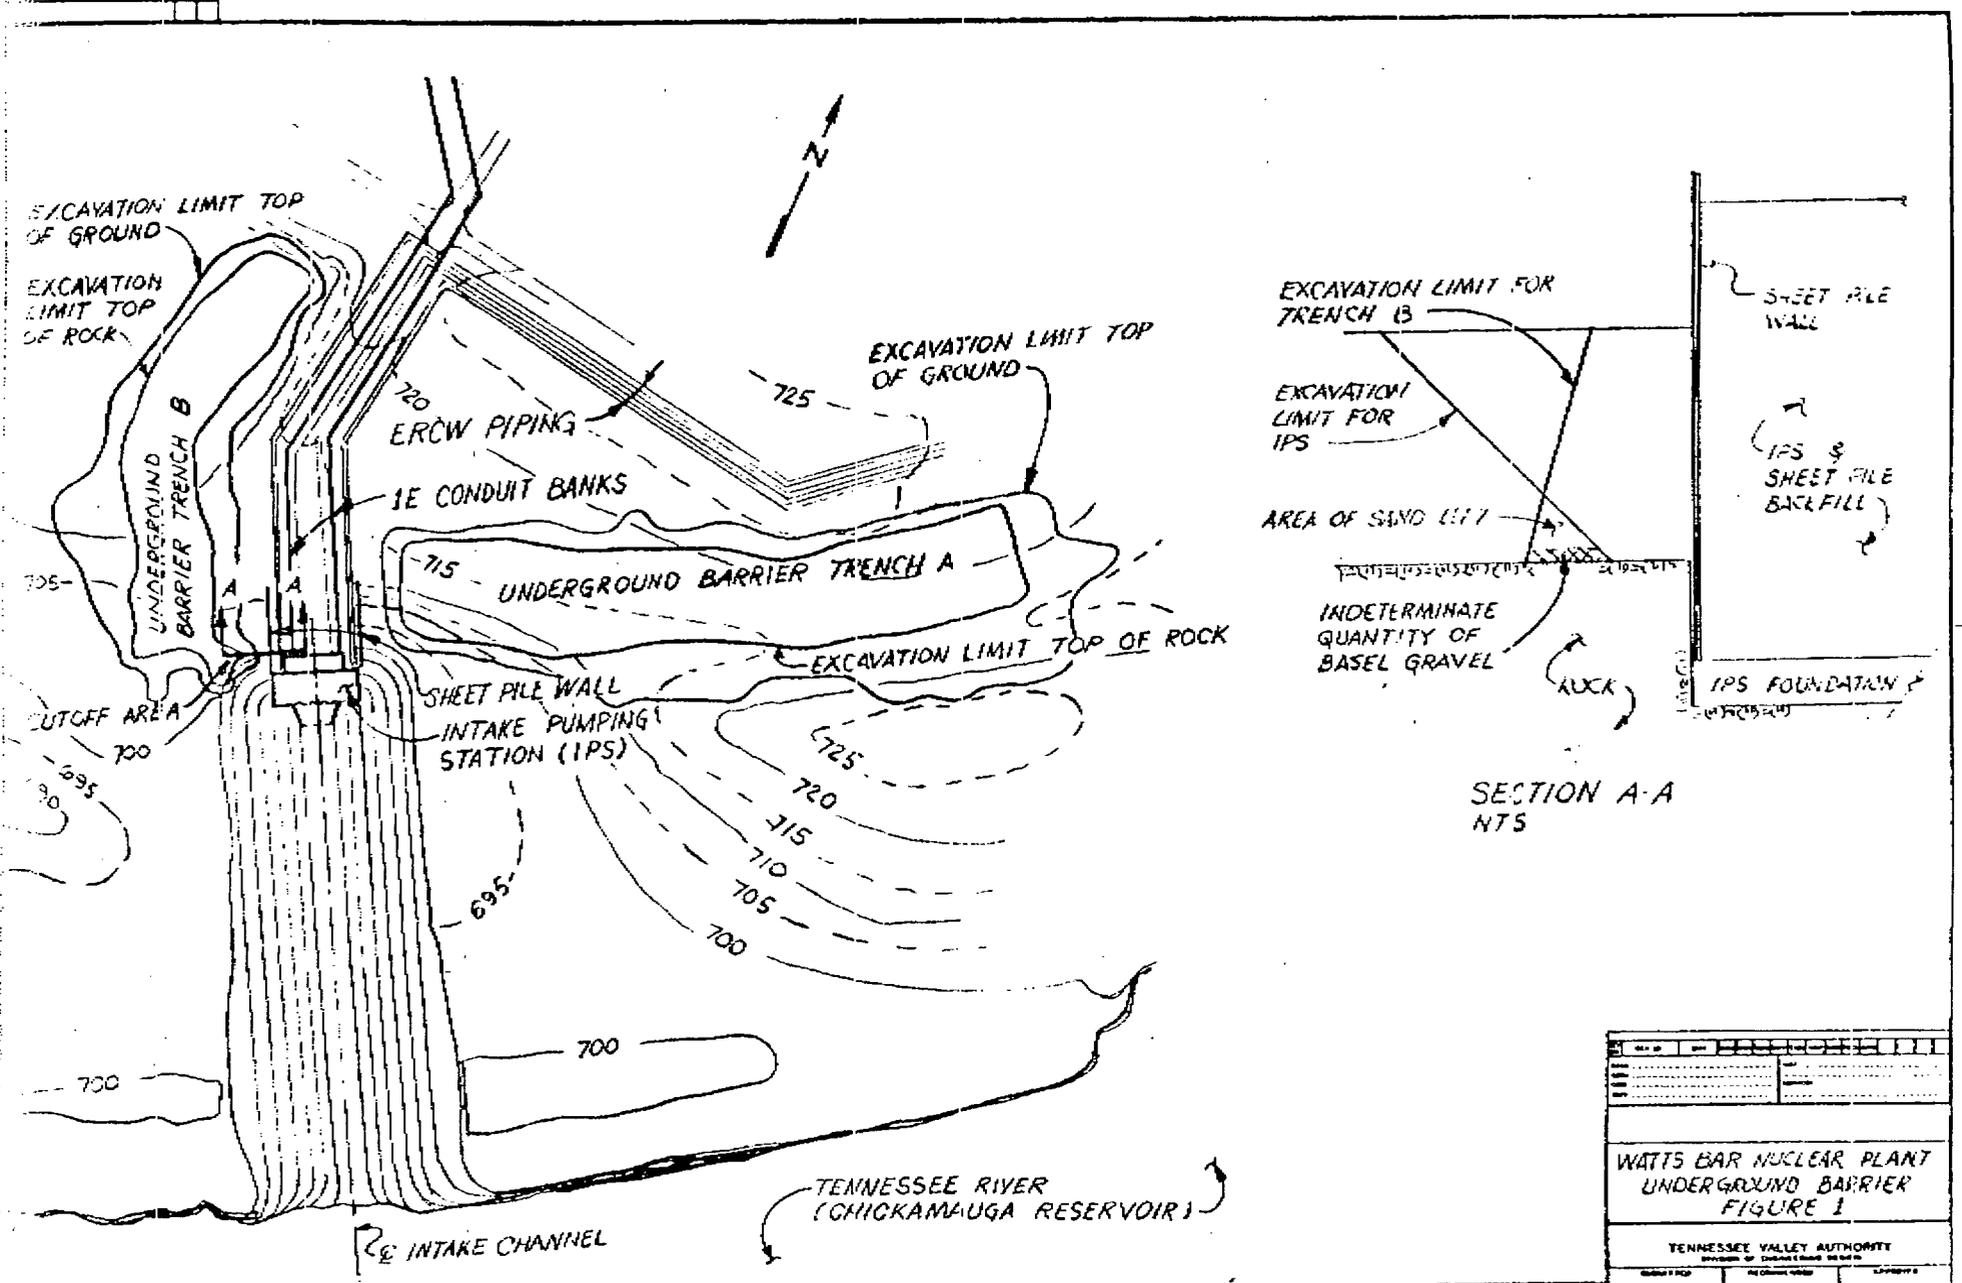
WATTS BAR NUCLEAR PLANT UNDERGROUND BARRIER FIGURE 1		
TENNESSEE VALLEY AUTHORITY DIVISION OF DAMS AND RESERVOIRS		
DESIGNED BY	PROJECT NO.	DATE
DRAWN BY	NO. OF SHEETS	NO. OF SHEETS
CHECKED BY	APPROVED BY	DATE
MEMPHIS, TENNESSEE

It is correct that for the Trench B underground barrier, some fine sands were intentionally left between the barrier trench excavation and the former IPS excavation. In lieu of making a total cutoff and possibly undermining the Category I sheet pile wall behind the IPS, the barrier trench excavation (cutoff) was extended to the extent evaluated to be adequate. This adequacy was based on (a) the geometrical relationship of the Trench B excavation and backfill with the IPS and intake channel excavation and backfill, and (b) on the fact that any loss of material from behind the underground barrier due to liquefaction must be preceded by movement of a massive amount of material on the flood plain into the river.

The geometrical relationship of the excavation and backfill limits of Trench B, the IPS, and the intake channel are such that only a small zone of sand was left in place. The excavation limits for these three features overlap except near the top of rock where the sand zone exists. Figure 1 shows the relationship of Trench B, IPS, and the Intake Channel. Section A-A on figure 1 shows the overlap of the excavation limits of Trench B and IPS. Also

Section A-A shows the small zone of in situ material left in place. The zone is estimated (based on construction photographs and visual observation of the trench excavation) to be approximately 3- to 4-feet high and 5- to 6-feet wide at the base or top of rock. This zone is probably from 100 to 125 feet in length in the area of concern. This zone also contains an indeterminate amount of nonliquefiable basal gravel. The basal gravel is the material layer just above rock at the plant and varies in thickness from 1 \pm foot to 8 \pm feet. This material was not removed during the over excavation of the intake channel. In fact, the basal gravel provides the foundation for the earthfill that was placed to construct the intake channel slopes.
