UNITED STATES  
NUCLEAR REGULATORY COMMISSION  
OFFICE OF INSPECTION AND ENFORCEMENT  
WASHINGTON, D. C. 20555

IE Circular 78-18

UL FIRE TEST

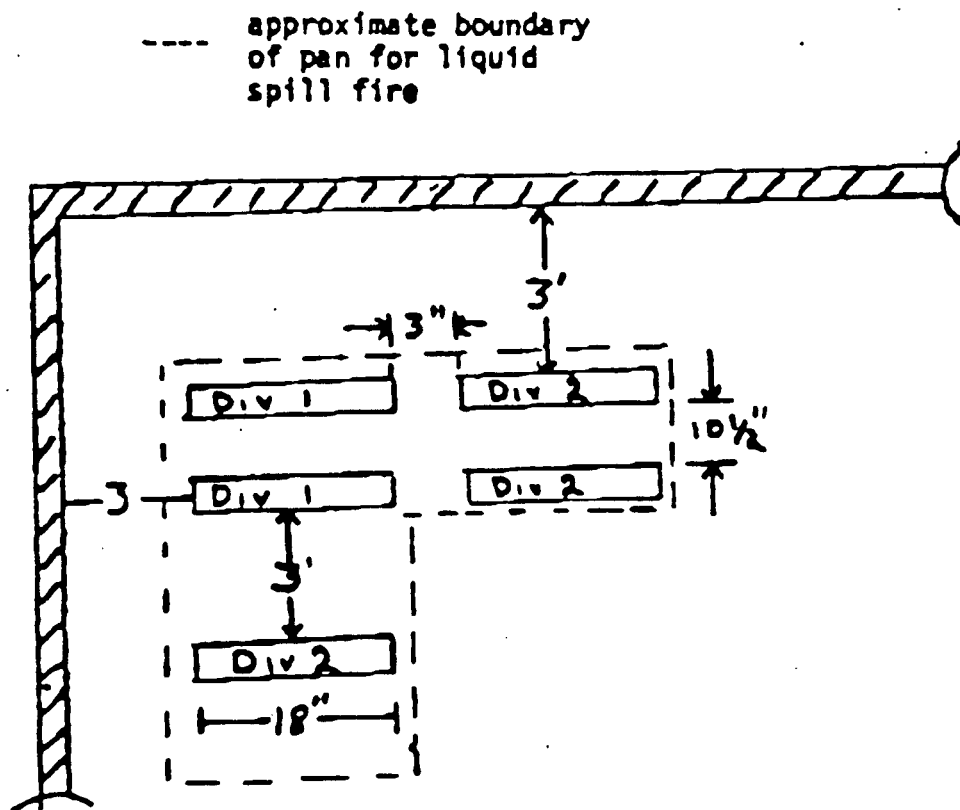
Figure 1

Preliminary information indicates that the flammable liquid or flames penetrated the protective barriers at the bottom of the vertical trays and caused fire damage to the polyvinyl chloride insulation on cables in four of the five trays.

The most probable cause of the fire damage in certain cable trays appears to be related to the absorption or seepage of heptane under the ceramic fiber blanket at the juncture with the floor. Once the heptane entered the interior regions of the cable tray, then ignition apparently occurred via the small opening at the floor or through a vapor/air path within the joints. There is some indication that some cable damage was caused by absorption of heptane on the inside of the barrier (wicking effect) and its ignition which heated a cable tray ladder rung, causing damage to a cable in contact with the rung. The ingress of the heptane into the ceramic fiber needs to be further evaluated since this appears to be the most significant failure mode.

Vertical Tray Corner Test

1. To protect against spills of flammable liquids, barriers or curbs may be needed to prevent entry of the flammable liquid behind fire barriers. A wick effect may also need to be considered in the design of fire barriers.
2. Some small fires may not actuate sprinkler heads. To reduce this possibility in sprinkler systems to be installed, fast response sprinkler heads should be considered (less than approximately 3 minutes in the UL Standard 199 "Automatic Sprinklers for Fire Protection Service").
3. The location of the fire detection devices and the sprinkler heads relative to the fire and components being protected is of great importance. The path of the air movement in the area influences the actuation of such devices and should be considered in the system layout.
