UNITED STATES
NUCLEAR REGULATORY COMMISSION
OFFICE OF INSPECTION AND ENFORCEMENT
WASHINGTON, D.C. 20555

IE Circular No. 79-02

FAILURE OF 120 VOLT VITAL AC POWER SUPPLIES

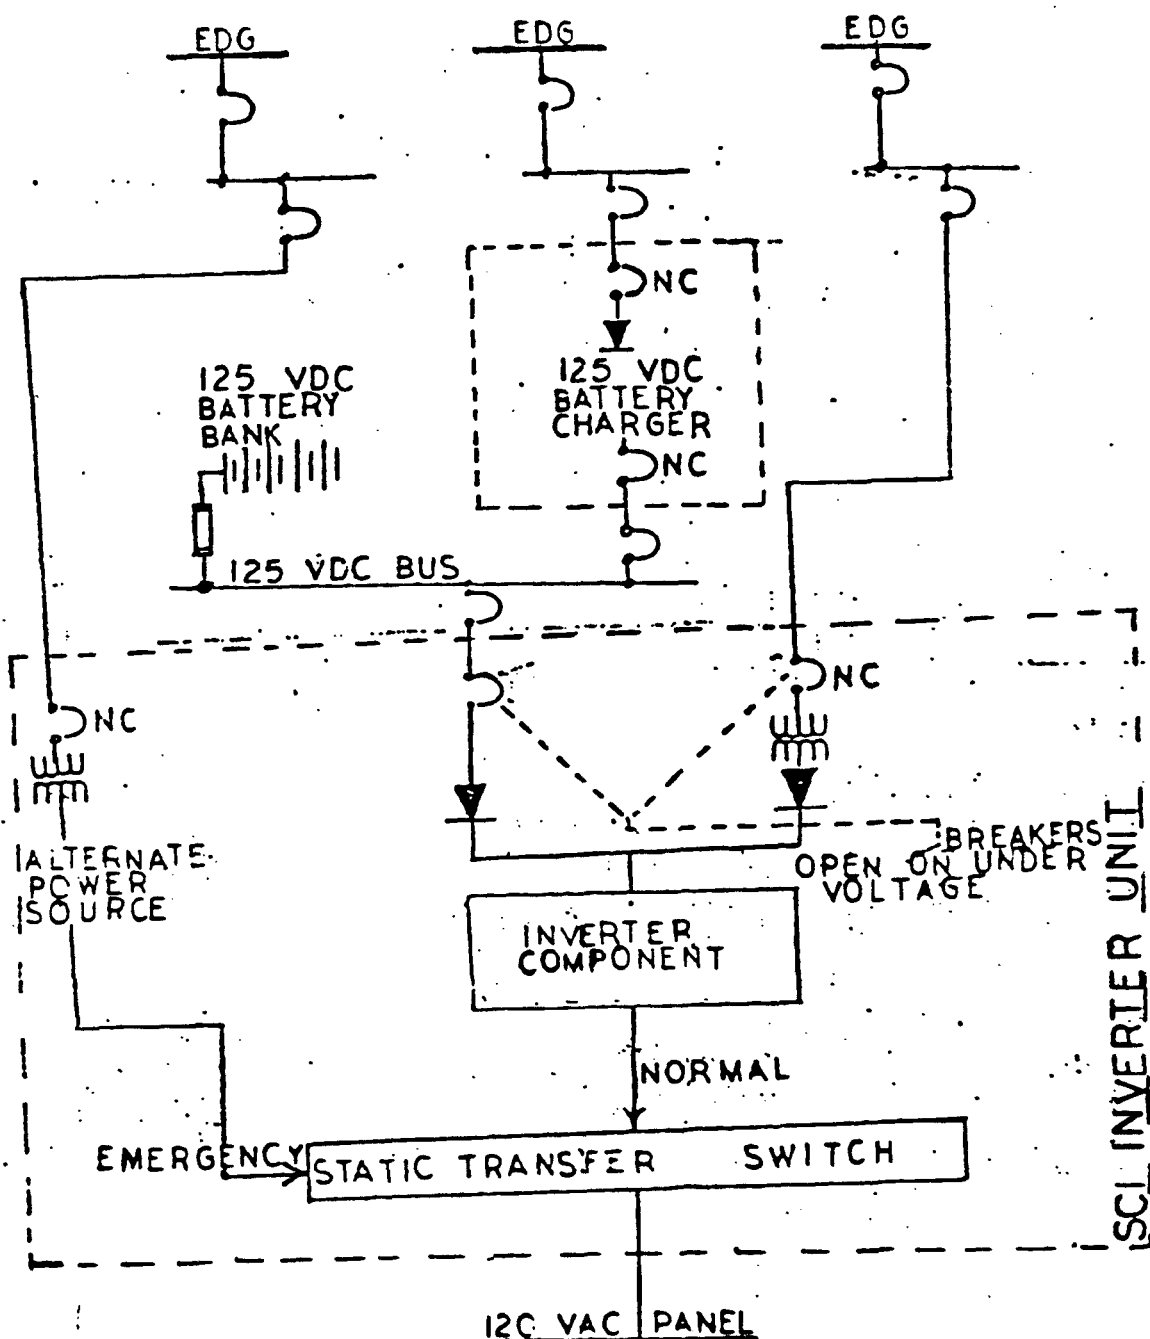
FIGURE 1
SINGLE LINE DIAGRAM-120 VAC

On September 16, 1978, Arkansas Nuclear One - Unit 2, while in hot functional testing preceding initial criticality, suffered a degradation of both of the independent off-site power sources. This produced an undervoltage condition on the Engineering Safety Features (ESF) Buses and caused an inadvertent ESF actuation. The licensee determined that the ESF actuation occurred on a loss of at least two of the uninterruptable 120 volt vital AC power sources. Immediate investigation revealed that all four of the Solidstate Controls, Inc., (SCI) inverter static switches had automatically transferred to the alternate power supply (the 120 volt AC being supplied by transformers directly off the ESF buses rather than from the inverter output.) Figure 1 (attached) shows the functional interconnection of the 120 volt AC power supply system.

A single conclusive cause of the undesired SCI inverter static switch transfer could not be identified. However, the following problems were discovered during subsequent investigation.

- (a) The SCI inverters have circuitry to monitor the incoming DC voltage level which, on sensing a low voltage (nominally 104 DC volts for these inverters) will trip both input breakers to the inverter component after an adjustable time delay.

The setting of these time delay relays were not verified during either preoperational testing or subsequent maintenance. The time delay is necessary in order to accommodate transient loading conditions which may be encountered.

- (b) On one SCI inverter, a DC fuse within the inverter component was found blown. The vendor indicated that this fuse will blow due to an excessive DC voltage to the inverter component caused by a transient on the 480 AC input. The licensee has subsequently reset the taps on the 480V to 120V three-phase AC input transformer to limit the DC voltage to the inverter to less than the nameplate maximum rating in the event of a high AC input voltage transient.

- (c) The SCI inverter static switch is designed to transfer to an alternate source on inverter output overcurrent or undervoltage. Initially, these trips were set at 125 percent overcurrent and 80 percent undervoltage. An explanation for the transfer of two of the inverter static switches is that during one of the transfers of site loads, the instantaneous inductive load caused these trip set points to be exceeded. The licensee has subsequently adjusted the transfer sensing circuitry to higher overcurrent and lower undervoltage trip settings to assure that the inverter will maintain load over the widest possible range of voltage and current. (Note that in this case, once the SCI inverter transfers to the alternate source, it will not automatically transfer back to normal source.)

1. Determine whether or not time delay circuitry is used in your inverter units. If so, have they been adjusted to the appropriate set point as required by equipment and the integrated system designs?

2. Determine if the AC input voltage and transformer tap settings are optimized to prevent exceeding the inverter component name-plate maximum rated DC input voltage in the event of a high AC input voltage transient.

3. If an alternate 120 volt source is used in your design, determine if the protection transfer circuitry of the inverter has been optimized within design limits to ensure maximum possible availability of the inverter system during transient loading conditions. An operating history of inexplicable transfers may be indicative of the above.

4. Determine if the administrative controls employed by your facility ensures operability of safety systems after its subcomponents (e.g., time delay relays, switches, etc.) have been subjected to maintenance or testing.
