UNITED STATES
NUCLEAR REGULATORY COMMISSION
REGION II
101 MARIETTA ST., N.W., SUITE 3100
ATLANTA, GEORGIA 30303

UNITED STATES
NUCLEAR REGULATORY COMMISSION
OFFICE OF INSPECTION AND ENFORCEMENT
WASHINGTON, D.C. 20555

IE Information Notice No. 80-38: CRACKING IN CHARGING PUMP CASING CLADDING

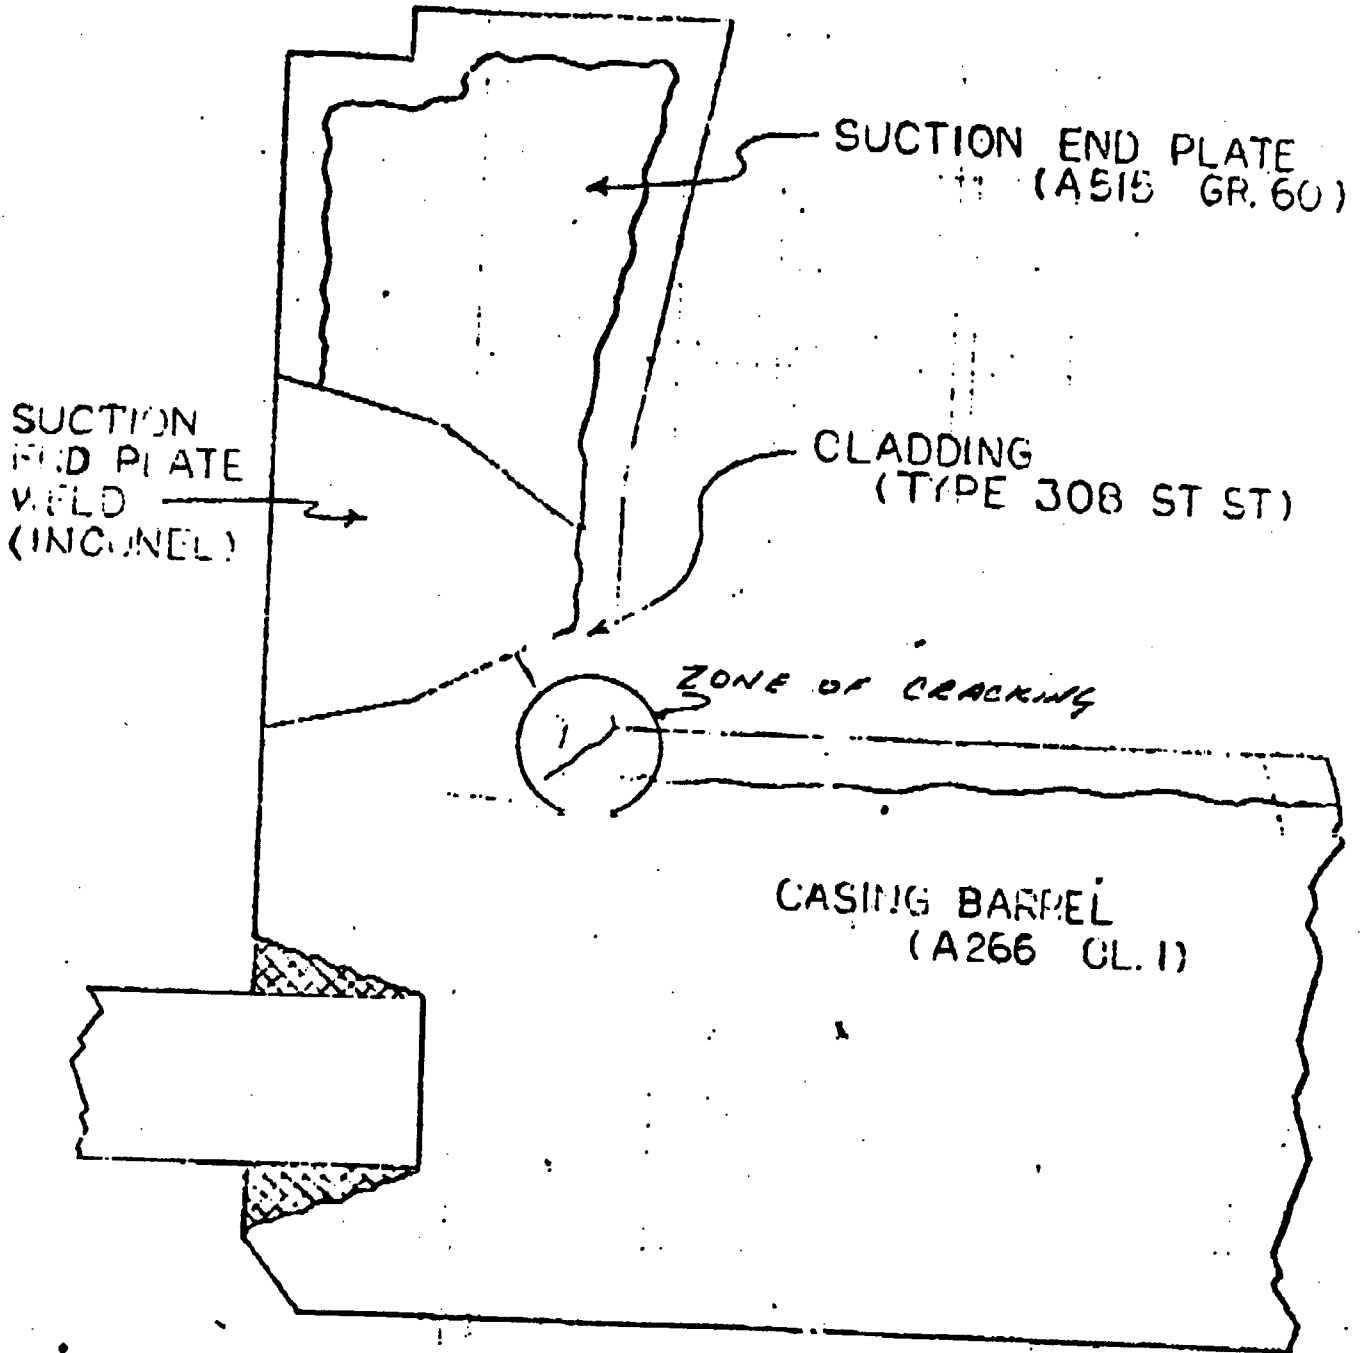
FIGURE 1

The pumps are 2-1/2 inch, 11 stage, Type IJ manufactured by the Pacific Pumps Division of Dresser Industries. The pump casing end assembly in the area of interest, Figure 1, consists of a suction end plate of A515 grade 60 carbon steel plate welded to the casing barrel forging of A266 class 1 carbon steel using an Inconel weldment. The entire inner surface is clad with type 308 stainless steel applied by submerged arc welding.

An in-situ ultrasonic examination conducted in late April confirmed clad cracking indications at the barrel case to end plate inner radius for approximately 330 degrees around the circumference and that the cracking possibly extended into the pump base material in the bottom 180 degrees of the assembly. A review of the original radiographs revealed crack like indications in the clad overlay, however, not to the extent observed during this examination.

Subsequently, the entire suction end of the pump was removed and cross sections metallographically examined to further evaluate the nature and extent of the cracking. It was determined that initiation and propagation of the clad cracks probably resulted from stress concentration and dilution effects in the initial corner bead pass due to the difficult access and bead sequencing required by the fairly sharp corner geometry. Extension of the cracks at the base metal-clad interface ranged to a depth of 1/16 inch maximum in the 1-1/2 inch thick base material. These crack tip areas were well blunted and slightly cavitaded from corrosion effects due lengthy exposure to the localized boric acid attack. Examination of the crack morphology revealed that the clad cracking essentially arrested at the base metal-clad interface and that base metal corrosion progressed at a relatively slow rate.

The 1A charging pump was replaced with a new pump provided with a casing constructed entirely of stainless steel. The licensee is currently developing improved NDE procedures for examination of the three remaining pumps at the next refueling outage. Further, the licensee and pump manufacturer are developing repair procedures in the event cracks are discovered in the remaining pumps.

Based on the available information no immediate safety concern is indicated. However, the observed conditions reveal a potential source of pump degradation over long term operations. Therefore, to assure maximum availability, it appears prudent to perform a nondestructive examination of this pump type at the earliest practical time during the first code required in-service inspection interval and if cracking is confirmed, take appropriate corrective actions per the rules of ASME Section XI BP&V Code.
