WATTS BAR NUCLEAR PLANT (WBN) UNITS 1 AND 2 - VIOLATION OF SINGLE FAILURE
CRITERIA FOR CONTROL BUILDING NORMAL PRESSURIZING SUBSYSTEM -
WBRD-50-390/91-32 AND WBRD-50-391/91-32 - INTERIM REPORT

ENCLOSURE 1
WATTS BAR NUCLEAR PLANT (WBN) UNITS 1 AND 2
VIOLATION OF SINGLE FAILURE CRITERIA FOR CONTROL BUILDING
NORMAL PRESSURIZATION SUBSYSTEM
SIGNIFICANT CORRECTIVE ACTION REPORT WBSA910234
WBRD-50-390, 391/91-32 - 10 CFR 50.55(e) INTERIM REPORT

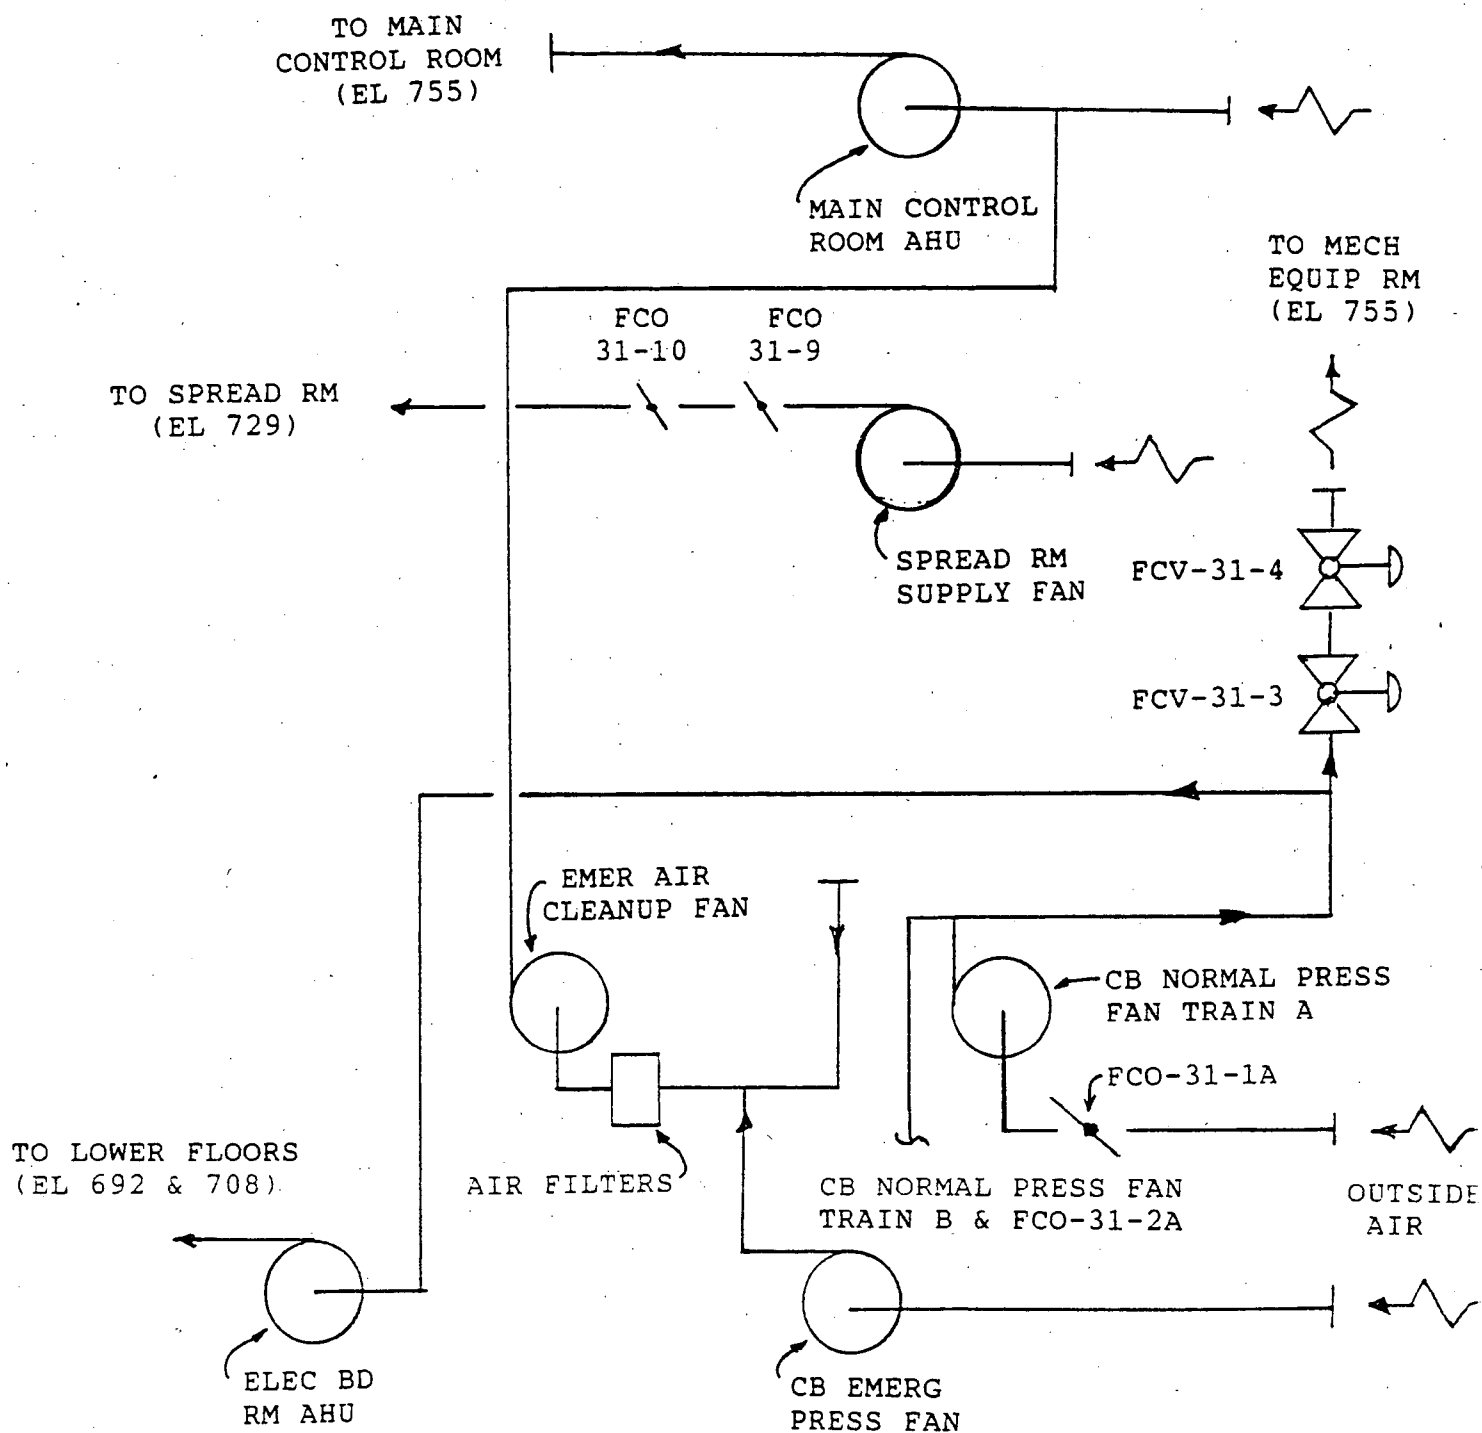
ATTACHMENT 1

During normal operation, one redundant CB normal pressurizing fan supplies approximately 8200 cubic feet per minute (CFM) of outside, unfiltered air to the control building, of which, 3200 CFM is supplied to the MCRHZ and 5000 CFM is supplied to the lower CB floors (elevations 729, 708, and 692) (See Attachment 1). The building is thus pressurized relative to atmosphere to minimize inleakage. The quantity of air is automatically controlled by the modulating dampers, FCO-31-1A or FCO-31-2A, to maintain approximately 1/8-inch water gauge (wg) positive pressure in the MCRHZ and a slight positive pressure in the remainder of the building. Following a CRI, normal pressurizing fan air flow is isolated from the MCRHZ and the fan operates to divert a reduced quantity (8200 CFM to 3000 CFM) of air to the CB lower floors in order to provide a slight positive pressure relative to atmosphere and to provide make up air to the battery room exhaust fans. During the CRI, pressurization of the MCRHZ is accomplished using redundant emergency pressurizing fans to supply approximately 325 CFM filtered (via air cleanup fans) air flow to the MCRHZ. A malfunction of modulating dampers FCO-31-1A or FCO-31-2A or their attendant control elements (pressure differential transmitters, differential controllers, differential pressure operators, or solenoid valves) could result in the modulating dampers failing in a full open position or otherwise failing to modulate properly such that air pressure in the CB lower floors could exceed the 1/8-inch wg pressure in the MCRHZ

As a result of this deficiency, the increased air flow to the CB lower floors could result in higher than designed air pressures in the lower CB resulting in exceeding the 1/8 inch wg pressure in the MCRHZ. Normal leakage around stairwell doors and wall penetrations could result in unfiltered and potentially contaminated air to infiltrate the MCR and potential radiological exposure to MCR/Technical Support Center personnel in excess of allowable limits specified in GDC-19.

The current design of the CB pressurizing subsystem is being upgraded under DCN-M-10706-A from a pneumatic to an electronic control system to eliminate system inaccuracies. TVA anticipates that under this design change, a differential pressure control system will be installed which will start the redundant normal pressurizing fan/damper assembly upon excess or insufficient pressure conditions. TVA will finalize the cause evaluation, corrective action plan, and schedule for this issue in a final report to be submitted by October 31, 1991.
