WBRD-50-390/91-32

WATTS BAR NUCLEAR PLANT (WBN) UNITS 1 AND 2 - VIOLATION OF SINGLE FAILURE  
CRITERIA FOR CONTROL BUILDING NORMAL PRESSURIZING SUBSYSTEM -  
WBRD-50-390/91-32 AND WBRD-50-391/91-32 - FINAL REPORT

ENCLOSURE 1  
WATTS BAR NUCLEAR PLANT (WBN) UNITS 1 AND 2  
VIOLATION OF SINGLE FAILURE CRITERIA FOR CONTROL BUILDING  
NORMAL PRESSURIZATION SUBSYSTEM  
SIGNIFICANT CORRECTIVE ACTION REPORT WBCA910234  
WBRD-50-390, 391/91-32 - 10 CFR 50.55(e) FINAL REPORT

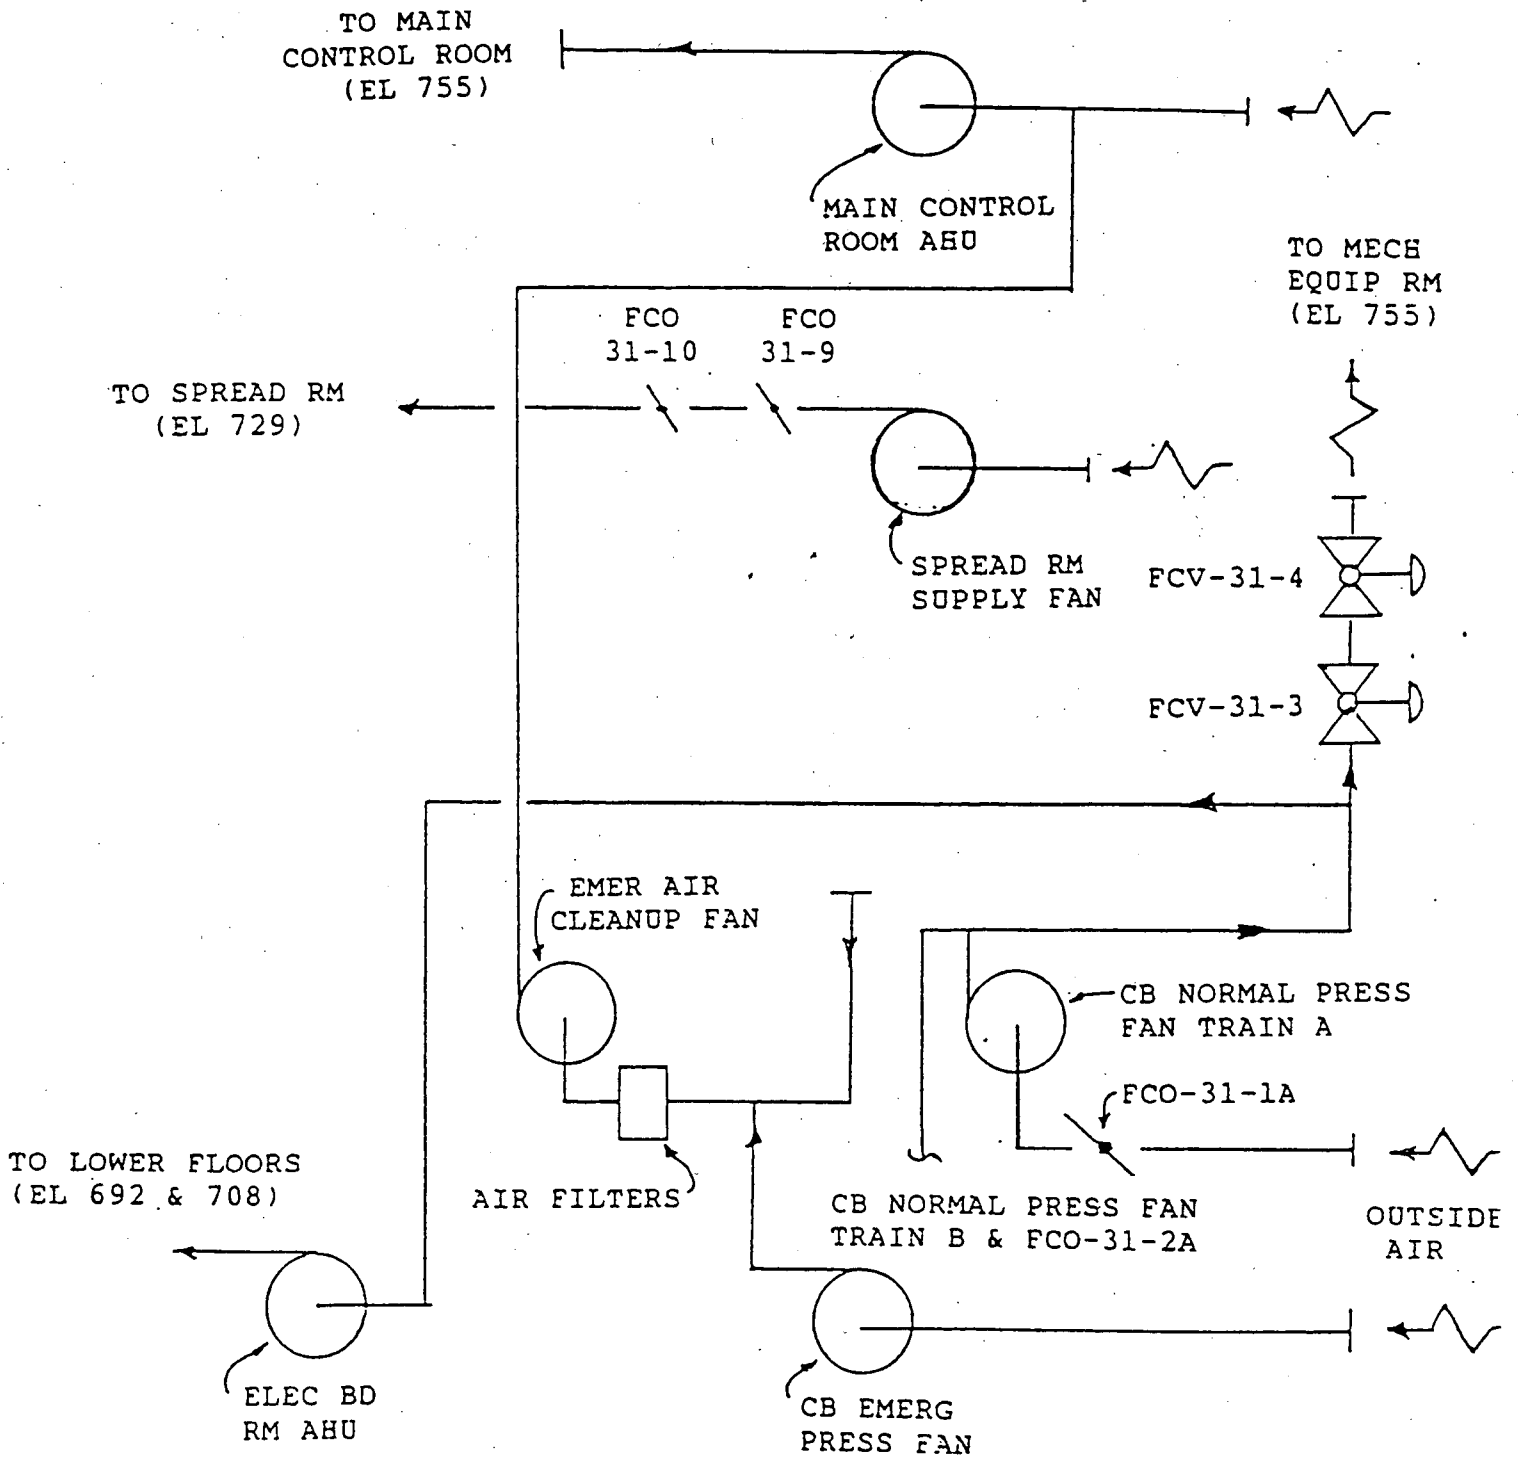
ATTACHMENT 1

During normal operation, one redundant CB normal pressurizing fan supplies approximately 8200 cubic feet per minute (CFM) of outside, unfiltered air to the CB, of which, 3200 CFM is supplied to the MCRHZ and 5000 CFM is supplied to the lower CB floors (elevations 729, 708, and 692) (See Attachment 1). The building is thus pressurized relative to atmosphere to minimize inleakage. The quantity of air is automatically controlled by the modulating dampers, FCO-31-1A or FCO-31-2A, to maintain approximately 1/8-inch water gauge (wg) positive pressure in the MCRHZ and a slight positive pressure in the remainder of the building. Following a CRI, normal pressurizing fan air flow is isolated from the MCRHZ and the fan operates to divert a reduced quantity (8200 CFM to 3000 CFM) of air to the CB lower floors in order to provide a slight positive pressure relative to atmosphere and to provide makeup air to the battery room exhaust fans. During the CRI, pressurization of the MCRHZ is accomplished using redundant emergency pressurizing fans to supply approximately 325 CFM filtered (via air cleanup fans) air flow to the MCRHZ. A malfunction of modulating dampers FCO-31-1A or FCO-31-2A or their attendant control elements (pressure differential transmitters, differential controllers, differential pressure operators, or solenoid valves) could result in the modulating dampers failing in a full open position or otherwise failing to modulate properly such that air pressure in the CB lower floors could exceed the 1/8-inch wg pressure in the MCRHZ. There are no instruments or alarms in the MCR to alert the operators of this condition.

As a result of this deficiency, the increased air flow to the CB lower floors could result in higher than designed air pressures in the lower CB resulting in exceeding the 1/8-inch wg pressure in the MCRHZ. Normal leakage around stairwell doors and wall penetrations could result in unfiltered and potentially contaminated air to infiltrate the MCR and potential radiological exposure to MCR/Technical Support Center personnel in excess of allowable limits specified in GDC-19.

To correct the specific deficiency, differential pressure switches are being incorporated into the new upgraded CB pressurizing system (DCN M-10706). These differential switches will detect over-pressurization in the lower floors of the CB and initiate action to prevent the pressure in the lower floors from exceeding the pressure in the MCR. This modification will be complete prior to system transfer for System 31.
