REPORT NO. R-85-02-SQN/WBN
SEQUOYAH AND WATTS BAR NUCLEAR PLANTS
SPECIAL REVIEW OF MANUFACTURER-IDENTIFIED
POTENTIAL MISAPPLICATION OF SWAGELOK TUBE
FITTINGS AT WESTINGHOUSE REACTOR SEAL TABLES

NSRS REPORT NO. R-85-02-SQN/WBN

SUBJECT: SEQUOYAH AND WATTS BAR NUCLEAR PLANTS -
SPECIAL REVIEW OF MANUFACTURER-IDENTIFIED
POTENTIAL MISAPPLICATION OF SWAGELOK TUBE
FITTINGS AT WESTINGHOUSE REACTOR SEAL TABLES

DATES OF
REVIEW: JANUARY 22-23, 1985 - SEQUOYAH
JANUARY 24-25, 1985 - WATTS BAR

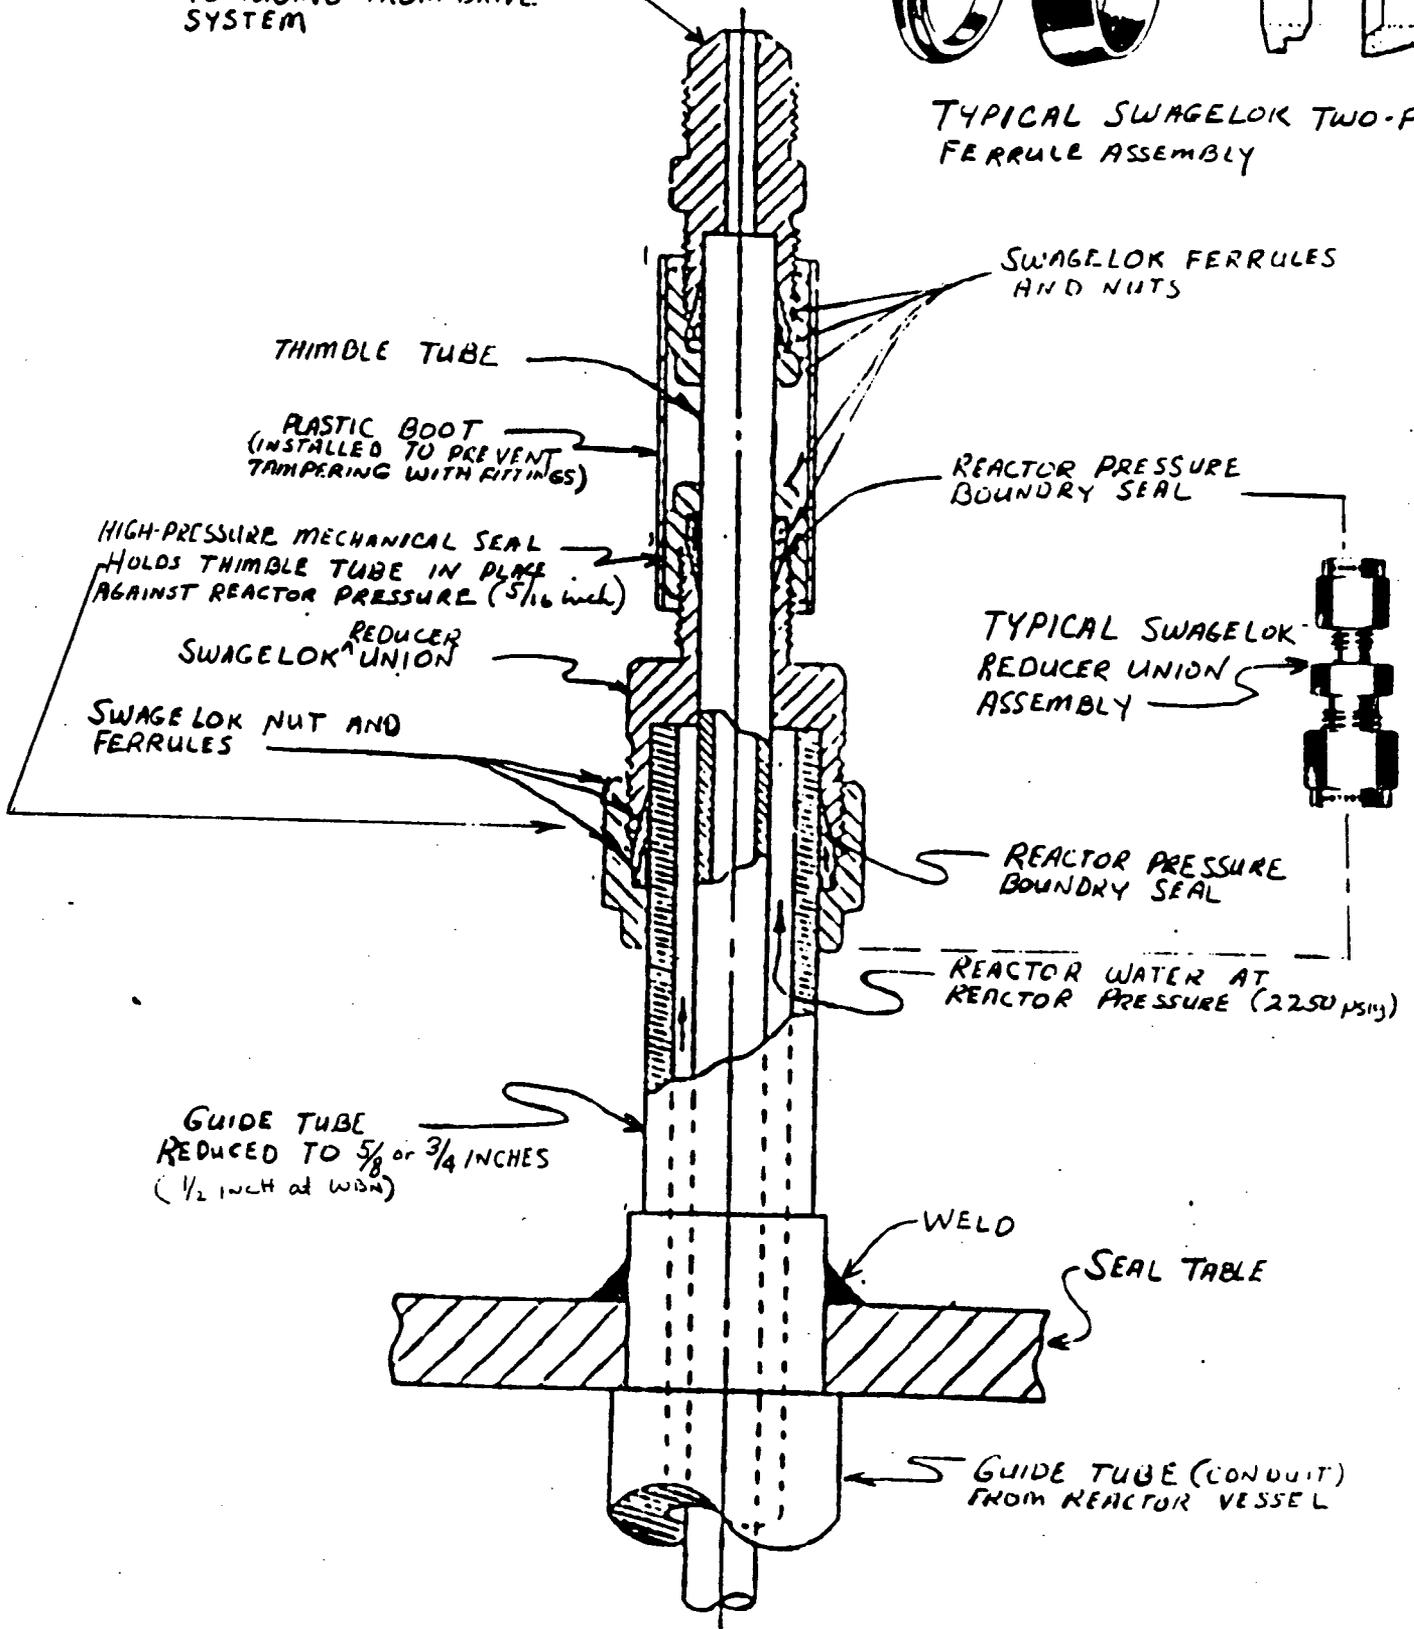
FIGURE 3

SEAL TABLE HIGH-PRESSURE MECHANICAL SEAL
ASSEMBLY (TYPICAL 1 OF 58)

NOTE: OVERTIGHTENING
THE SLOTTED PLUG CAN
CAUSE THE RANGE NUT
TO ACT AS A GEAR
PULLER DISPLACING THE
FERRULE ASSEMBLY TOWARD
THE END OF THE GUIDE TUBE.

MI-1.9 should be revised to clarify that the low-pressure seal cap cannot be used to properly SWAGE newly installed guide tube ferrule assemblies. Reference should be made to SMI-0-94-3, "Seal Table High-Pressure Seal Repair," for high-pressure mechanical repair or proper replacement of new ferrule assemblies on the guide tubes. Some maximum value past handtight should be specified for the low-pressure seal and a caution should be added to prevent exceeding the maximum value which could cause displacement of the ferrule assemblies on the guide tubes.

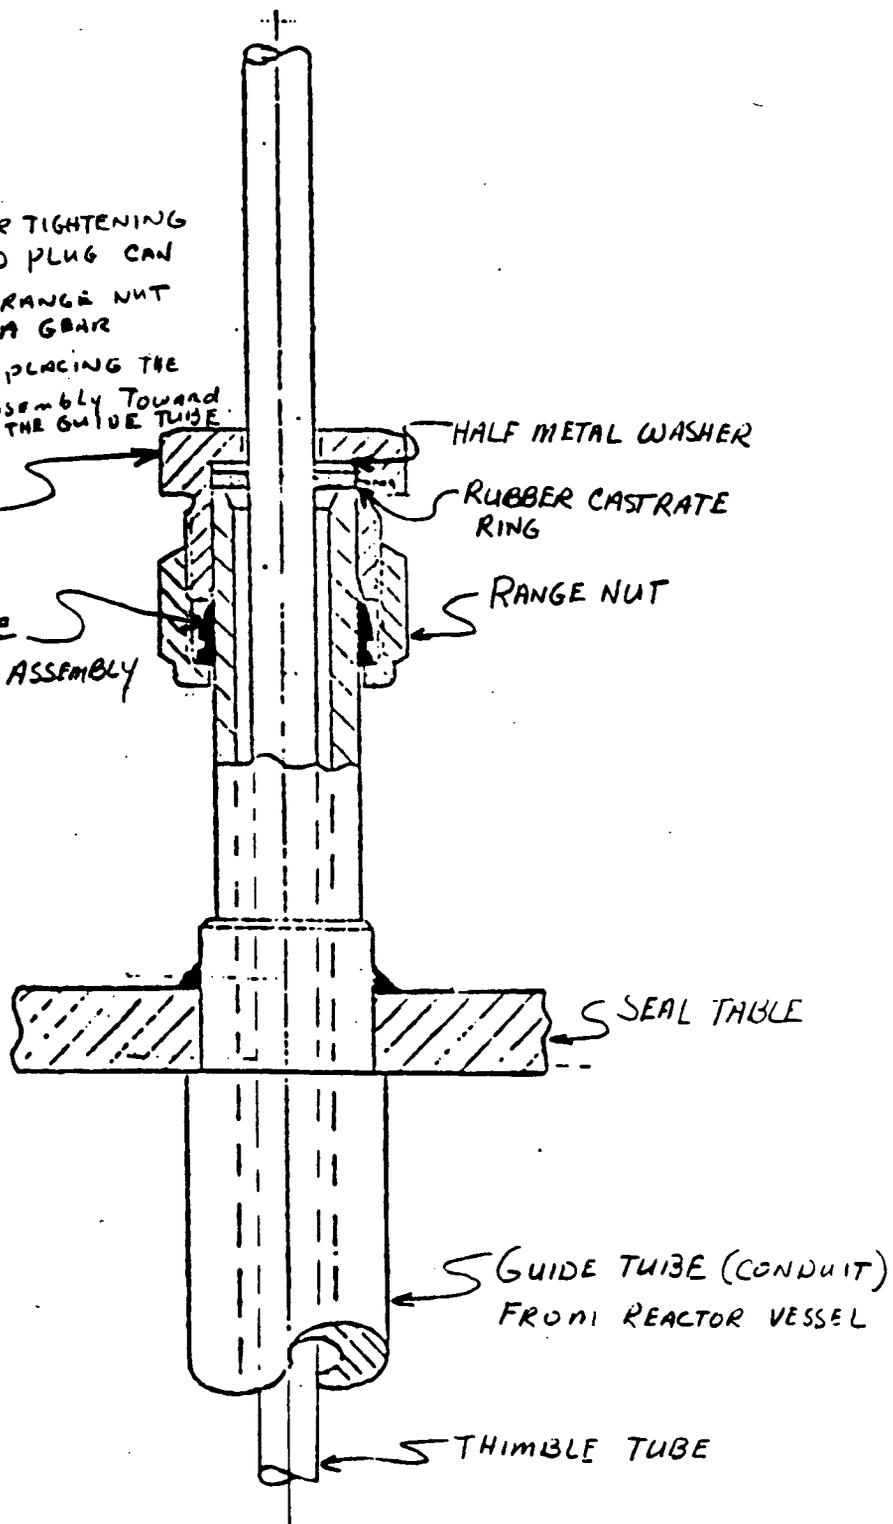
FIGURE 4

Use of the W modified and supplied low-pressure seals had forced ferrule assemblies on the guide tubes out of their sealing position. Over-tightening of the range nut and the slotted plug could cause the range nut to act as a gear puller thus displacing the two-piece ferrule assembly out of its original position and up toward the end of the guide tube increasing the probability of seal failure when the system is pressurized after the refueling operations. The low-pressure seals were not standard SWAGELOK components but were SWAGELOK components modified and supplied by W.

LOW-PRESSURE SEAL USED DURING
REFUELING OPERATIONS WHEN THIMBLES
ARE RETRACTED

A guide tube ferrule assembly inspection step had been added to MI-1.9, "Bottom-Mounted Instrument Thimble Tube Retraction and Reinsertion," that should be effective in preventing reassembly of the high-pressure seals with displaced ferrule assemblies on the guide tube. However, step 5.1.16 of SQN MI-1.9 implies that for a newly installed ferrule assembly on the guide tube the ferrule assembly can be SWAGED with the low-pressure seal cap. It is doubtful that the low-pressure seal cap can properly SWAGE the newly installed ferrule assembly as it is not designed for that purpose. Step 5.1.17 allows snugging the low-pressure seal with a wrench if leakage occurs while raising the water level in the reactor cavity, but no maximum torque value is specified to prevent displacing the ferrule assemblies on the guide tubes.

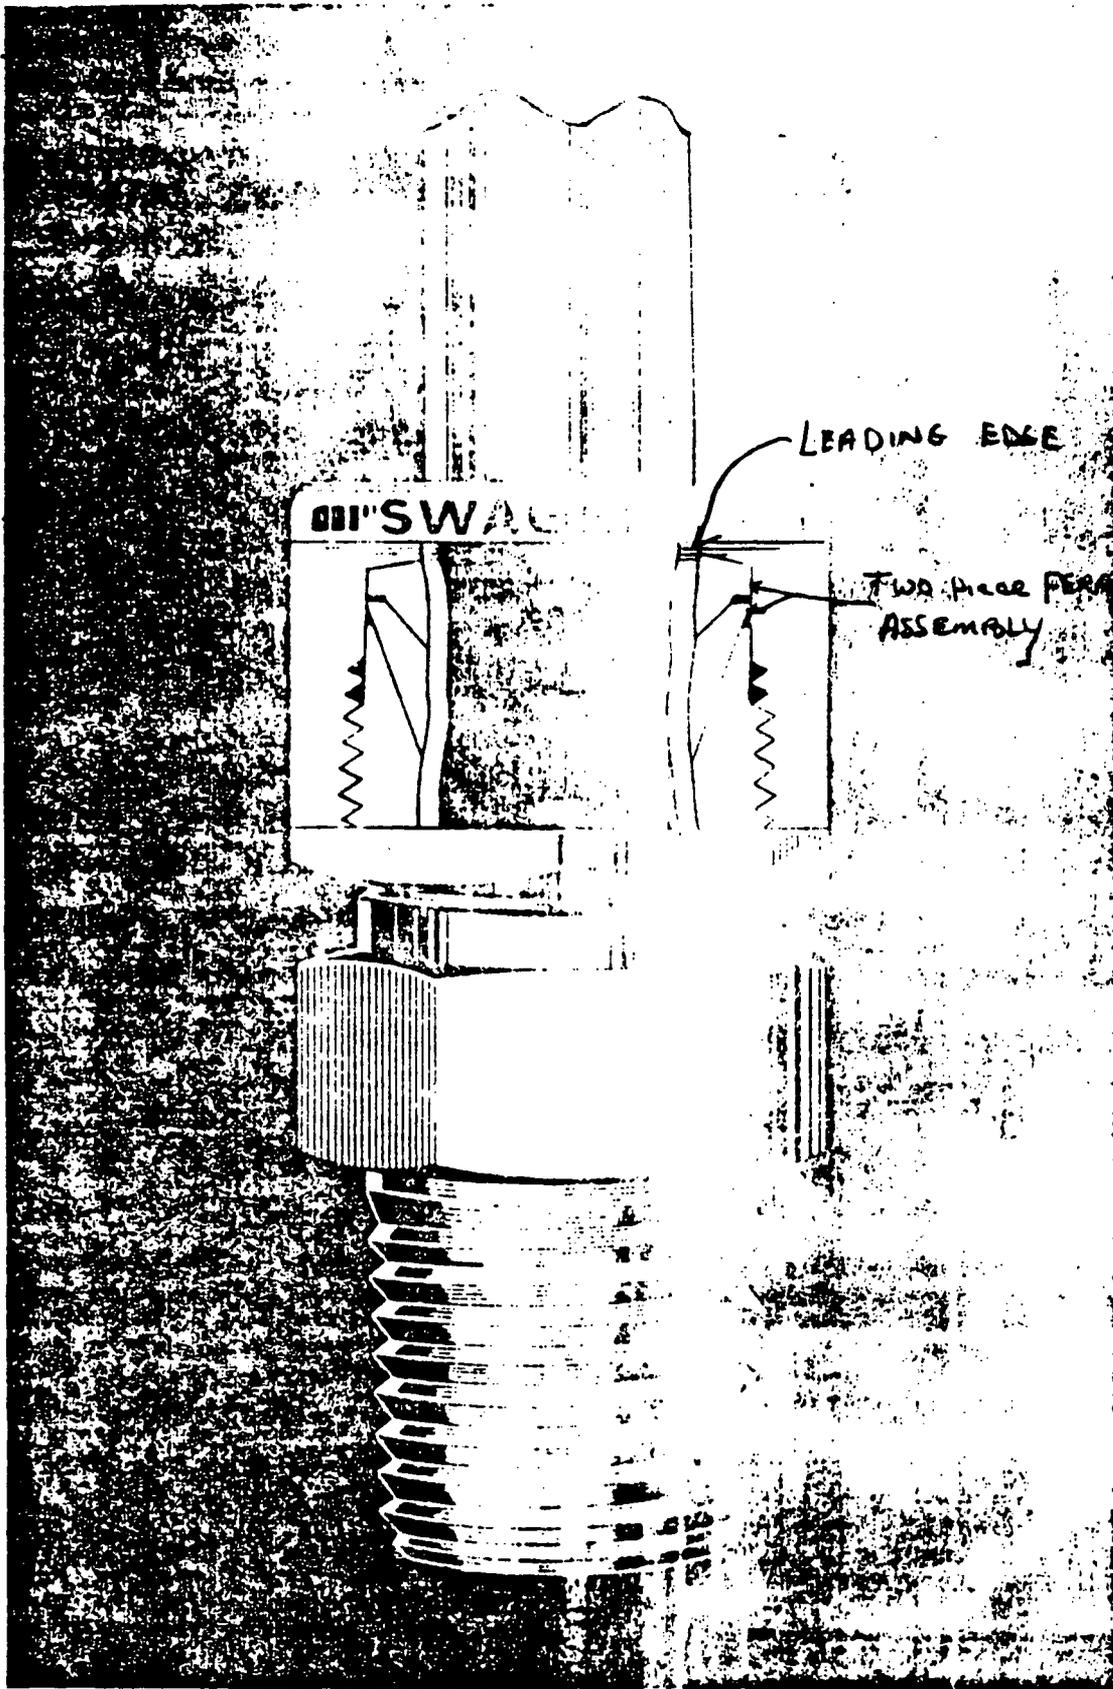
Heavier than recommended wall thickness of guide tubes could result in inadequate "SWAGEING" action (see figure 5) on the tube resulting in improper sealing and holding functions. When the SWAGELOK fitting is tightened on tubing, the two-piece ferrule assembly deforms the tubing in a manner that causes a slight indentation of the tubing and a slight increase in the outside diameter of the tubing above the leading edge of the ferrule assembly. This action forms the seal and secures the ferrule assembly in place on the tubing.

"SWAGING" ACTION OF A SWAGELOK
FITTING ON TUBING.
Figure 5

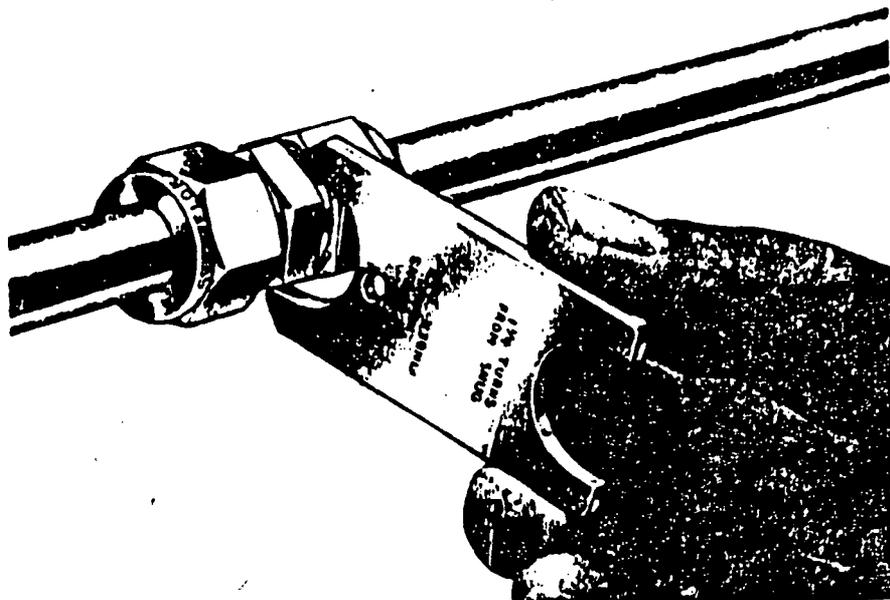
Gap Inspection Gage does not fit between nut and body hex. Fitting is sufficiently tightened.

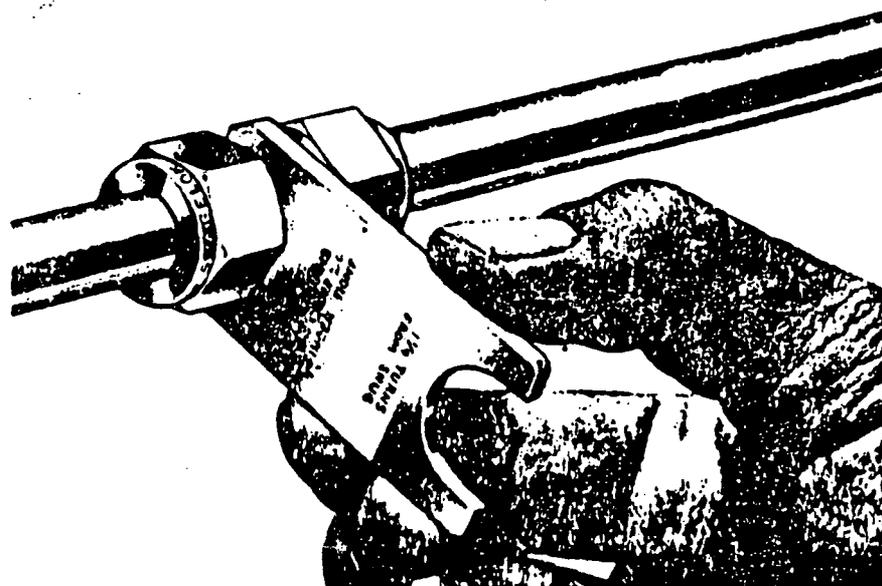
Gap Inspection Gage fits between nut and body hex. Fitting is not sufficiently tightened.
