Electrical Insulation Research Center
Institute of Materials Science, U-136
University of Connecticut
Storrs, CT 06269-3136

Performed for
Tennessee Valley Authority
contract TV-79850T

ANALYSIS OF DAMAGE TO INSTRUMENTATION CABLES
REMOVED FROM
WATTS BAR NUCLEAR PLANT

December 11, 1989

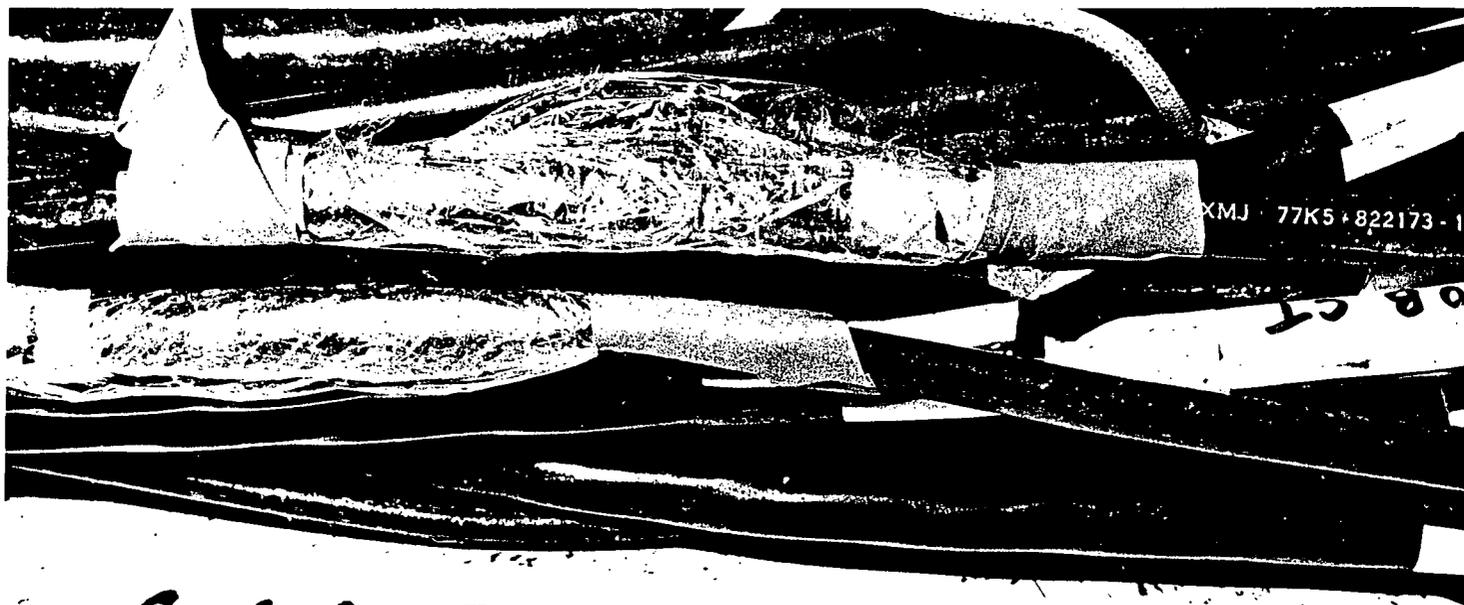
CONDUIT
MC 400 B

Figure 4
Damaged Sites On Cables from Conduit MC
400B, Showing Protective Wrapping Applied
by TVA Prior To Shipment

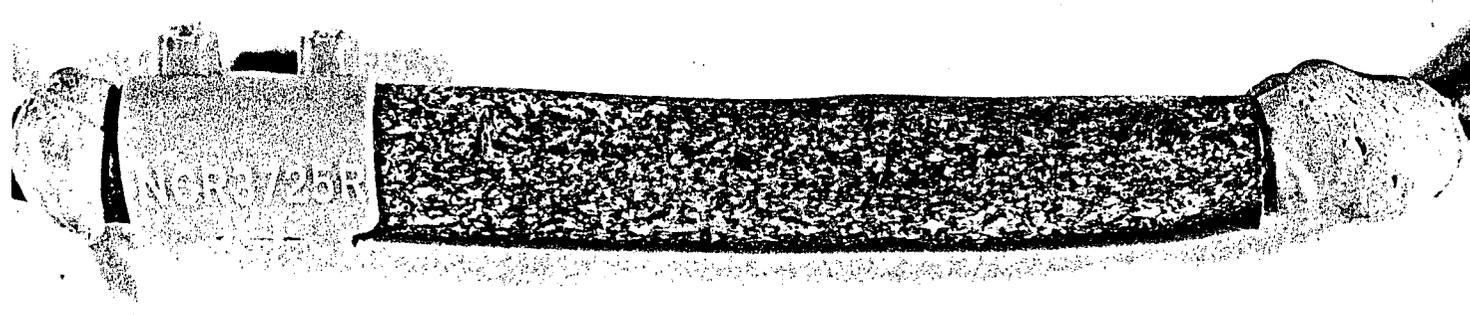
1-2PS-68-283-D
from
Conduit 1PS-702D

Inspection of the suspected repair sleeve, 1-2PS-68-283-D, shown in Figure 18, was first conducted with X-radiography. The corresponding X-radiograph of the cable within the repair sleeve, Figure 19, reveals a cut through the cable jacket. The underlying cable components appeared to be unaffected, but the cable was subsequently dissected for more detailed examination. Figure 20 reveals the cable jacket with the repair sleeve stripped away. The cut in the jacket is shown at the center of this figure, with the open end on the right. The cut was found to have been filled with an elastomeric resin. Figure 21 shows the cable components underneath the jacket cut, with no damage to these components evident.

Figure 18
Cable Repair Sleeve 1-2PS-68-283-D Shown In
Its As-Received Condition

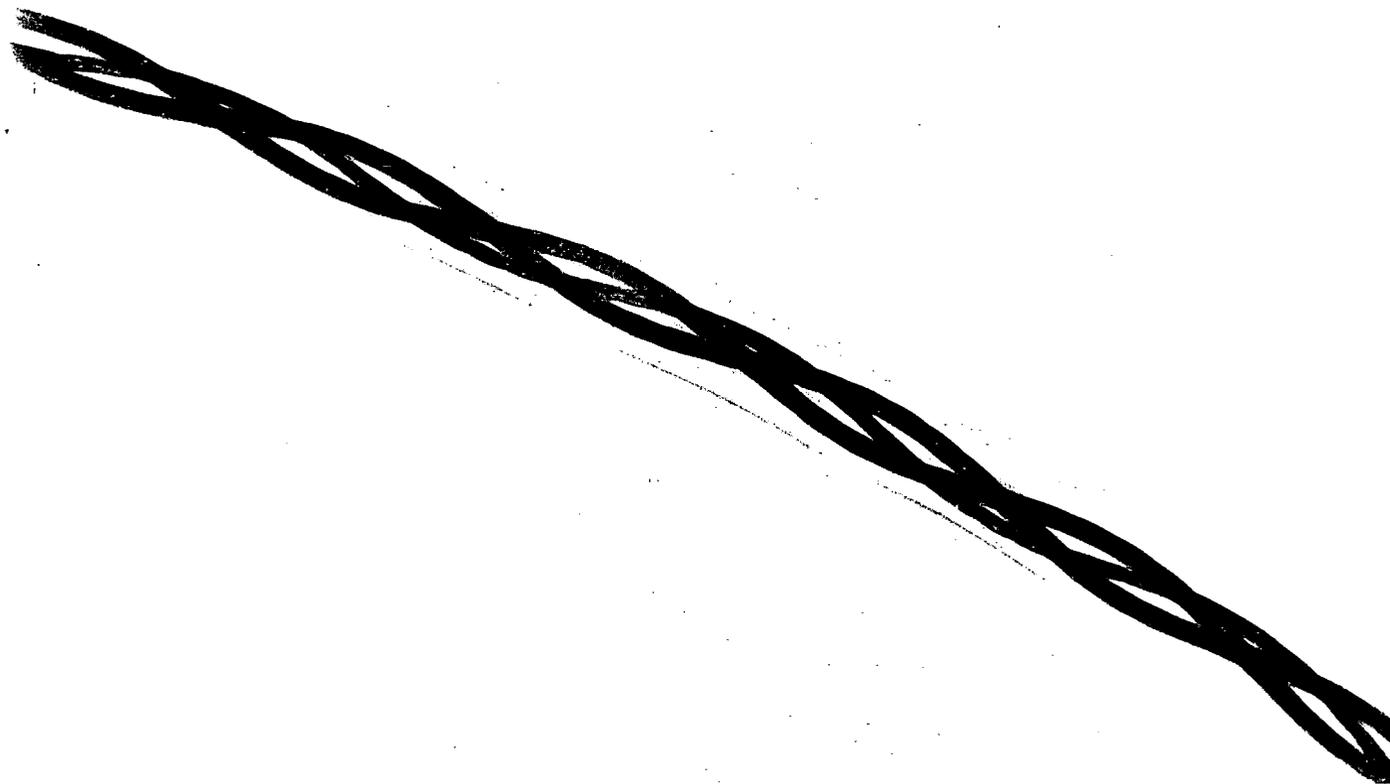
respectively, on the surface of cable 1-2PM-3-3990A. The "bump" on the surface of this cable was subjected to X-radiographic examination, as shown in Figure 24. This shows that there is no interruption in the conductor bundle. Similarly, Figure 25 is an X-radiograph of the "bulge" on the surface of the same cable. Again, there was no interruption in the conductors noted. The "bump" site was subsequently dissected and found to contain a large chunk of material embedded within the jacket, as shown in Figure 26. The "bulge" site was found to contain similar inclusions of material within the jacket. Small bits of these materials were removed from the jacket for characterization. They were found to be black, opaque, brittle, and insoluble in a range of polar and non-polar organic solvents. No further analyses were conducted on these materials. Cable 2PS-284-D was found to contain a similar particle embedded in its jacket immediately under a "bump". X-radiographic inspection revealed that this cable did not contain any interruptions or splices within the conductors.

Figure 24
X-radiograph of "Bump" On Surface of Cable
1-2PM-3-3990A. Location Corresponds to that
Shown In Figure 22

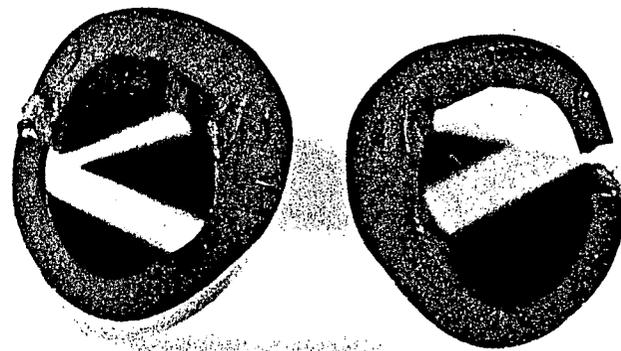
1-2PM-3-3990A

Figure 26
Cross-Section Through "Bump" On Surface of
Jacket, Cable 1-2PM-3-3990A. Note Small
Particle Embedded In Jacket

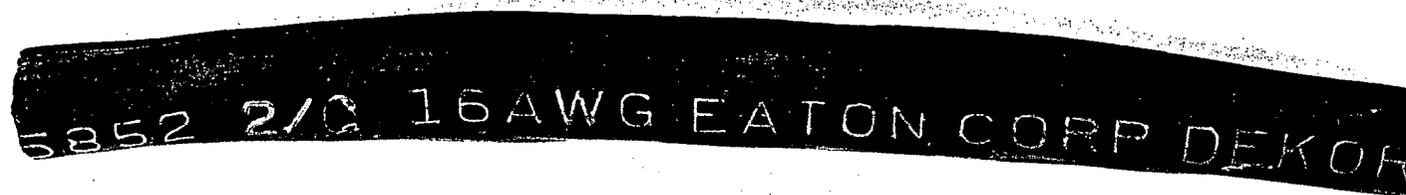
2 PM -1694 D-3

Figure 28
"Bulge" On Surface of Cable 2PM-1694-D
(bottom) with Corresponding Splice In Assembly
Wrap Shown Above

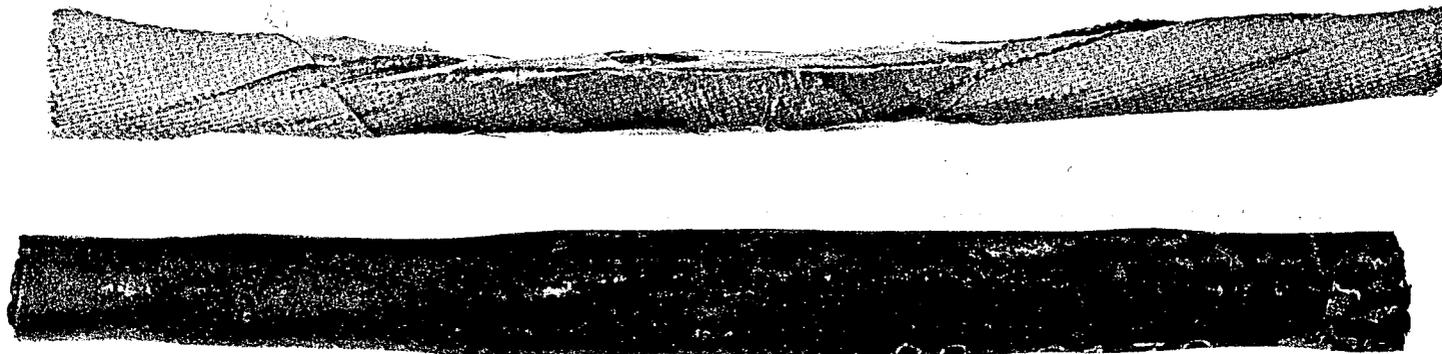
2 PM 1041 D-4

Figure 29
Representative "Bulge" On Surface of Cable
2PM-1041-D (bottom) with Corresponding
Assembly Wrap Splice Shown Above

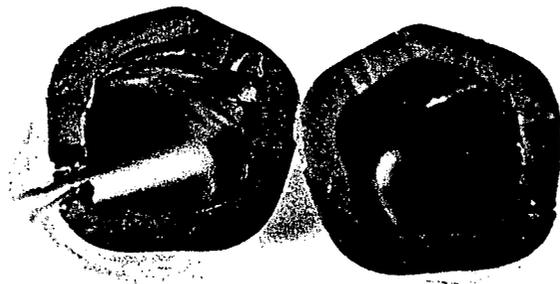
Figure 30
Jacket Cross-Section Through "Bulge" On
Surface of Cable 2PM-1041-D

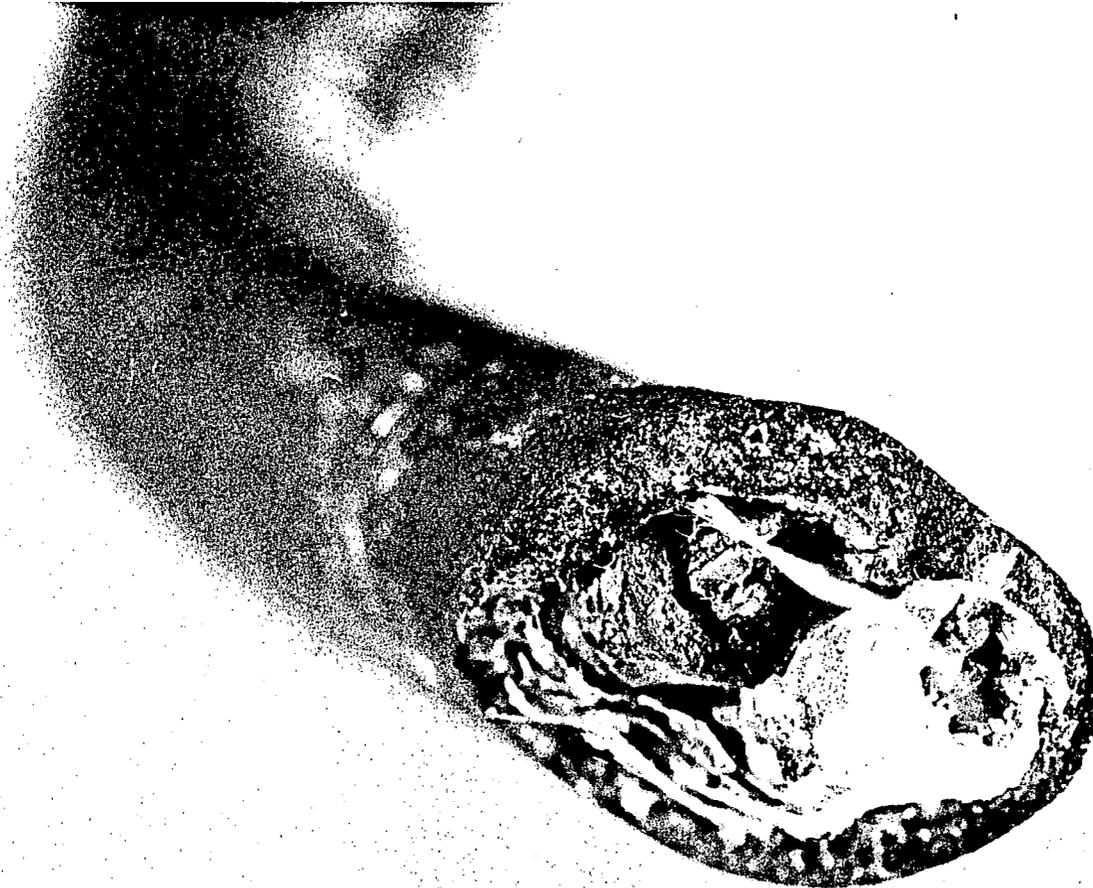
Cable 2PS5281D had been found as a short section that had been abandoned in the WBN Unit 2 conduit in which it had been installed. The ends of this cable were examined in order to determine how it had failed, specifically whether it had broken or had been cut. Figure 31 is an overall view of the end of this cable. In Figure 32, more details of the ends of the conductors are shown. These were found to be elongated and tapered which is consistent with a tensile overload fracture [5].

Figure 31
End of Cable 2PS281D Abandoned In Conduit,
WBN Unit 2

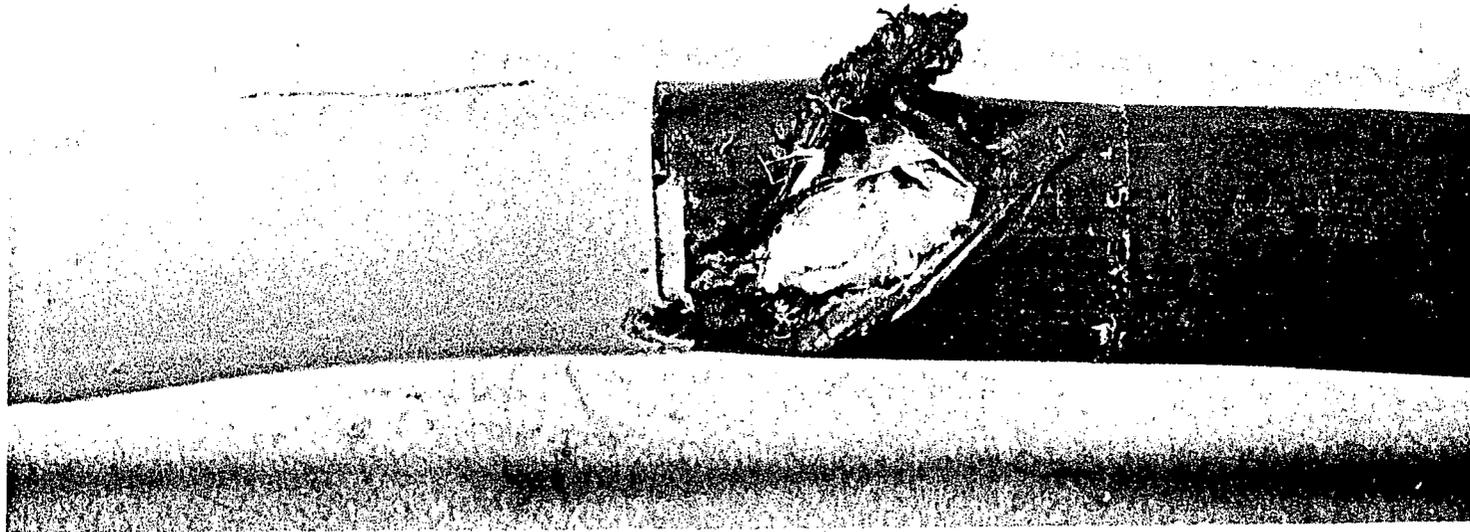
1-PM-1656-D were each found to have a groove approximately 0.150 in. wide penetrating through and limited to the jacket, as shown in Figure 33, for cable 1-PM-778-D. In a short experiment, contacting an unaffected area of this cable with an abrasive cut-off wheel (Makita 12-304), at 3500 rpm, resulted in a site with damage similar to that found on this cable.

Figure 33
Groove In Jacket of Cable 1-PM-778-D Caused
by Cut-Off Wheel Contact

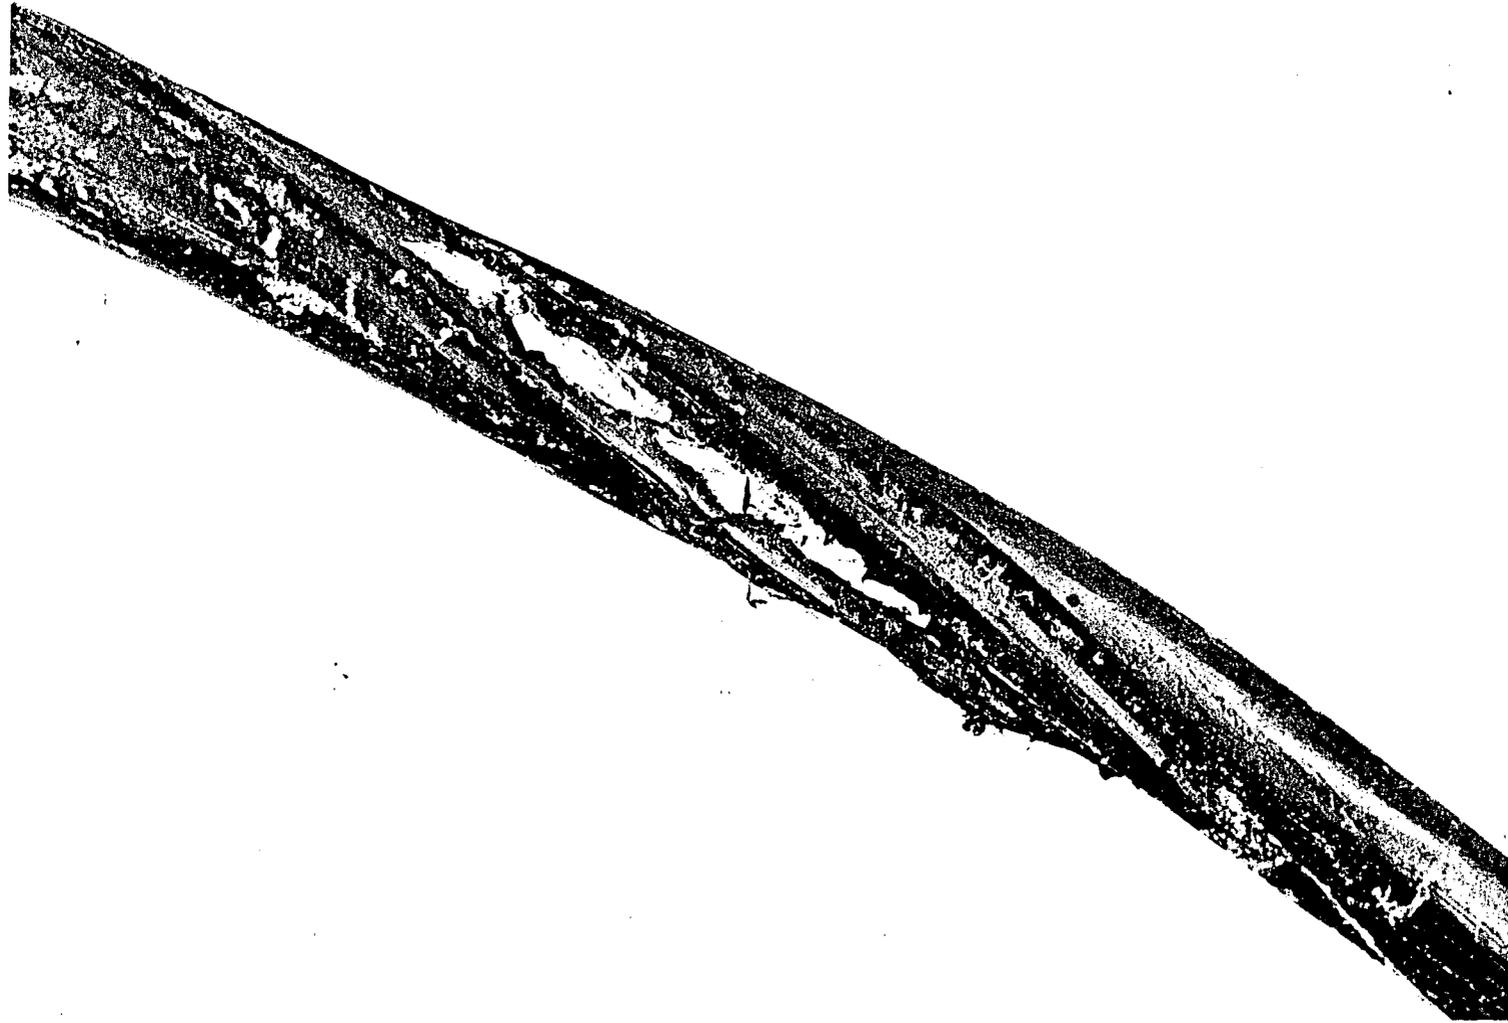
Of the cables listed in Table 6, cables 2PS-284-D, 2PM-516-D, 2PM-871-D, and 1-3M-74-2451-B were found to have deep, narrow grooves in their surfaces, sharing virtually all features with those produced in the pull-by simulations with the parachute cord over the jacketing materials. Cable O-SP-285-529 was found to contain a deep, sharp cut into its jacket surface, through the insulation, with exposed the conductor strands. Figure 38 shows one example of a sharp, long cut in the jacket of cable O-SP-285-529. Cable 2PM-881-D was found to be highly twisted and distorted with the jacket severely pulled back along the cable. This apparently resulted from entanglement with other cables or pull cord in the conduit.

Figure 34
Damage To Surface of Cable 2PM-871-D-1

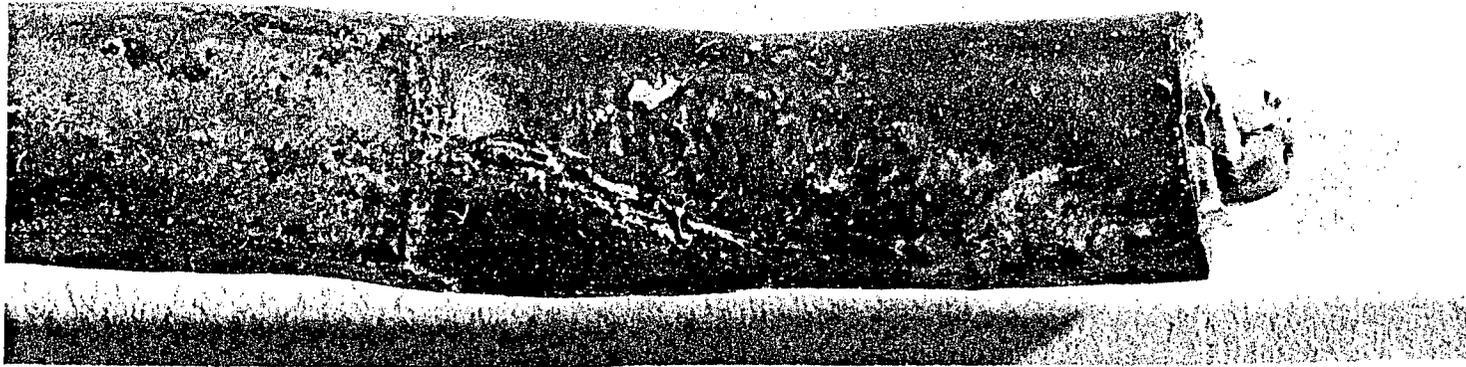
The final group of cables from Table 8, cables 1M-591-B, 1-PM-506-D, and 1-2PM-203-4470-B were found to contain splits in their jackets. Examination of the split surfaces indicated that these were caused by excessive, local tensile stresses. This may have resulted from sidewall tension caused by high frictional contact forces (pull-by) or bunching of the cables during secondary pull-by operations. Figures 36 and 37 show examples of splits in the jackets of cables 1M-591-B and 1-PM-506-D, respectively.

Figure 37
Split In Jacket of Cable 1-PM-506-D

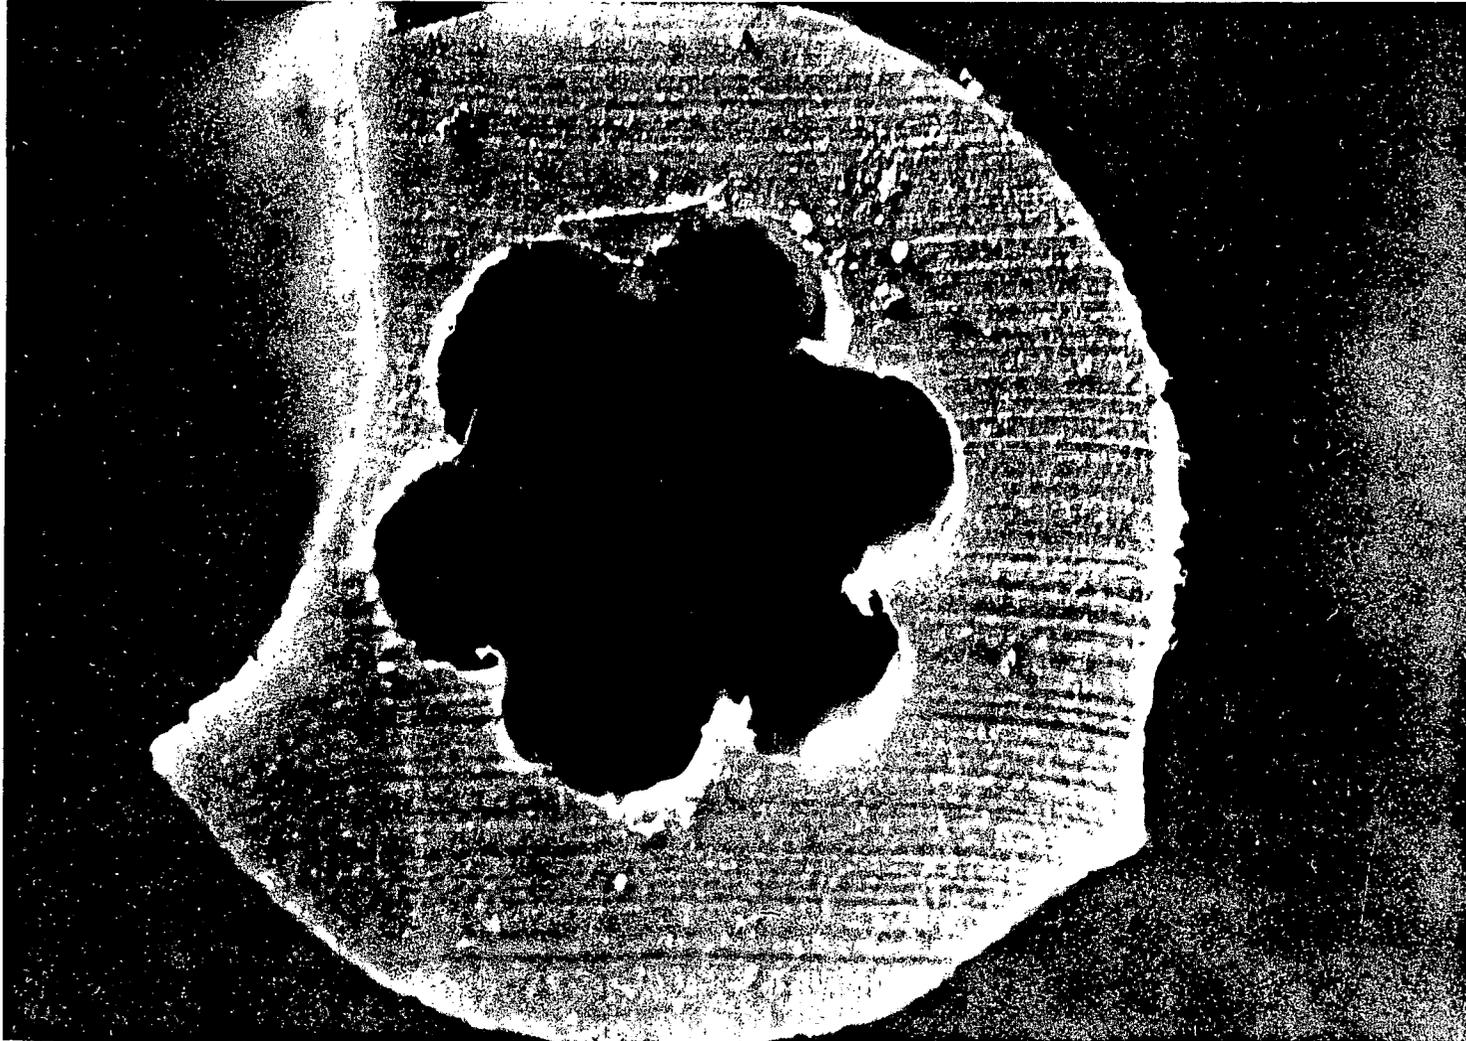
Figure 38
Cross-Section Through Damaged Site of Cable
1M-2450-B

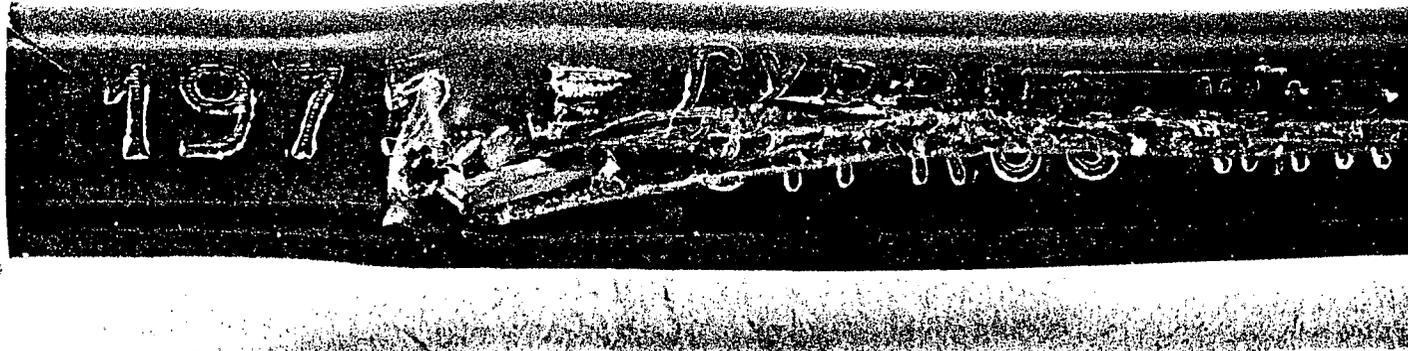
Figure 39
Sharp, Deep Cut In Surface of Cable
O-SP-255-529 (Conductors Exposed)

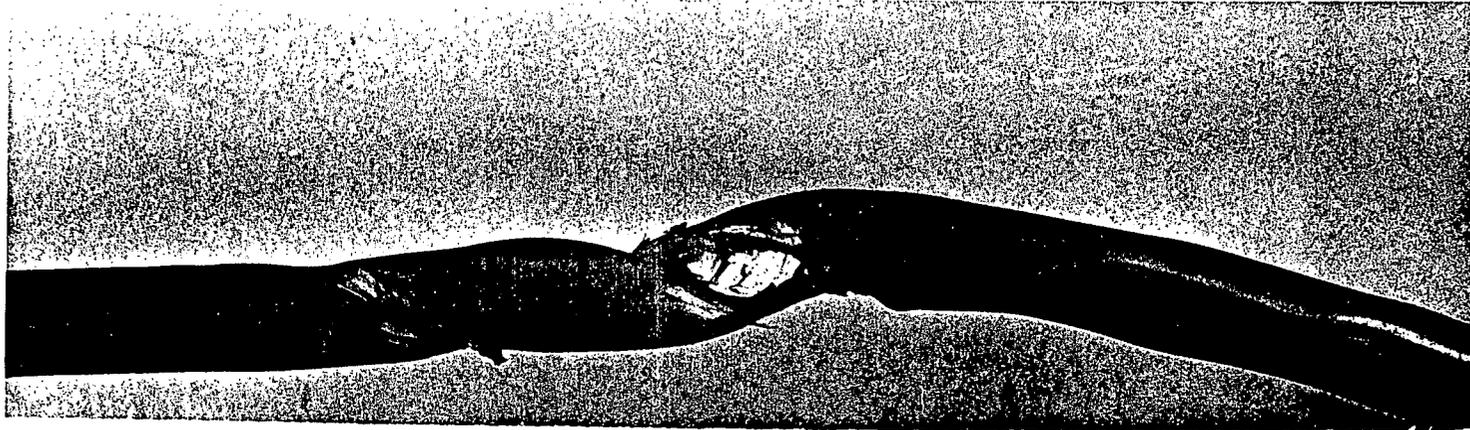
CPE JACKET PULL-BY
SIMULATION

The surface of the CPE jacket was severely damaged by the parachute cord during the pull-by simulations with a contact load of 75 lb. This produced a narrow groove that nearly penetrated the jacket thickness. With a load of 100 lb., the jacket was fully penetrated by the parachute cord, as shown in Figure 39. The groove was measured and found to have a width of approximately 0.13 in. The edges of the groove were found to be smooth, with a great deal of feathering at the edges with "stringers" present. The latter term is used to describe the strings of elongated jacket material extending past the end of the groove cut by the parachute cord. These result from plastic flow of the polymer, caused by high contact forces and high temperature produced by interfacial friction.

Figure 40
Pull-By Simulation Damage To Surface of CPE
Jacket from Contact with Parachute Cord
