# TENNESSEE VALLEY AUTHORITY

## SEQUOYAH NUCLEAR PLANT

## ISOLATED PHASE BUS FAILURE REPORT

JANUARY 19, 1982 THROUGH FEBRUARY 8, 1982

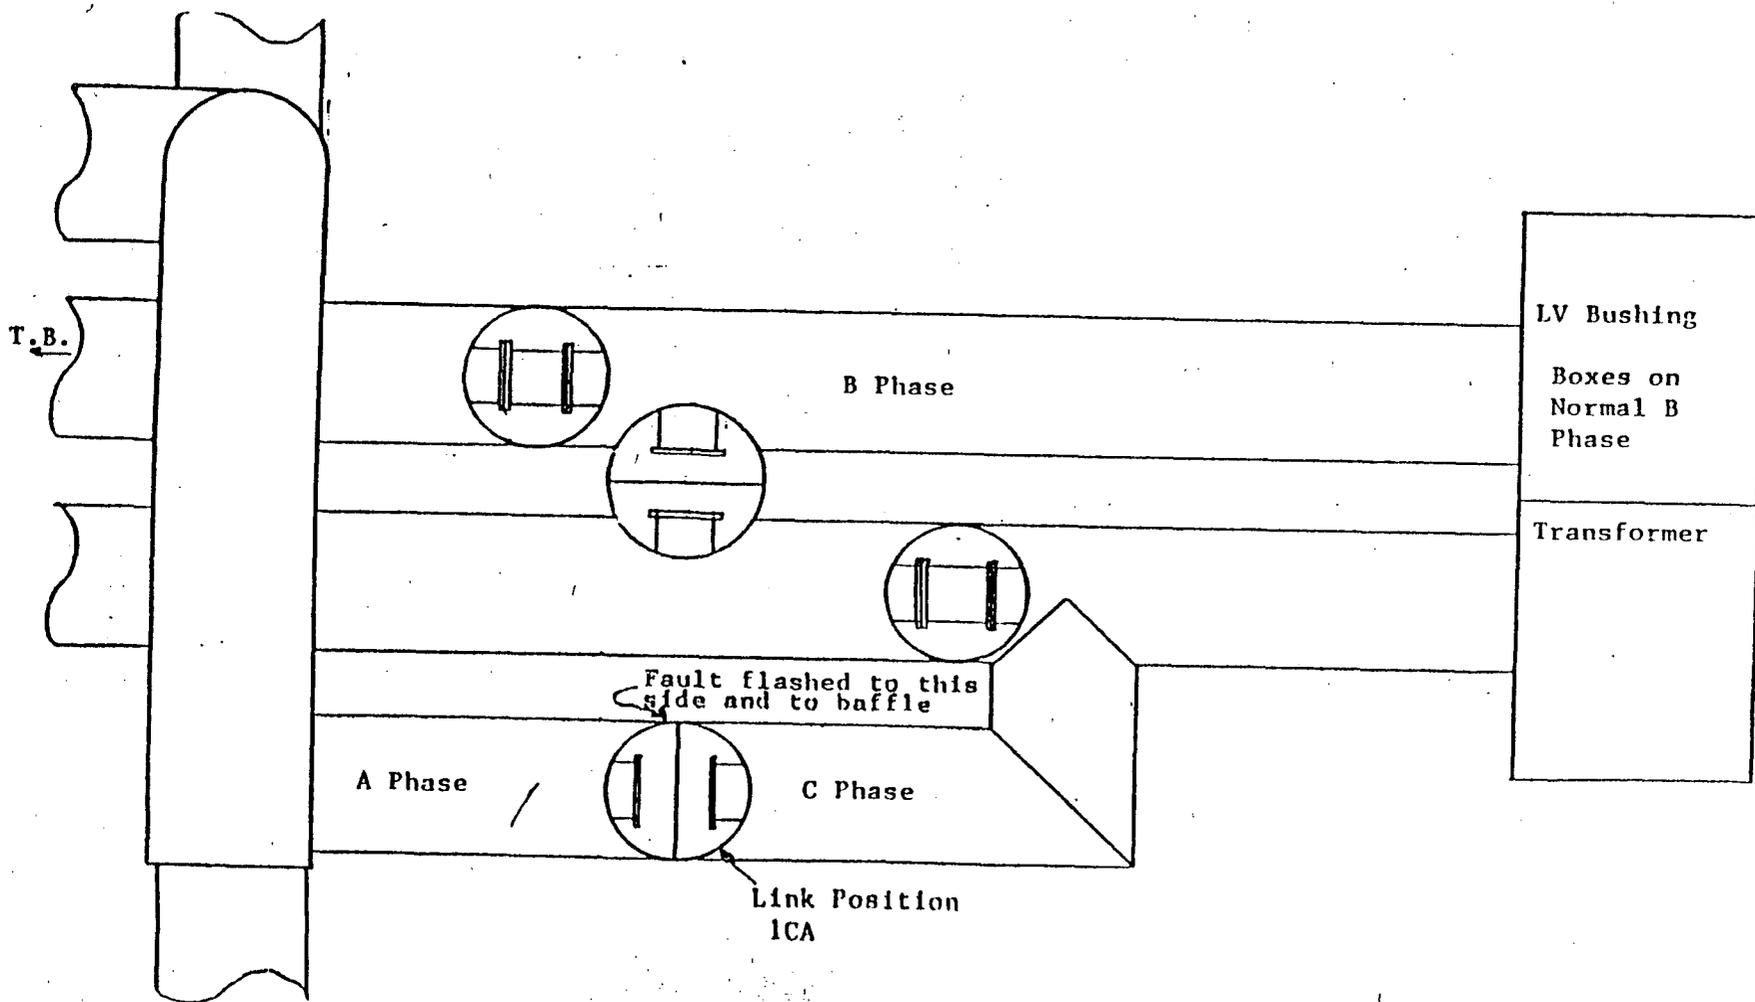
Figure 1. Physical Layout of Isolated-Phase Bus in Fault Area

After the transformer failed, the fault current in the isolated phase bus fault increased causing the end caps, that are removed for access to link position 1CA, to be blown off. The top cap was blown across the top of the B phase main transformer and landed in the gravel near the road. The bottom cover was blown into the B phase main transformer fire protection piping, then fell to the ground. At this point, the fault

During this sequence of events, after the neutral transformer had failed and the generator lost its ground connection, a flash occurred from the neutral bus piece on C phase to the neutral connection housing, burning a hole in the side of the housing and distorting the housing. This flashover and ionized gas, along with the gases from the transformer, were blown into the isolated phase bus where the generator disconnect links are housed via the makeup cooling fans. This, in turn, caused B phase to flash to ground. At this point, all three phases were involved in the fault, but B phase did not get involved in the fault until after the 500-kV breakers were open.

The origin of the ground fault in the isolated phase bus was most likely condensation of moisture on an insulator. If the neutral overvoltage relay had operated properly, the fault consequences would have been minor. The two major problem areas are moisture in the isolated phase bus and some type of backup protection for a ground fault in the generator or the isolated phase bus. Preferably, the detection for this fault should come from another source other than the neutral transformer. The following situation now exists. If the fuses that feed the neutral overvoltage relay are blown, no alarm or other means of detecting the blown fuse is available. The operators take readings from the neutral voltmeter in the control room; however, the voltage that is present

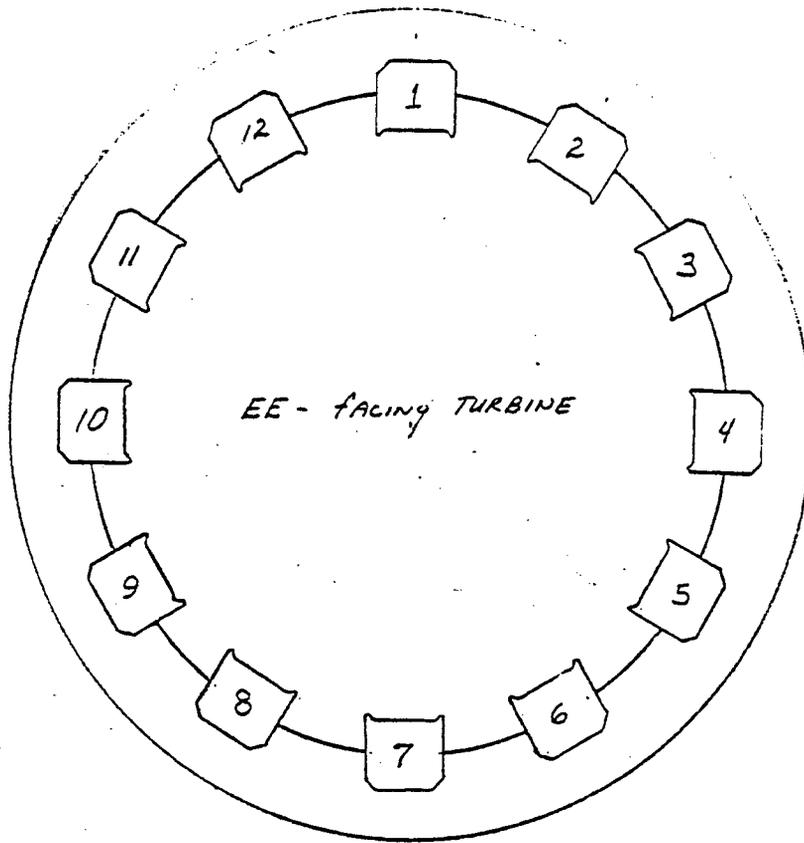
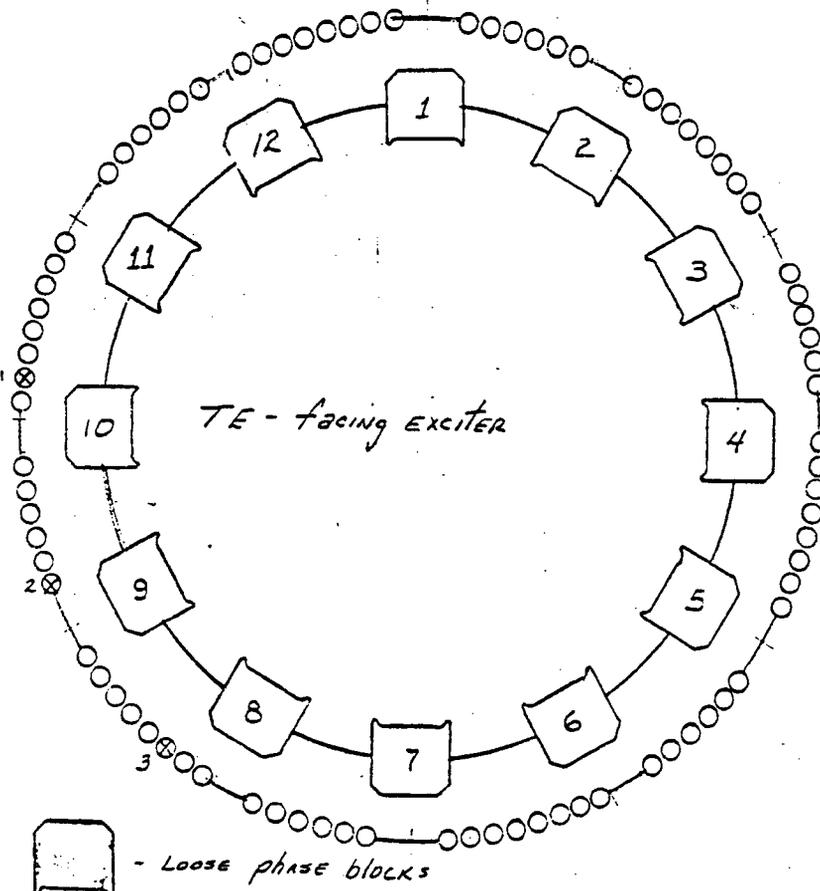
Unit 1 Generator Inspection Diagrams

The backside of the endturns are not accessible on the exciter end and the inspection was limited to the boreside. The overall appearance of the winding was clean but oily. Approximately 10 to 12 ties were found broken, mostly between phase groups indicating relative movement between phases. None of the diamond spacers had been displaced and all appeared captive. There was evidence of vibration dusting appearing at about 10 percent of the spacers. However, it was not severe and this condition has been observed on previous inspections of the unit. Westinghouse stated that most ties are used as an aid in winding and that they are not instrumental in securing the diamond spacers. The spacers are secured by wrapping them in epoxy-soaked dacron and forcing them between the coil halves. The stator slot end wedges were observed to be in their original positions and there was no observable filler strip migration. The rotor retaining ring fit was inspected for arcing and no discrepancies were noted. Of the 12 phase blocks (2 blocks in Westinghouse terminology), 6 were loose enough to be moved by

The overall appearance at this end was also clean but oily. Broken ties were again visible on the boreside (top coil halves) and also on the backside (bottom coil halves). Two of the diamond spacers had fallen out and were found in the bottom of the generator. Another spacer had come halfway out but was not loose enough to be pulled out by hand. Only one phase block was noticeably loose. The relative locations of these blocks and spacers are noted on the diagram in appendix II. Vibration dusting was also observed on this end and is known to have existed prior to this inspection. All stator slot end wedges and filler strips were intact. There were no discrepancies noted on the rotor. The taping on one bottom coil had been cracked and came loose. This was superficial damage and does not violate the integrity of the insulation. Three stator water outlet thermocouples were found defective at the header. One had been broken loose at the nipple and the wires for the other two were broken. Their locations are marked on the diagram in appendix II.

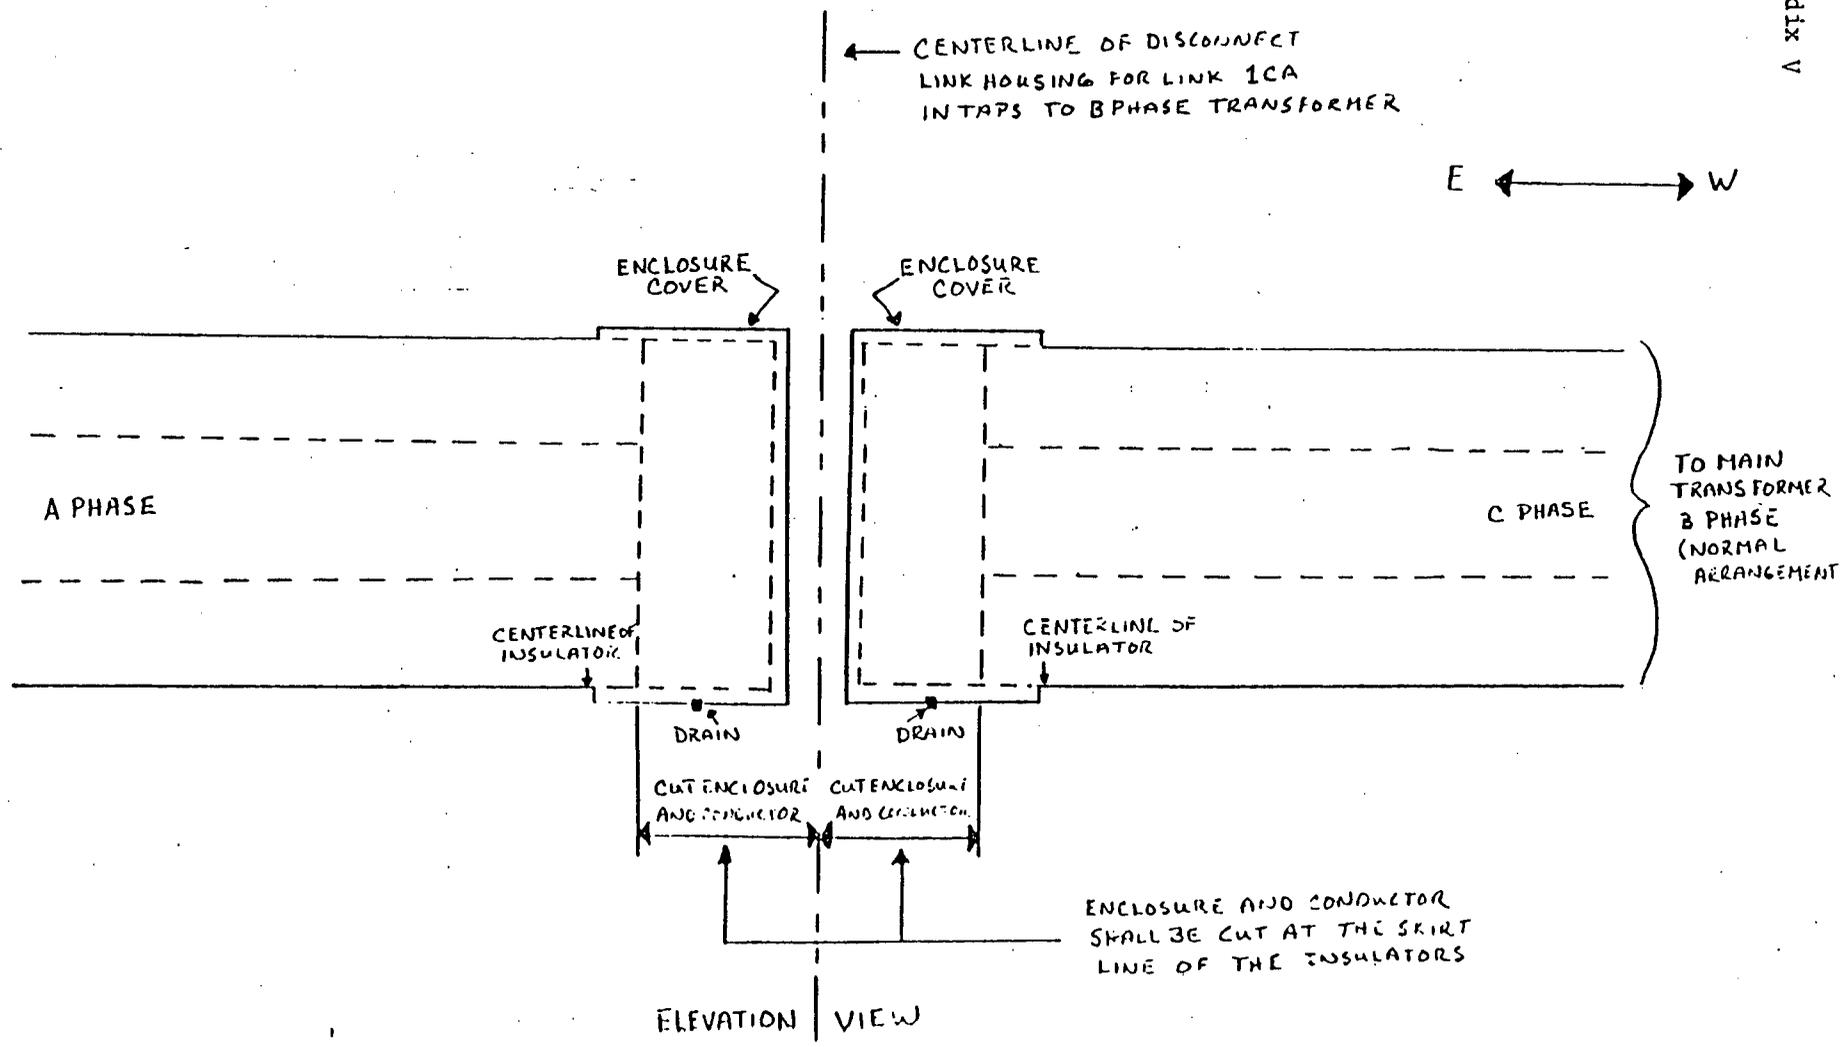
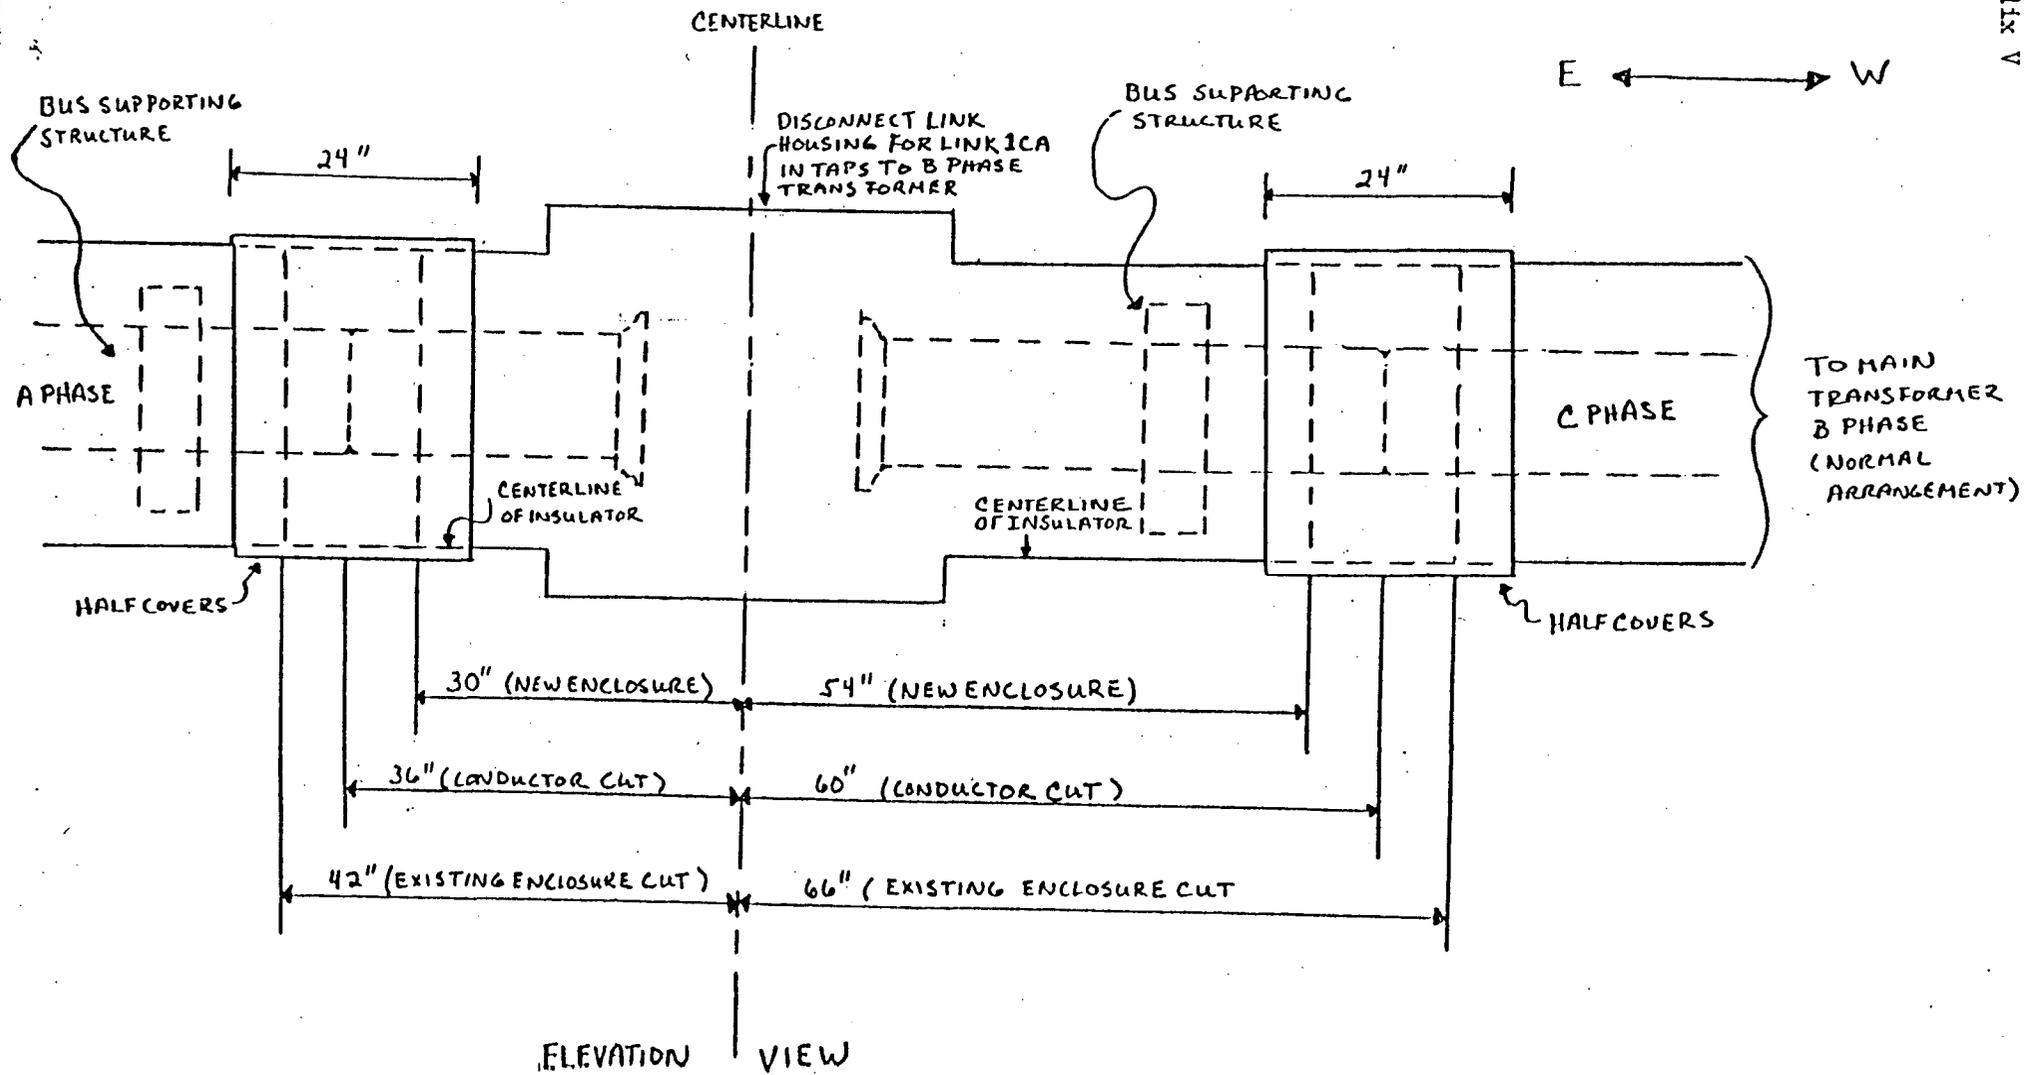
1. Link Position 1CA Temporary Repair
2. Link Position 1CA Permanent Repair

in the isolated phase bus near the normal B phase main transformer, resulted in extensive damage. The top and bottom covers were blown completely from the housing. The air flow baffle was melted away approximately 60 percent. The link mounting flanges on both A and C phases were partially melted. The support insulators were severely damaged and another on A phase was splattered with aluminum. There was no structural damage to the isolated phase bus support structure.

The damage on the 1CA disconnect link was too severe to perform onsite repairs. The delivery date on a replacement disconnect link and housing prevented the complete repair of the damaged section of bus before unit 1 startup. A temporary fix was agreed on and implemented. Appendix V, figure 1, depicts the temporary fix. The permanent repair will be performed during the unit 1 fall refueling outage as outlined in appendix V, figure 2. The three damaged insulators at the 1CA disconnect link were replaced along with two additional insulators discovered during the support insulator cleanup and inspection. Following the cleanup, the isolated phase bus was meggered and dc high-potential tested (see appendix III for results). All tests proved satisfactory.
