Special Report to the Tennessee Valley Authority

**Evaluation and Testing of Cables Removed from Watts Bar
and
Browns Ferry Nuclear Plants**

TVA Contract TV-82820V

prepared by:
The Electrical Insulation Research Center
University of Connecticut
Institute of Materials Science
Storrs, CT 06269-3136

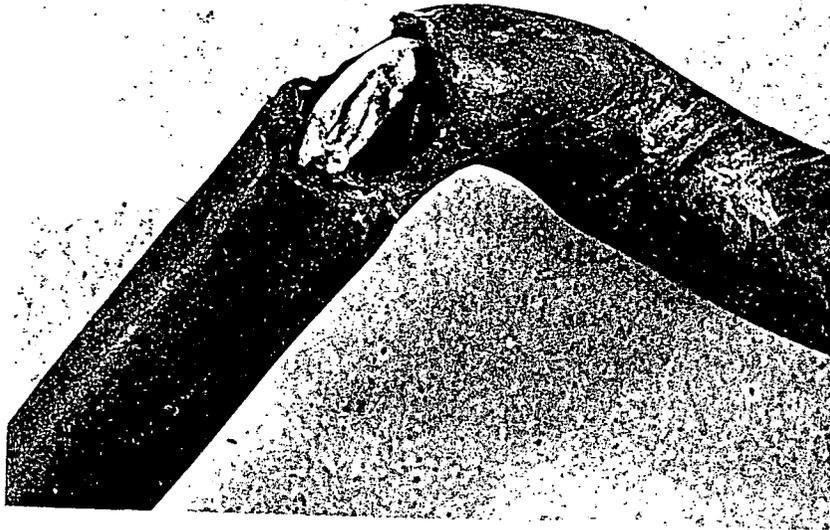
Cable 2PM3806B was noted to contain a significant kink approximately 3" away from footage marker 0009392. The jacket at this location was observed to have been torn resulting in the exposure of the insulations of both conductors. Significant charring of the insulations was noted in the area of the kink. The damaged site is shown in Figure 1. Visual examination revealed evidence of surface tracking, conductor melting, and a large eroded area in the overlying aluminum shield tape. Abrasion

damage on the surface of the white insulation and the black insulation was noted.

Figure 1. Exposed Mechanical Damage and Fault Site At Location of Kink in Cable 2PM3806B

The fault site in cable 2PM3806B was found to correspond to the location of a severe kink. Mechanical damage of the insulation was located at this site and assumed to have compromised its electrical integrity, thus leading to the fault under in-situ testing conditions.

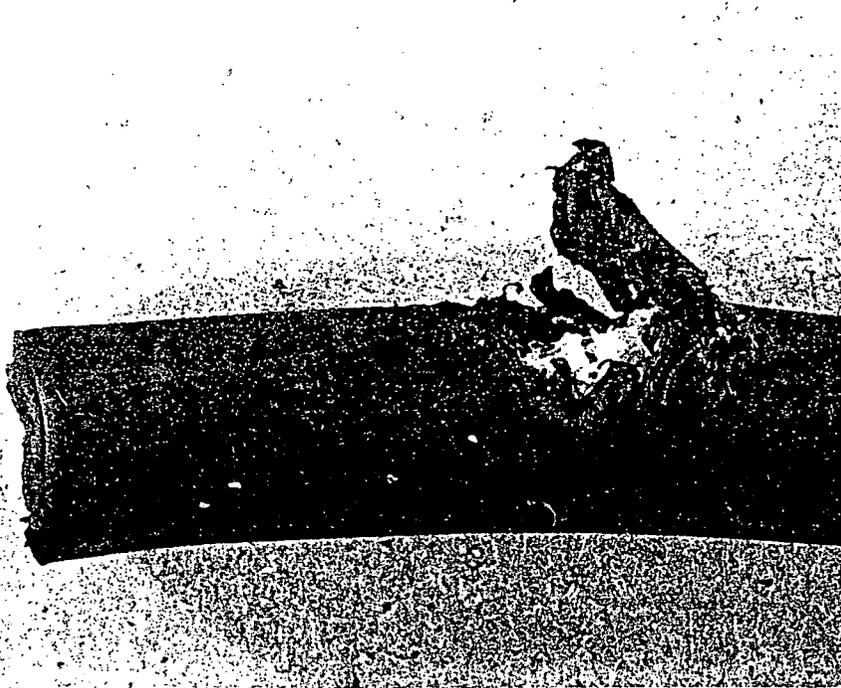
Figure 2. Damaged Site on Cable 2PS207B

Cable 2PS207B was found to contain a series of small cuts in its jacket over a length of approximately 0.45 in. The jacket was observed to be punctured with damage to the underlying shield, assembly wraps, and black insulation, as shown in Figure 2.

Since the fault site of cable 2PS207B corresponded to the site of significant mechanical damage, no further analysis was conducted. The cuts were characterized as having been inflicted by a sharp object/instrument. Surface details at the damaged site

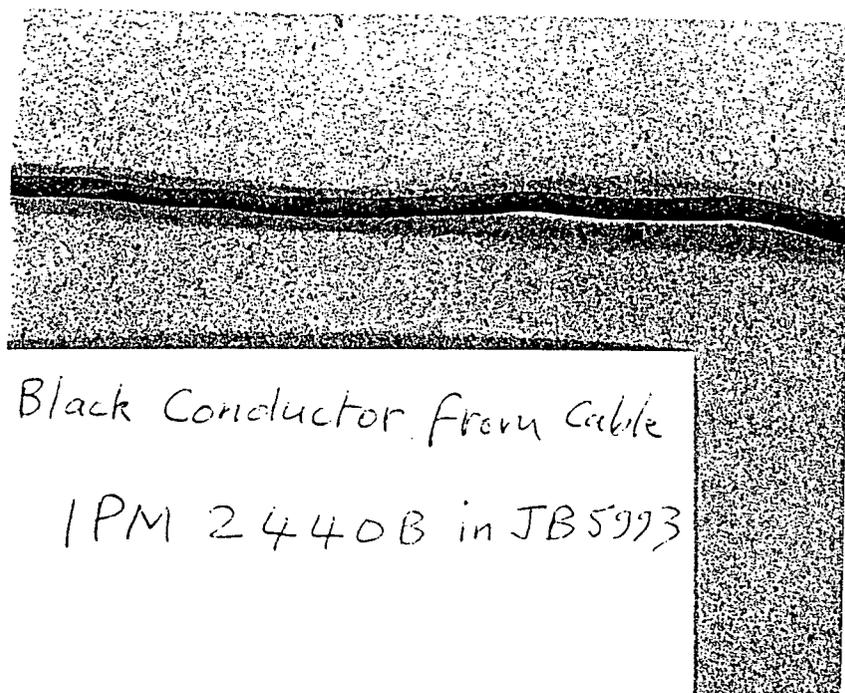
Cable 1PM2440B was found to contain a shallow surface cut approximately 2 in. back from the crimp connector and another sharp cut approximately 4 in. behind the crimp connector. The shallow cut was inspected under a stereomicroscope and found to be limited to the outermost surface of the insulation. It was noted by Kent Brown, of TVA, that this shallow cut was previously

located under a Raychem® insulating sleeve. The second cut was inspected with a stereomicroscope and found to penetrate through the insulation to the conductor. This cut appeared to have been made with a sharp instrument. The insulation was pulled back to expose the conductor strands under the cut. At this location, sharp circumferential score marks were noted in the outer surface of two of the conductor strands. The insulation and conductor strands contained evidence of electrical discharge damage at this location. The deep cut, with underlying conductor damage, can be seen on the right side of Figure 3.

Figure 3. Cuts in Black Insulation of Cable 1PM2440B, Near Crimp Connector

Electrical discharge damage was noted within a small, sharp cut through the insulation of cable 1PM2440B at a location that was not originally contained within the Raychem® insulating sleeve. This cut was determined to have been introduced by a sharp instrument.

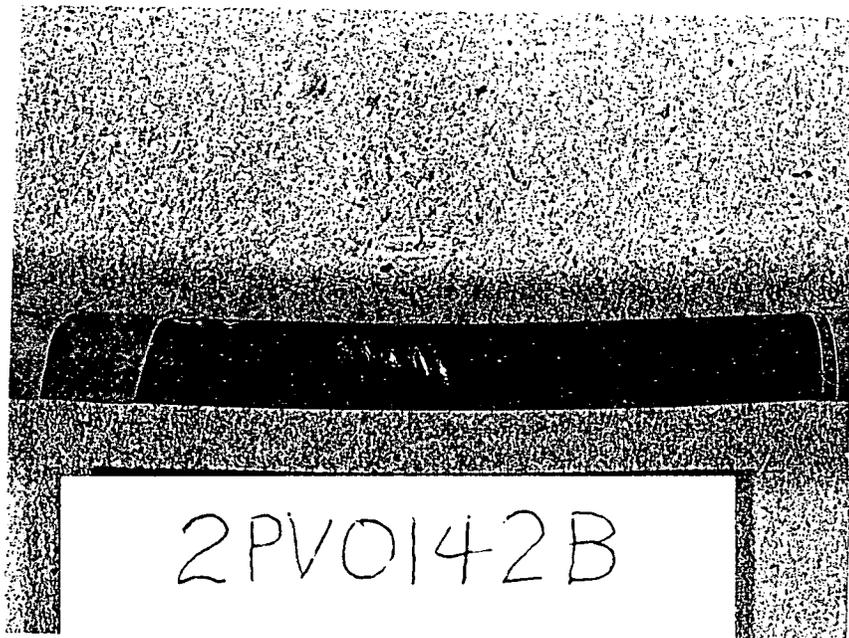
The jacket of cable 2PV142B was found to contain two damaged sites. At the first site, approximately 4 in. away from footage marker 34332, the damage consisted of a series of four parallel, equally-spaced gouges on the outer edge of the cable, adjacent to the white conductor. Their orientation was transverse to the cable length. This damage site is shown in Figure 4. The second damage site, approximately 8 in. away from footage marker 34324, consisted of a longitudinal gouge approximately 1 in. long. At one end, the gouge was very shallow and deepened steadily in one direction, ending with a puncture through the jacket, as shown in Figure 5.

Figure 4. Surface Damage on the Jacket of Cable 2PV142B

At the damage site of cable 2PV142B, nearest footage marker 34324, the damage appears to have been inflicted by the penetration of a tool or other sharp object. From the fiberglass residue found within the gouge, it appears that the object that inflicted the damage was either made with fiberglass or contained fiberglass residues. The damage nearest footage marker 34332 appears to have resulted from high pressure contact with a coarse-threaded surface such as a conduit coupling. The reported failure in this cable was not consistent with the absence of observed electrical damage.

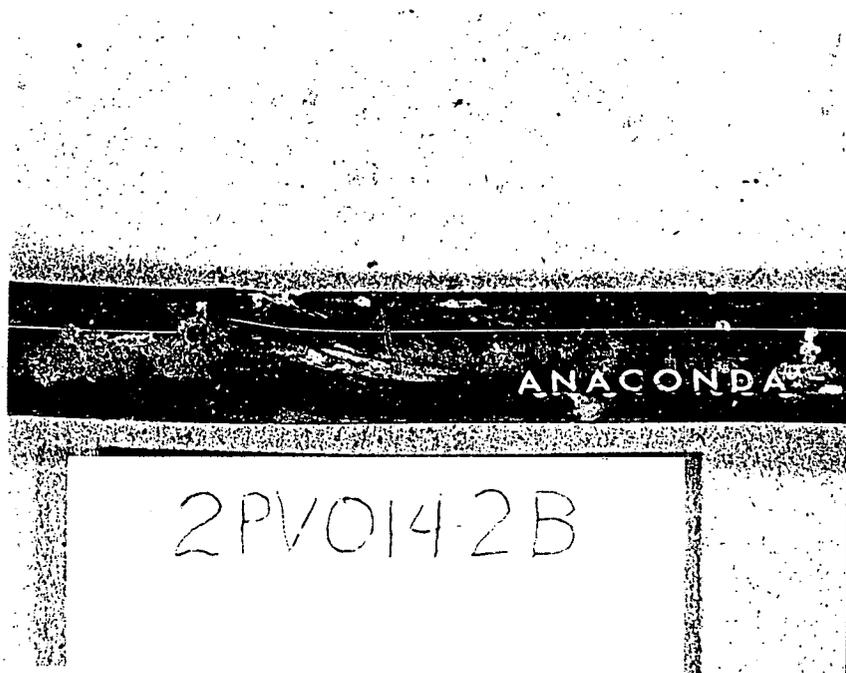
Figure 5. Puncture Site in the Jacket of Cable 2PV142B

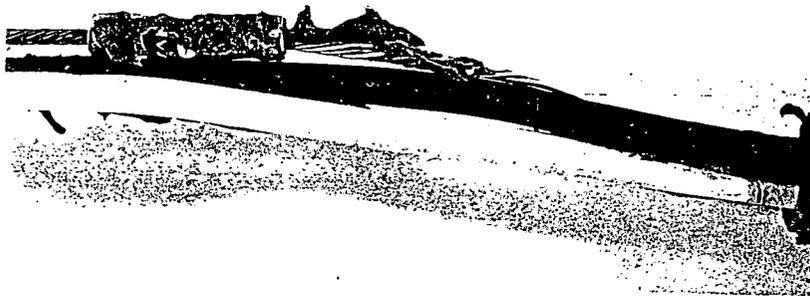
Cable 2PM3765B consisted of a section that had been stripped to accommodate a splice in its drain wire. A considerable amount of red-colored, elastomeric adhesive was present on the surface in the area of the splice. According to TVA, this was a sealant used under the Raychem® splice sleeve. The latter had been stripped for inspection by TVA prior to being shipped to EIRC for evaluation. The black and white insulations were noted to contain sharp cuts, extending approximately halfway around, near the end of the cut-back in the cable jacket. Electrical discharge damage was evident on the surface of the white insulation only. Below these cuts, shallow corresponding nicks were found in the underlying wire strands. The insulation cuts can be seen on the right side of Figure 6.

Figure 6. Exposed Insulation Cuts Located Under Repair Sleeve in Cable 2PM3765B

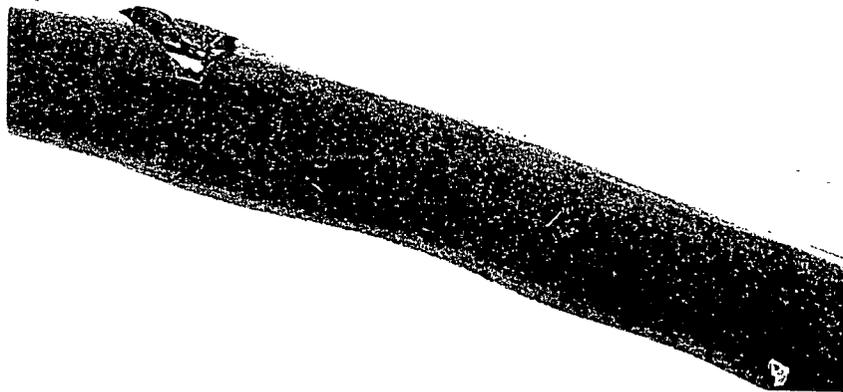
Cable 1PM1835K was found to contain two punctures in its jacket, as shown in Figure 7. The larger of the two consisted of a V-shaped flap, approximately 0.35 in. long. With the stereomicroscope, it could be seen that this penetrated the jacket and that a cut was present through the insulation of the underlying black insulation. Electrical discharge damage was also noted at this site on the black insulation. A smaller puncture was found in the jacket at a location nearly opposite to that of the first puncture. This was limited to the jacket, with no damage to the underlying cable components.

Figure 7. Jacket Damage on the Surface of Cable 1PM1835K

The jacket of cable 1PM1835K appears to have suffered a puncture from a sharp, square-edged tool, such as a screwdriver. The electrical failure in the black conductor of this cable occurred where this instrument caused damage to the insulation.

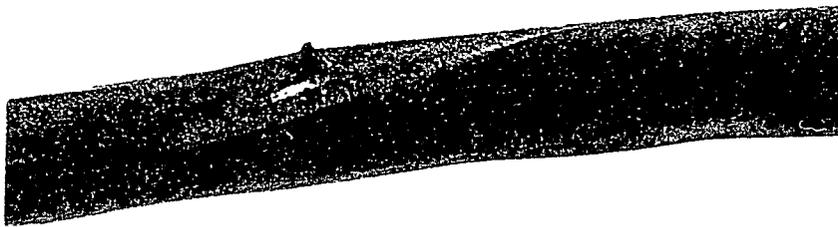
Figure 8. Abrasion Damage on the Jacket Surface of Cable 1PM1381G

Cable 1PM1381G was found to contain a shallow groove in the outer surface of its jacket, as shown in Figure 8. The jacket material was noted to be worn away at this location, with a resulting roughened surface in the bottom of this groove. The groove extended approximately 2 in. along the length of the cable, at approximately the 0001413 footage position. No punctures were found in the jacket at this location.

The jacket of cable 1PM1381G was found to have been abraded. This damage may have resulted from localized high sliding contact force with another cable or pulling rope. The jacket surface of cable 1PM1232G was damaged in a similar fashion.

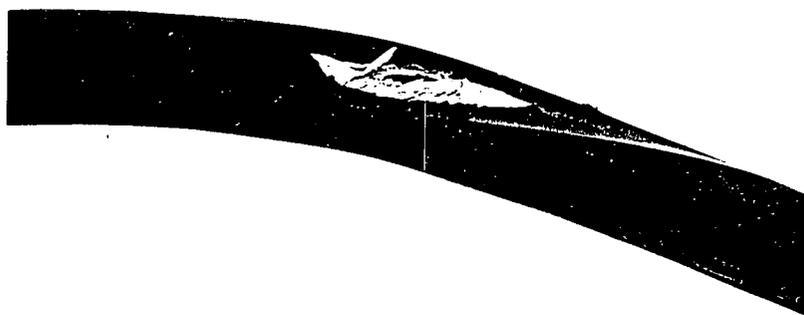
As shown in Figure 12, cable 1PM1026G contained a groove in its jacket, oriented at an oblique angle to the cable axis. The groove was approximately 0.36 in. wide at its greatest width. At the mid-point of this groove, the jacket was penetrated, with limited damage to the underlying assembly wrap tapes. No conductors were exposed.

Figure 12. Groove in the Jacket Surface of Cable 1PM1026G

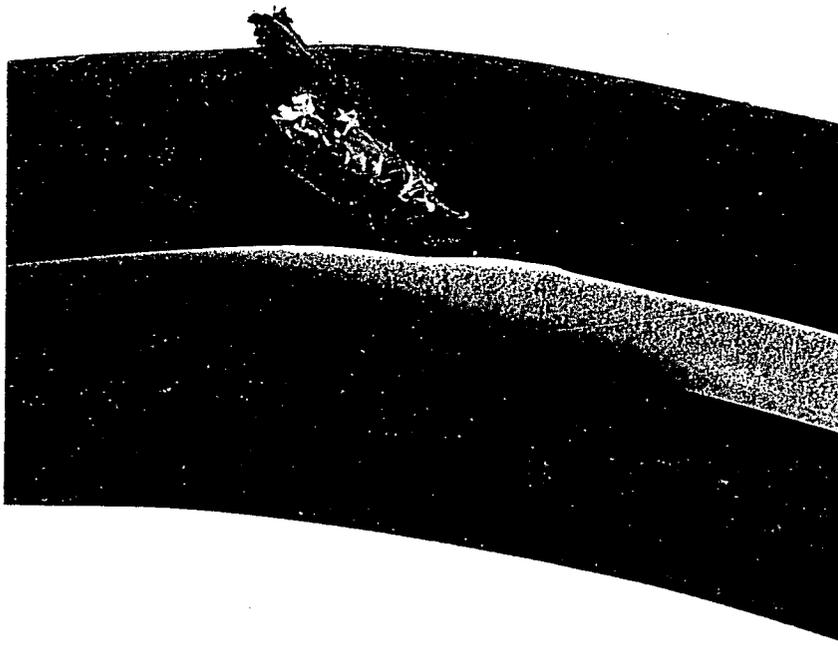
The four longest sections of cable 1PM1661J contained only minor surface nicks and scrapes at all locations except one. Approximately halfway between footage markers 17366 and 17368, a 1 in. long diagonal gouge through the jacket was noted. This is shown in Figure 13. This gouge could be seen to have penetrated through the underlying metal shield and assembly wrap tapes. The section of this cable previously contained within the conduit was found to contain a series of small sharp nicks and scrapes on the end that was nearest the RTV foam fire seal. For examination, the cable had been carefully removed from this conduit to avoid inflicting any surface damage. Figure 14 shows this cable and the conduit from which it was removed.

Figure 13. Gouge through the Jacket and Underlying Assembly Wrap Tapes of Cable 1PM1661J

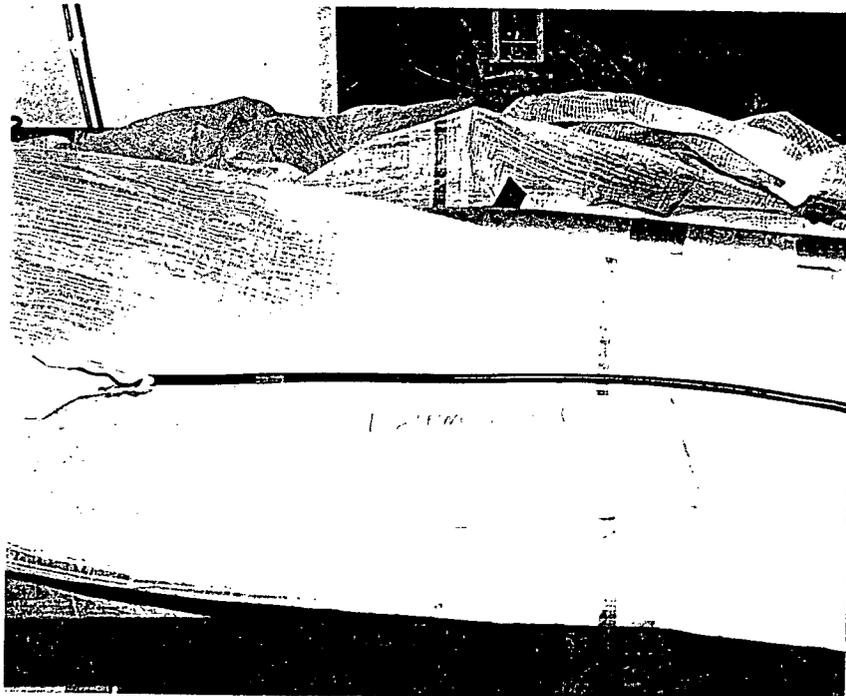
Figure 14. Short Section of Cable 1PM1661J and the Conduit from which it was Removed

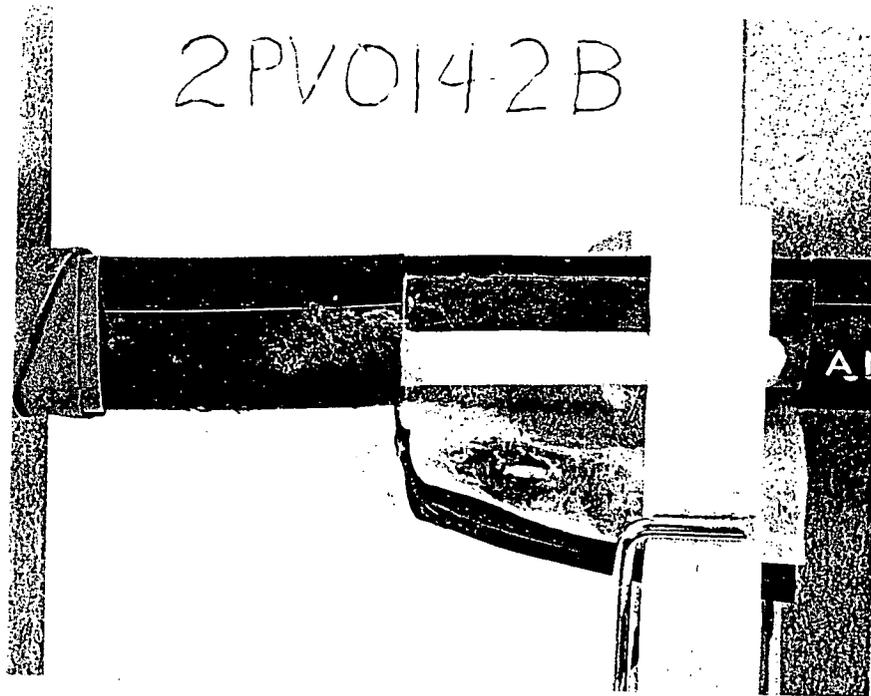
Cable 2PV142B was noted to have failed during in-situ dielectric testing. During visual examination, two sites containing surface damage were noted but there was no corresponding evidence of an electrical failure occurring at either site. At the site of the surface mechanical damage shown in Figure 4, the jacket was sectioned to expose the conductors. No damage was found on the insulation of either conductor or to the overlying assembly wrap tape. The puncture site in this cable, shown in Figure 5, was examined visually and with the aid of a stereomicroscope. The jacket was then dissected to expose the cable components underlying this damaged site. The insulation of the black conductor was observed to contain surface damage, but the conductor was not exposed. This is shown in Figure 15. The gouge and the area immediately surrounding the gouge were found to contain a cluster of glass fibers in a paste-like matrix. The white conductor exhibited no evidence of surface damage. No electrical damage was found at either mechanically damaged site.

Figure 15. Damage on the Surface of the Black Conductor of Cable 2PV142B

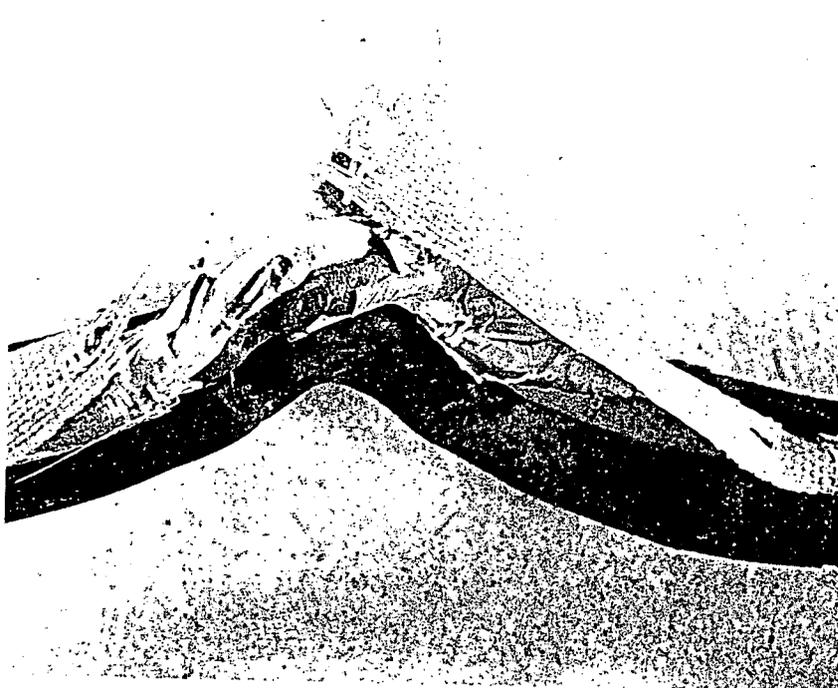
Dissection of the mechanically damaged site on cable 2PM3806B revealed some electrical damage to the white and black conductors. This damage indicated surface arcing between the shield tape and both conductors. The electrical damage occurred at sites where the insulations had been peeled due to the mechanical damage that occurred where the cable had been kinked. This is shown in Figure 16.

Figure 16. Exposed Fault Site in Cable 2PM3806B

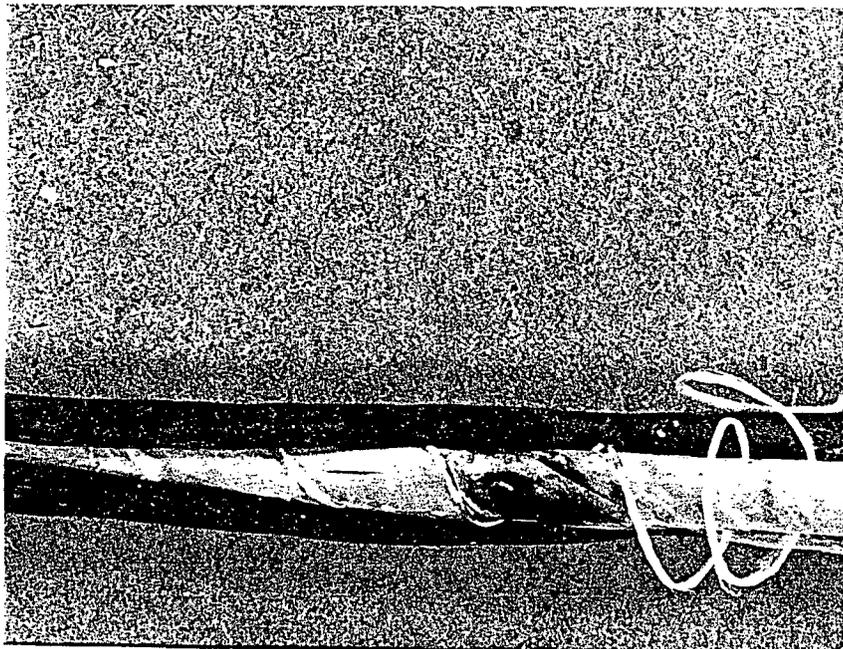
Figure 18. Fault Site in Cable 1PM2485B

Cable 1PM2485B contained a radial fault between the white conductor and the drain wire and shield, as shown in Figure 18. There were no physical or construction anomalies at this site visible with the stereomicroscope. Cable 1PM2445B contained a similar radial fault between the black conductor and the drain wire, as shown in Figure 19. There were no physical or construction anomalies noted at this fault site.

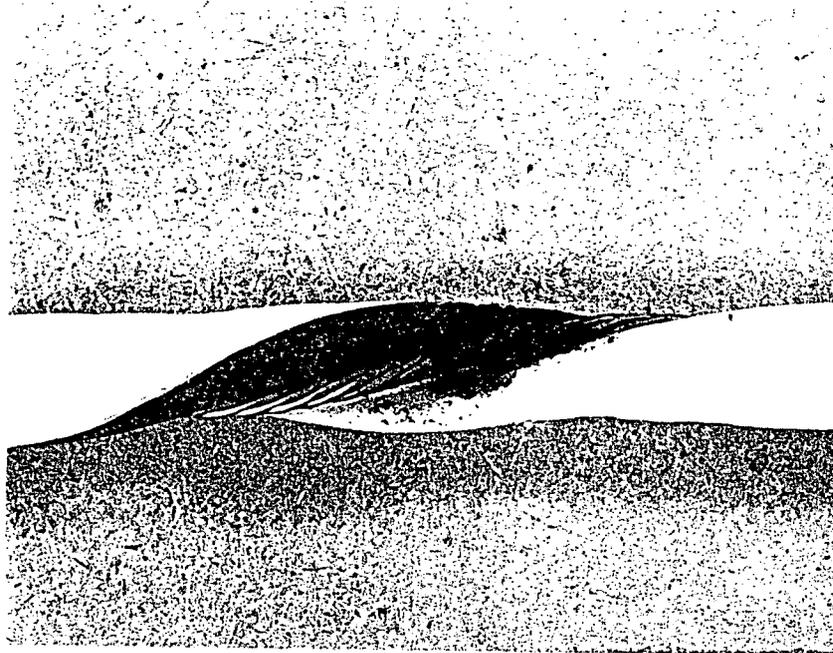
Figure 19. Fault Site in Cable 1PM2445B

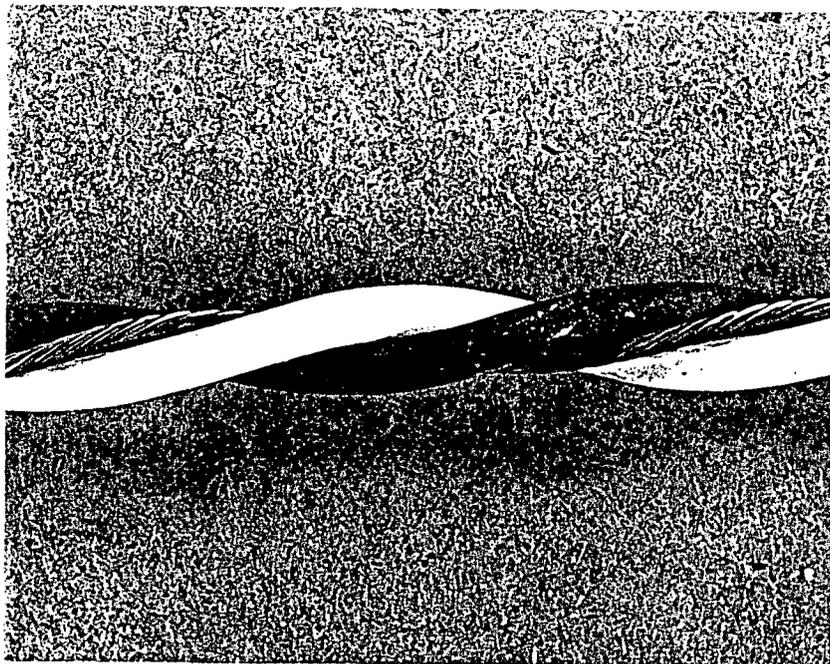
construction anomalies in the cable components could be found at this location.

Figure 20. Fault Site in Cable 1PM2080B

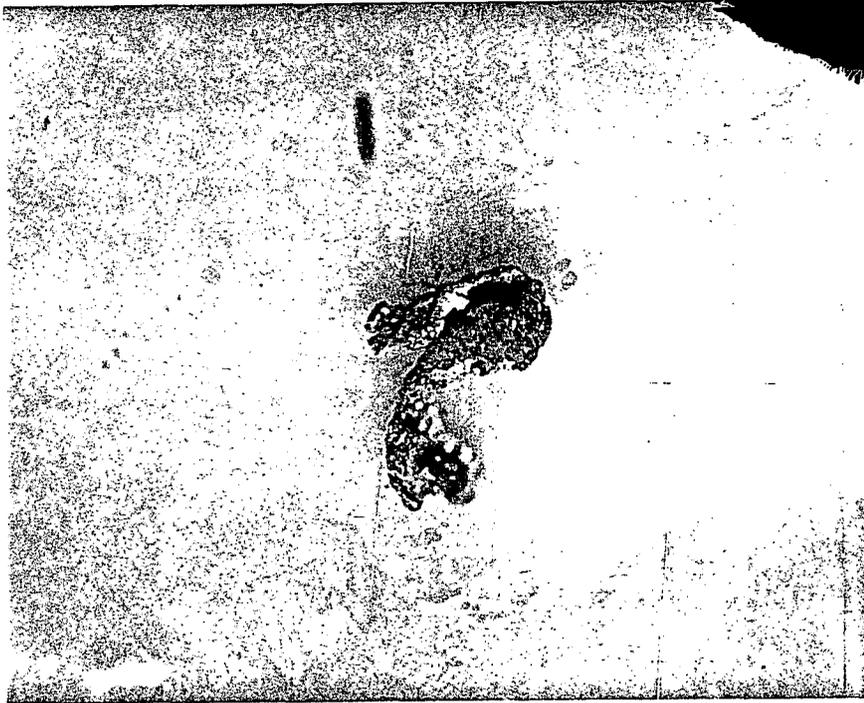
Figure 22. Gray-Black Particle Removed from the Insulation at the Fault Site of Cable 1PM2485B
