R3
From: James Caldwell
To: Jared Heck
Date: 07/05/2007 2:33:16 PM
Subject: Fwd: Additional Document for Davis-Besse Call

Please find attached one additional section from the Exponent report regarding the wastage of nozzle 3 of the Davis-Besse head that may be helpful to review in advance of tomorrow's call.

10. The Unique Nature of the Davis-Besse Nozzle 3 Crack and the RPV Head Wastage Cavity

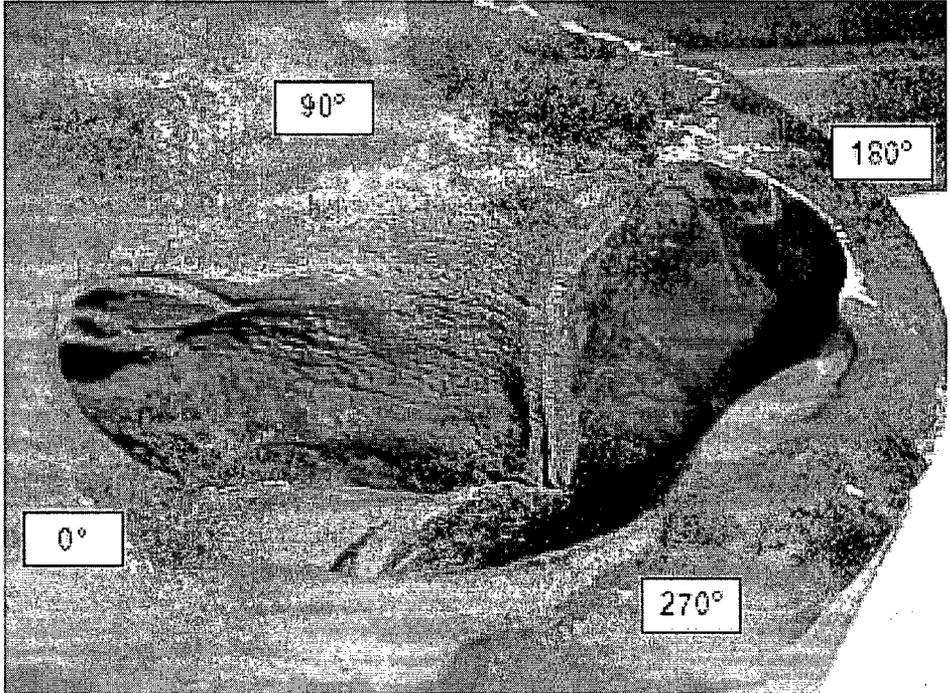
Figure 10.3 View of cavity looking toward 90°

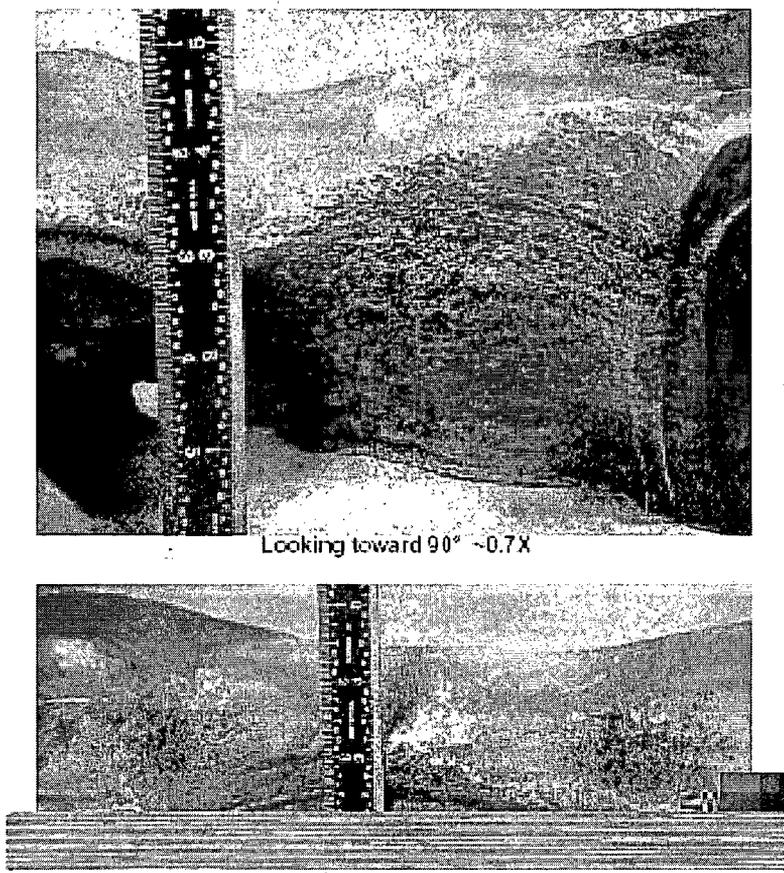
- General corrosion of the upper RPV head surface around the cavity is evident to a depth of 1 to 1.5 inches. This can be seen in the view of the top section of the cavity (Figure 10.4) and more clearly shown in the dental mold impressions (Figure 10.5).

Figure 10.4 Low magnification photographs of cavity sidewalls

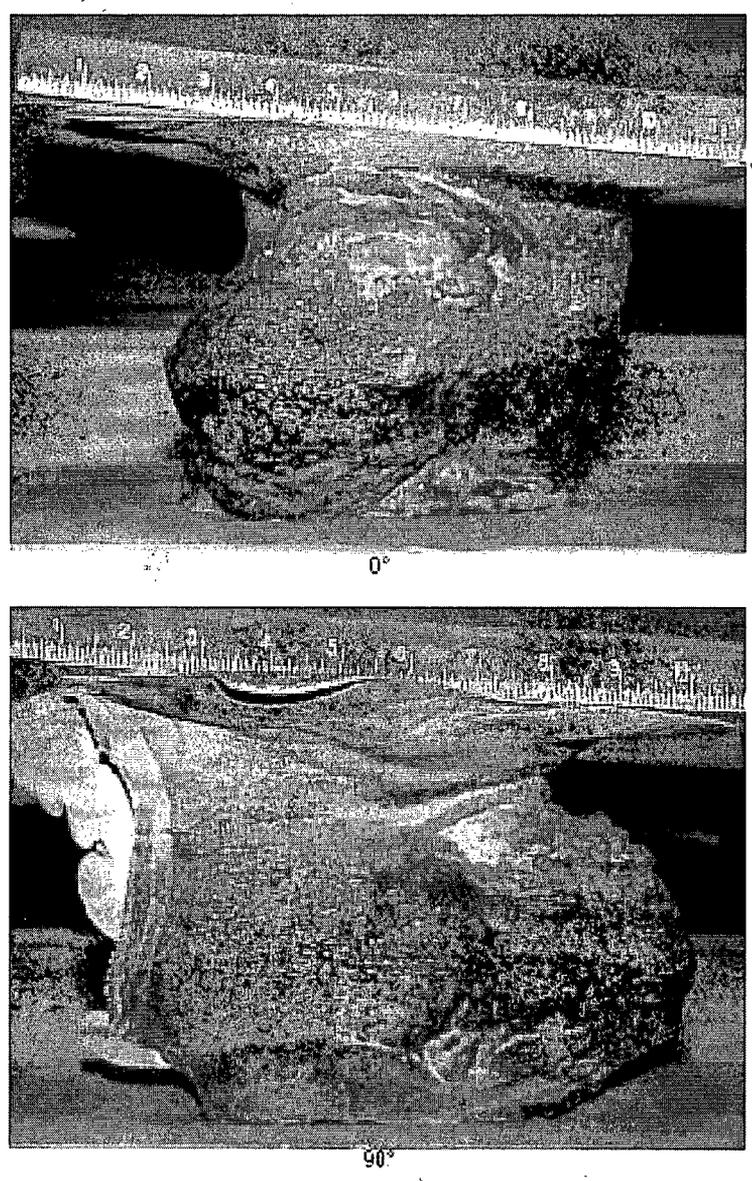
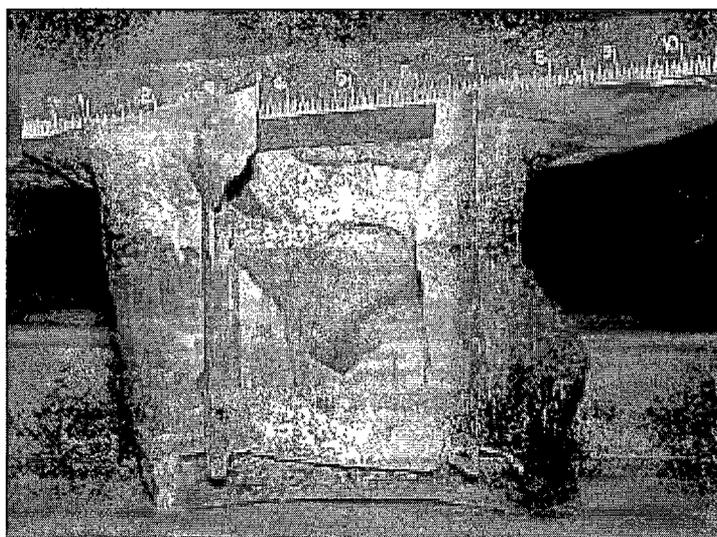
Figure 10.5(a) Photographs of cavity dental mold

Figure 10.5(b) Photographs of cavity dental mold

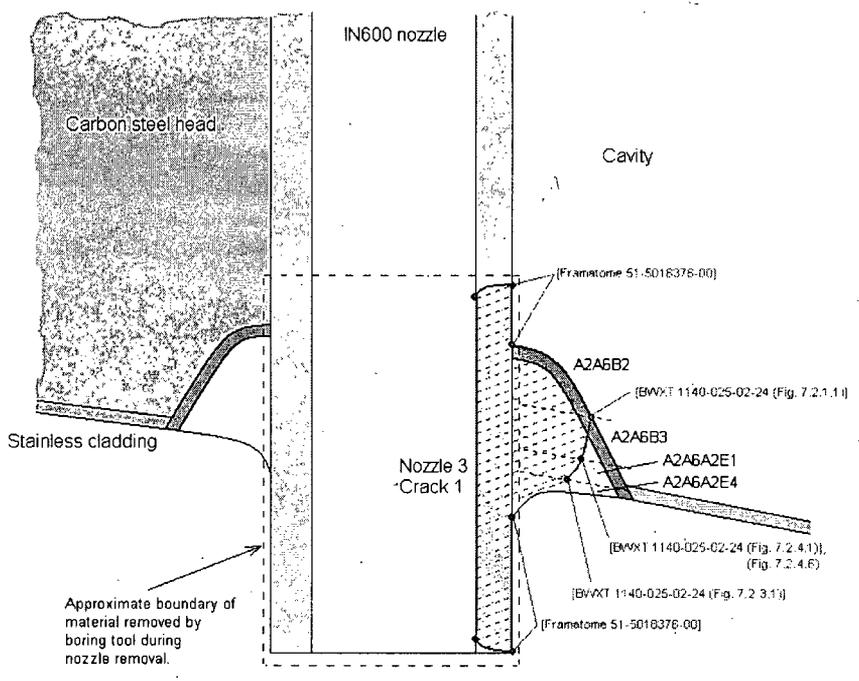
However, careful metallurgical examination of the portion of the J-groove weld that remained after the RPV head section containing the cavity was removed from the RPV head, together with the UT data, allowed us to build up a composite picture of the large nozzle and weld crack at CRDM Nozzle 3 that is shown in Figure 10.8 (See Section 8.4.2).

- A large axial through-wall crack (Crack 1) at the 3° location at the top of the J-groove weld extended from almost the bottom of Nozzle 3 to 1.23 inches above the weld on the OD.
- This axial nozzle crack appears to have extended into and almost completely across the J-groove weld at Nozzle 3.
- The metallurgical examination of this weld crack showed that it was quite wide and extended approximately 0.75 inches across the weld in the radial direction at the 10° location (Figures 10.9 through 10.14).
- The weld crack was in line with the upward bulge and crack in the stainless steel cladding at the bottom of the wastage cavity. The bulge in the cladding may have contributed to opening of the weld crack.

Figure 10.8 Schematic of final size and shape of Crack 1 in Davis-Besse CRDM Nozzle 3 (from Section 8, Figure 8-10)

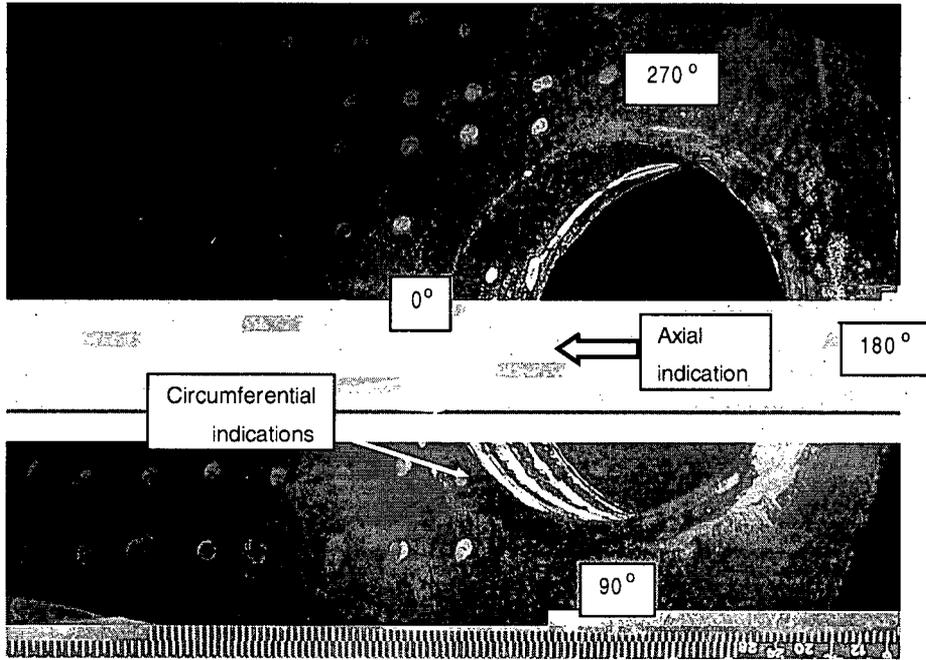
Figure 10.9 PT results for nozzle 3 J-groove weld bore and cladding underside. The J-groove weld contained an axial indication near 10° on the bore ID and circumferential indications on the RCS side from ~20° to ~45°.

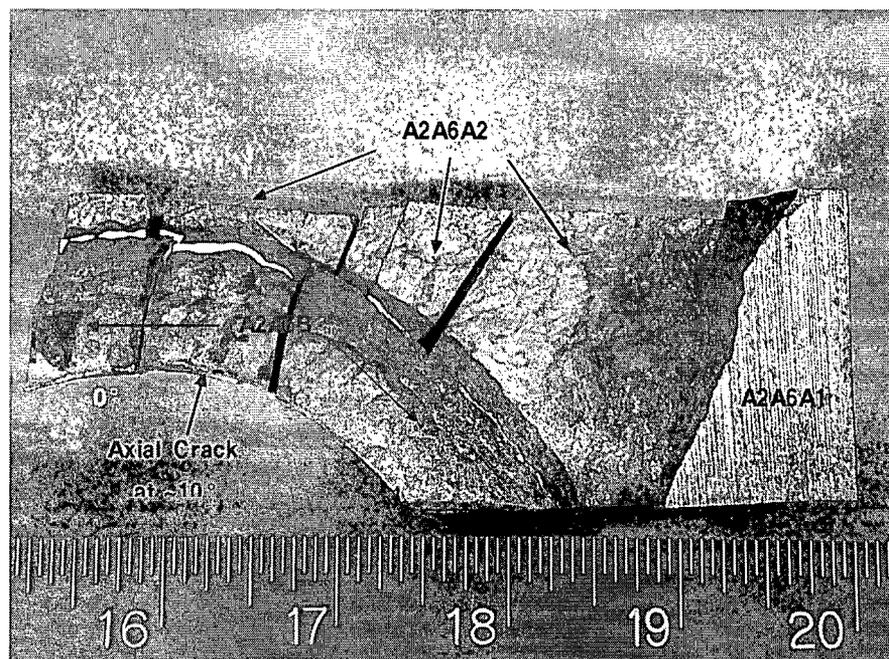
Figure 10.12 Piece A2A6 was first sectioned into Pieces A2A6A and A2A6B. Piece A2A6A was further sectioned into Pieces A2A6A1 and A2A6A2. Both cuts were made on the same plane, parallel to the paper. The first cut line is partially visible; Piece A2A6B is the upper portion of the weld. The second cut line between Pieces A2A6A1 and A2A6A2 is obscured by Piece A2A6A1

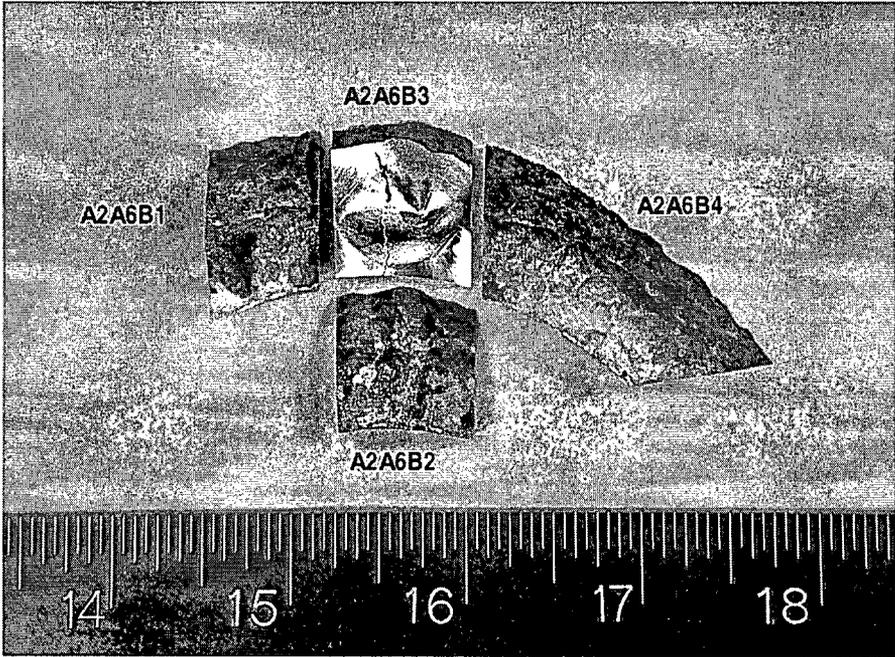
Figure 10.13

Piece A2A6B after sectioning. The bottom surface of A2A6B2 was mounted. The axial crack in A2A6B3 was opened up for SEM.

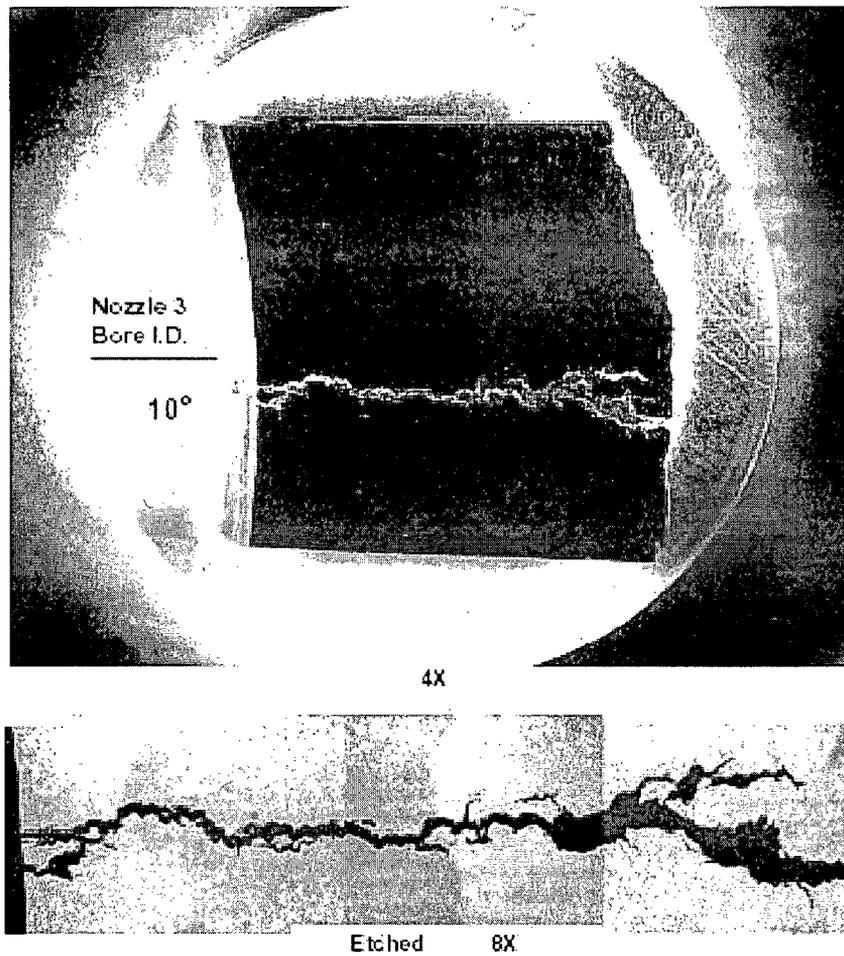
Figure 10.14 Macro photograph of metallographic mount sample A2A6B2 (see Figures 5.4 and 5.5 for the sample orientation). The axial cracking at $\sim 10^\circ$ is through the J-groove weld, in contrast to the cracking near 180° , which was partially through the weld. A slightly higher magnification micrograph is also provided
